Technical Service BULLETIN

A/C COMPRESSOR MAINTENANCE FOR STORED VEHICLES

AC002-00

HEATING & AIR CONDITIONING

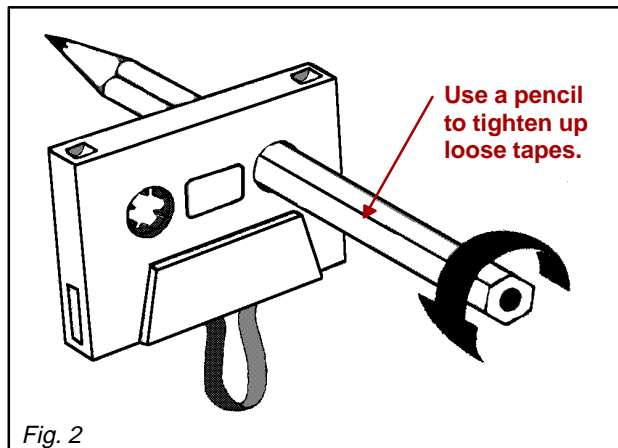
1. Remove the cassette from the player when the cassette is not in use.
2. Store the cassette in its case.
3. Store the cassette in a cool, dry area away from direct sunlight and magnetic components such as speakers.
4. Avoid touching the tape itself. This could result in poor sound quality or sound drop out.
5. Keep the tape tightly wound as shown in figure 2. Tape speed can be affected by loosely wound tape.

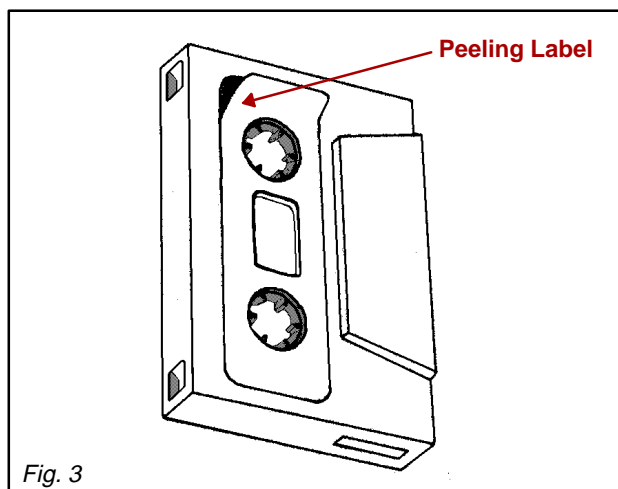
6. Avoid inserting a cassette into the player if the cassette label is loose or peeling as shown in figure 3. This can cause a cassette to become stuck in the player.

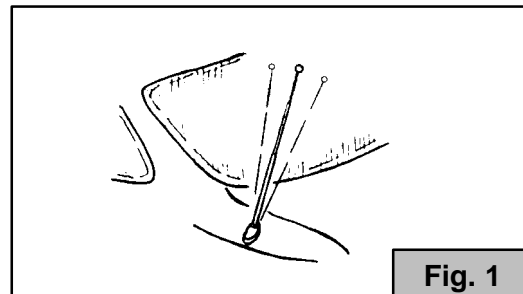
Fig. 1

1. Tune the radio to a strong, static-free AM station and slowly move the tip of the antenna mast forward and back approximately 2 inches (Fig. 1). If static noise is not heard, go to Step 2. If static noise is heard during antenna movement, replace the antenna mast and go to Step 3.

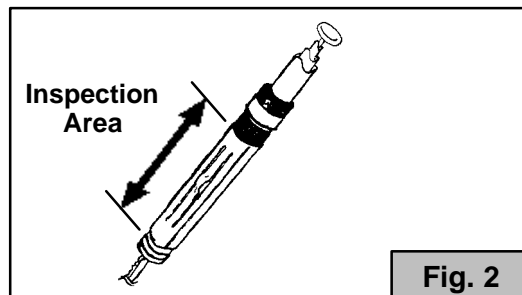
Fig. 2

2. Remove the antenna mast and inspect the base of the mast for corrosion and damage (Fig. 2). Clean with 1500 grit sandpaper.
3. Remove the antenna assembly and inspect the inner fender around the antenna hole for corrosion (Fig. 3). Clean with 1500 grit sandpaper.

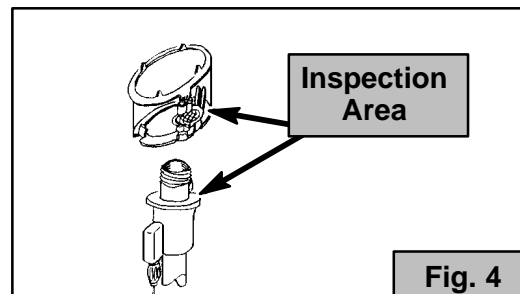
4. Remove the antenna spacer grommet at the top of the antenna assembly and inspect for corrosion (Fig. 4). Clean with 1500 grit sandpaper.

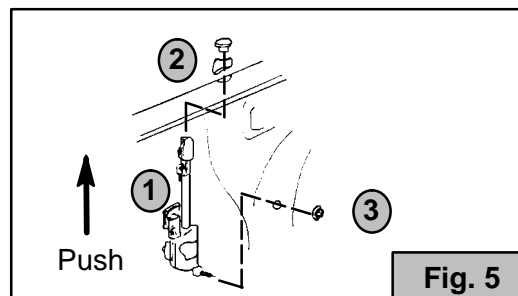
5. Reinstall the antenna assembly. Be sure to install the external antenna nut (escutcheon) first. Then install the nut which holds the assembly to the inner bracket (Fig. 5).

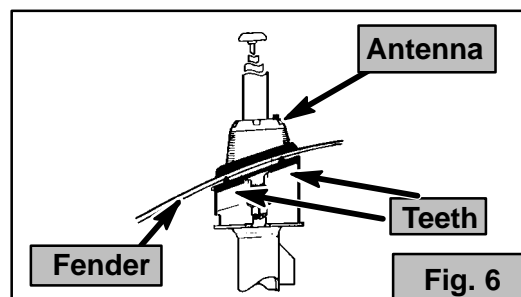
6. Check to make sure that the teeth on the antenna spacer grommet make good contact with the inner fender well (Fig. 6).

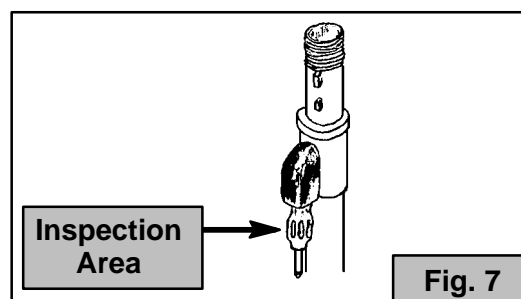
7. Inspect the antenna cable connection and clean as necessary (Fig. 7). Reconnect the antenna cable, the wire harness and the drain hose.

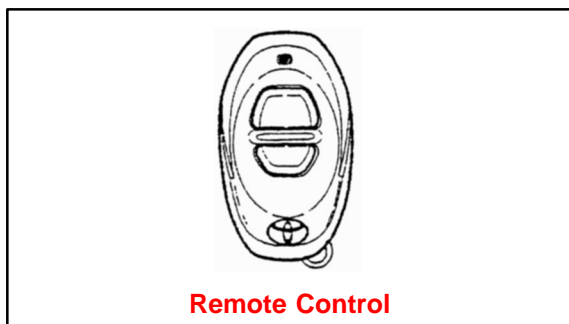
- **The remote transmitter** has two buttons, Top and Bottom.

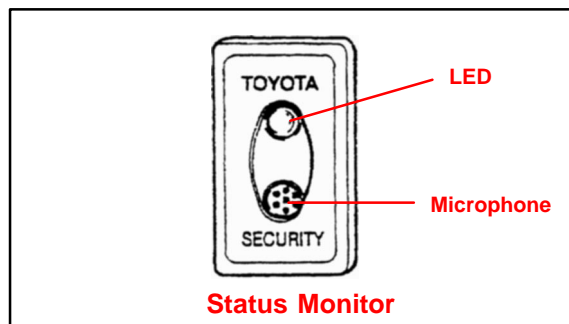
- **The status monitor** has a Toyota label, LED, and microphone.

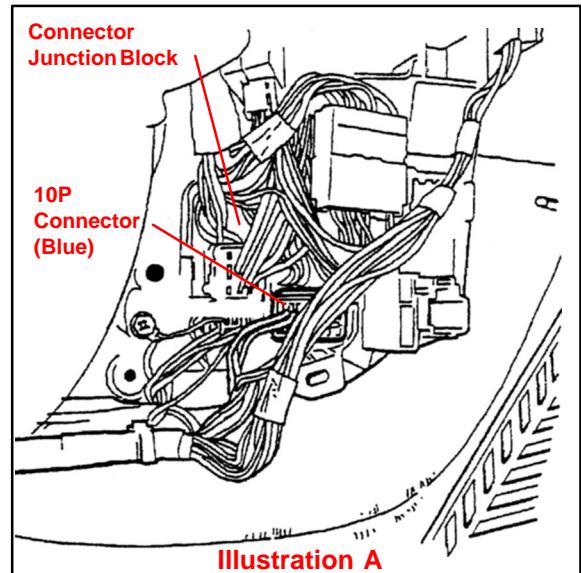
1. Remove the negative battery cable.
2. Remove the driver's step cover.
3. Remove the driver's cowl cover (1 nut).
4. Locate the Connector Junction Block in the driver's cowl area. You will notice a RED/YELLOW wire routed to the Blue 10P connector which terminates at an adjacent splicing connector. This is the TVIP Trunk Courtesy Wire.

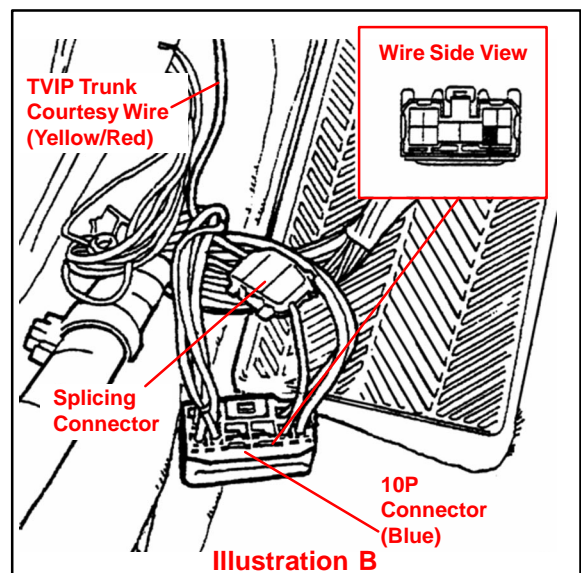
The White 1P connector for the Vehicle's Trunk Courtesy Signal is located at the trunk courtesy lamp switch near the trunk latch in the vehicle's trunk.

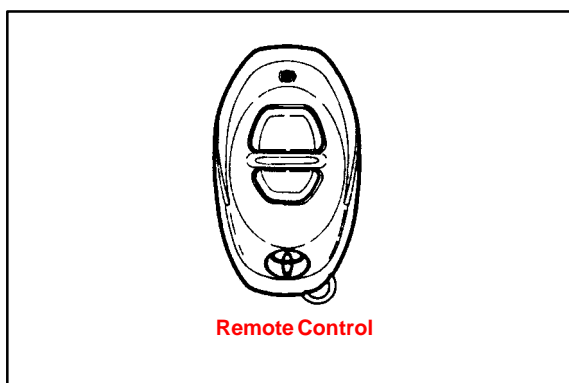
- **The remote transmitter** has two buttons, Top and Bottom.

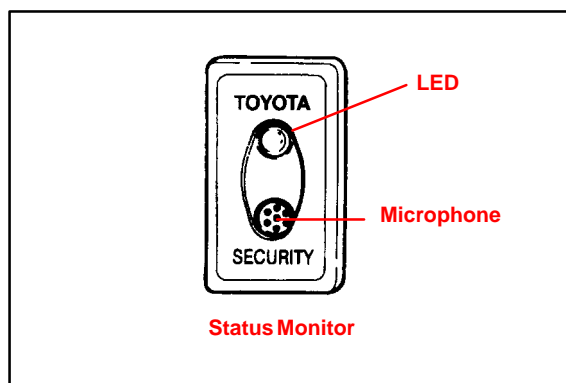
- **The status monitor** has a Toyota label, LED, and microphone.

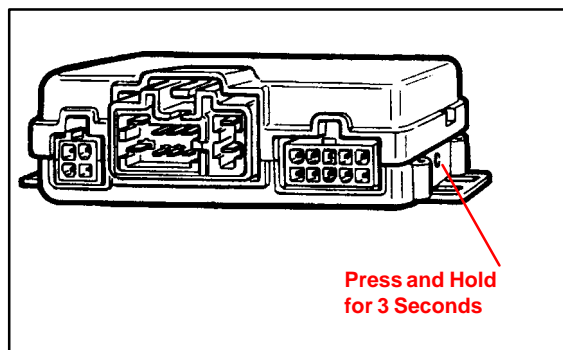
1. Insert the key into ignition switch, and turn it to "ON".
2. Press and hold the ECU's PROGRAMMING SWITCH for 3 seconds.

The STATUS MONITOR LED turns on for 5 seconds.

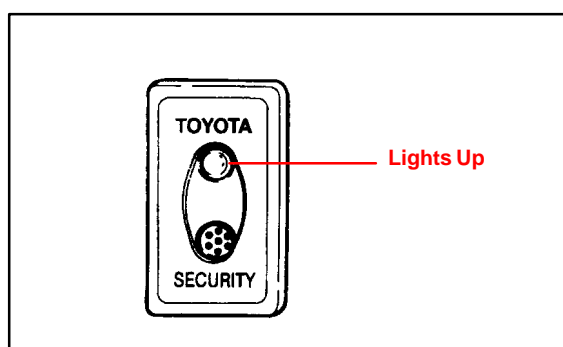
3. Press and release a REMOTE CONTROL's top or bottom button.*

The STATUS MONITOR LED turns off.

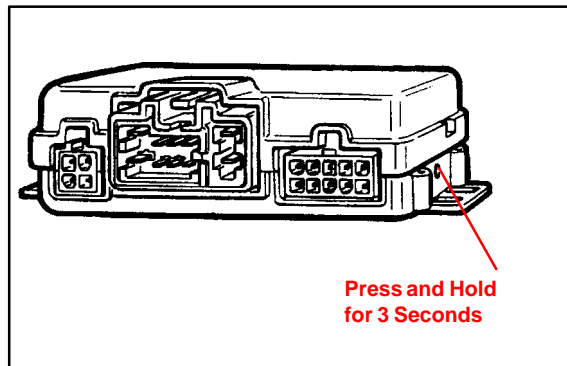
1. Insert key into the ignition switch, and turn it to “ON”.
2. Press and hold the ECU's PROGRAMMING SWITCH for 3 seconds.

The STATUS MONITOR LED turns on for 5 seconds.

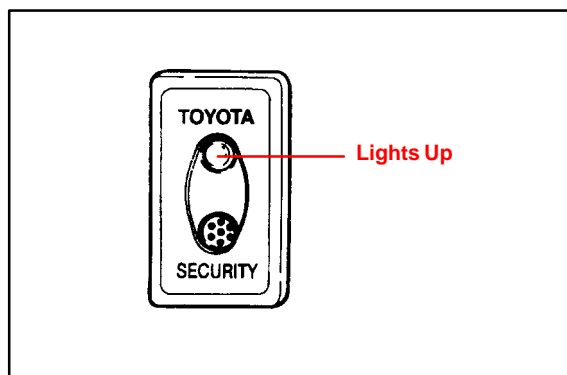
3. Press and hold the ECU's PROGRAMMING SWITCH for over 2 seconds again.

The STATUS MONITOR LED turns off, then flashes 3 times.

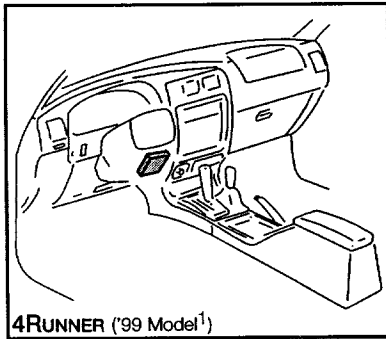
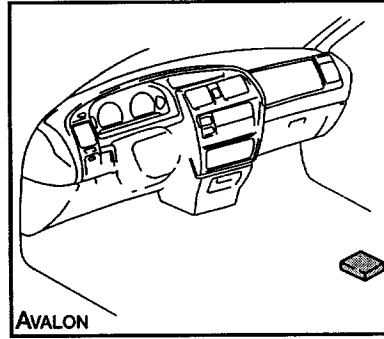
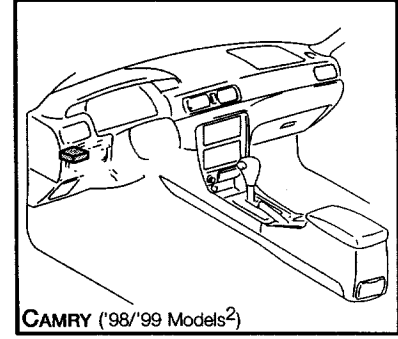
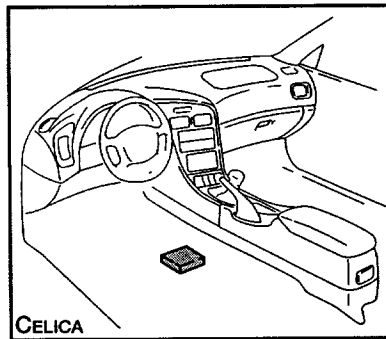
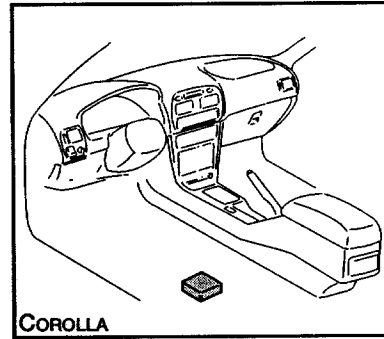
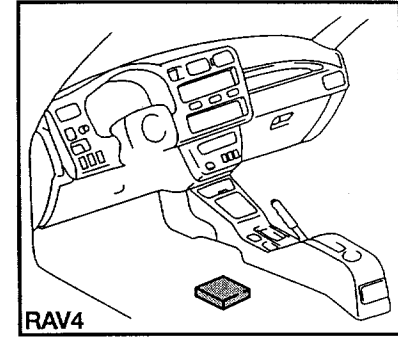
ECU MOUNTING LOCATIONS

1. '98 Model and prior has ECU located beneath the driver's seat.

2. '97 Model and prior has ECU located beneath the driver's seat.

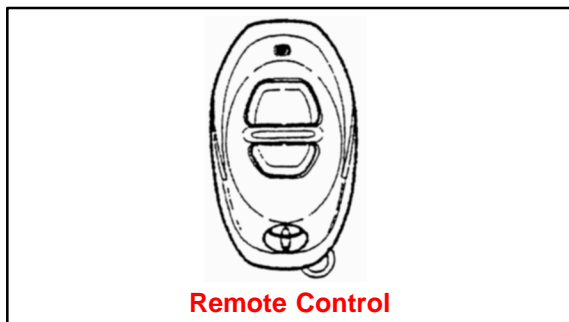
Remote Control

- The remote transmitter has two buttons, Top and Bottom.

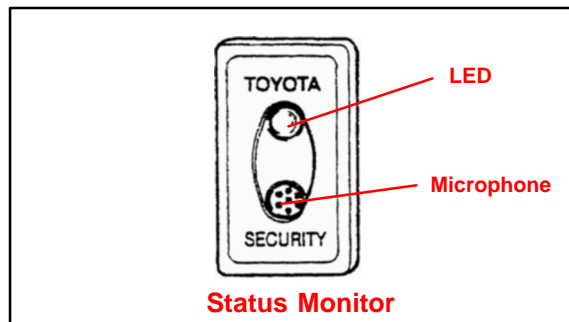
Status Monitor

- The status monitor has a Toyota label, LED, and microphone.

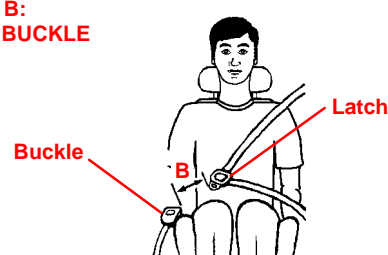
Dimension B:
LATCH TO BUCKLE

1. Place the seat in the position the applicant normally uses
2. With applicant in the seat, wearing thickest coat expected to be worn, pull belt all the way out and try to buckle belt
 - If the belt latches into buckle and feels comfortable against upper chest area, an extender is not needed.
 - If belt does not buckle continue with step 3
 - If buckle latches but belt has no slack remaining, continue with step 3
3. Measure distance between applicant's navel and seat belt buckle (dimension A) and enter on worksheet
4. With belt all the way out, measure distance between latch tip and buckle tip (dimension B) and enter on worksheet

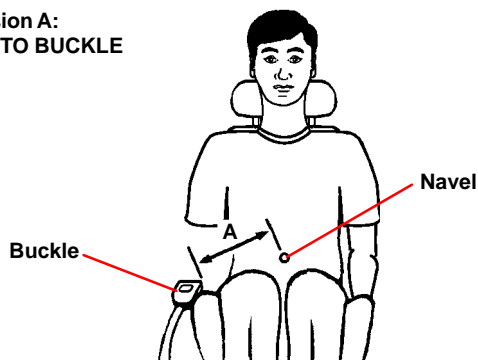
**Dimension A:
NAVEL TO BUCKLE**

1. Place the seat in the position the applicant normally uses.
2. With the applicant in the seat, wearing the thickest coat expected to be worn, pull belt all the way out and try to buckle belt.
 - If belt latches into buckle and feels comfortable against upper chest area, an extender is not needed.
 - If belt does not buckle, continue with Step 3.
 - If buckle latches but belt has no slack remaining, continue with Step 3.
3. Measure distance between applicant's navel and seat belt buckle (Dimension A) and enter on Worksheet.
4. With belt all the way out, measure distance between latch tip and buckle tip (Dimension B) and enter on Worksheet.

NOTE: If belt latches but there is no slack enter zero as Dimension B.
5. Subtract Dimension B from Dimension A and record number in Check Number box on Worksheet.
6. Seat Belt Extender length is Dimension B rounded up to next extender length (without exceeding Check Number).

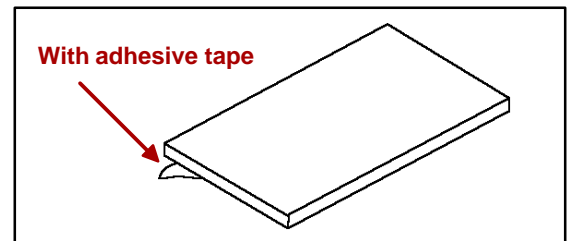
1. Caulking Sponge Sealant No. 1, No. 2 and No. 3 (Ept-sealer).

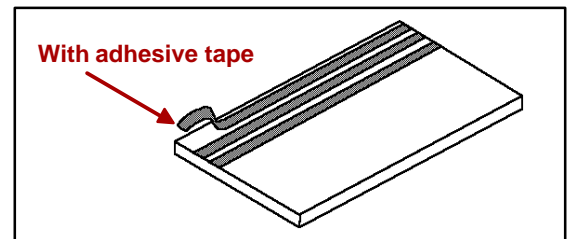
2. Caulking Sponge Sealant No. 4 and No. 5 (Ept-sealer). This sheet is divided into 27 strips, 5 mm wide.

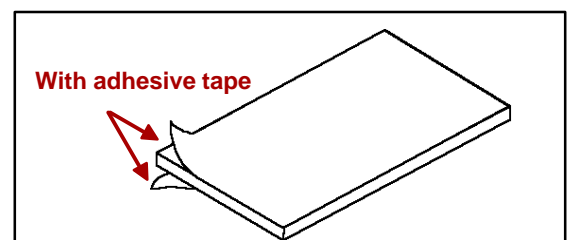
3. Caulking Sponge Sealant No. 6 (Ept-sealer).

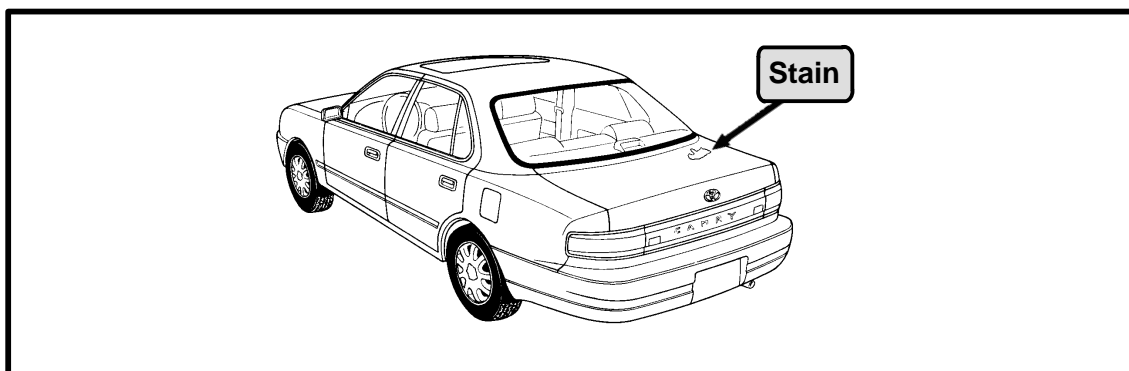
On some Toyota models, when Rapgard is removed from the vehicle, a stain is left on the paint surface. This stain can be seen under the clear coat and is not a defect of the clear coat. The stain corresponds to a wrinkled area of Rapgard which retained liquids, such as window washer fluid, that left a discoloration.

To remove a stain from a vehicle, heat the stain surface to a temperature of 70°C – 80°C. When the stain is removed it will not reappear.

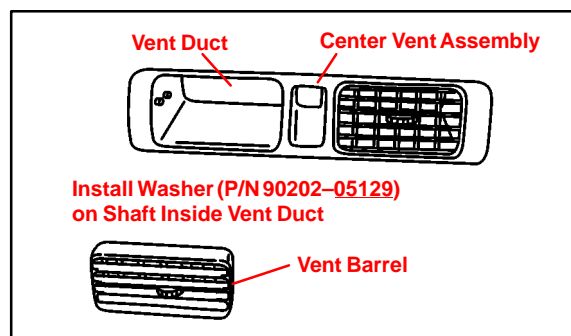
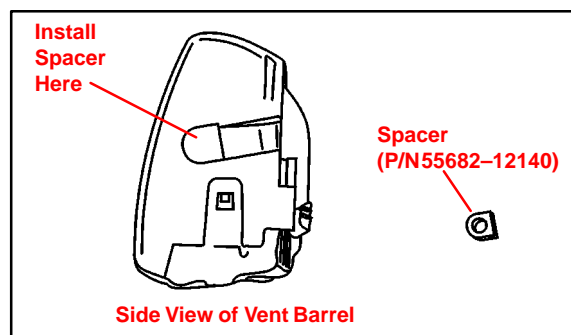
1. Remove the left vent barrel by gently prying using a wide flat tool with smooth edges. Be careful not to damage the vent assembly.
2. Install a washer (P/N 90202-05129) on the shaft inside the vent duct.
3. Reinstall the vent barrel by carefully pushing it into position until it locks onto the shafts on the sides of the duct. Be sure the spacer and/or washer do not fall down into the vent duct.

4. Confirm that the vent vertical adjustment is tighter and moves smoothly.
5. Repeat steps 1 through 4 for the right center vent.

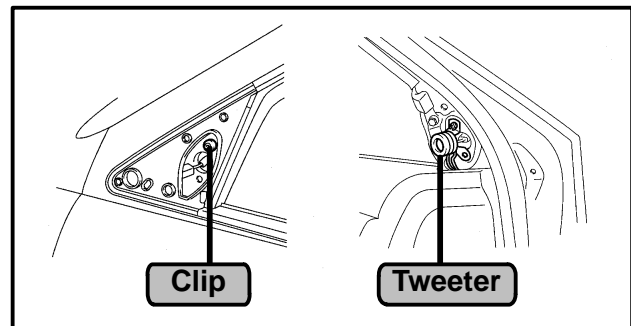
1. Remove the retaining clip and tweeter (if applicable) from the door. Discard the removed clip.

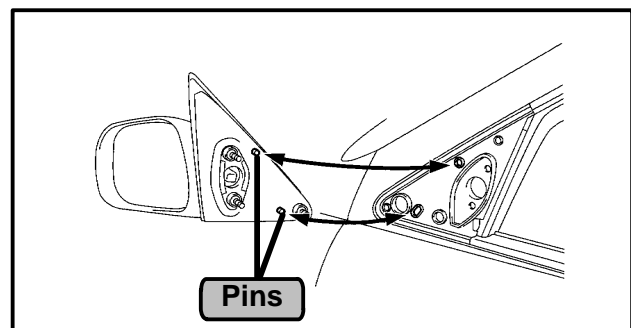
2. In order to secure the door mirror to the correct position, insert the 2 pins of the door mirror base into the holes of the door.

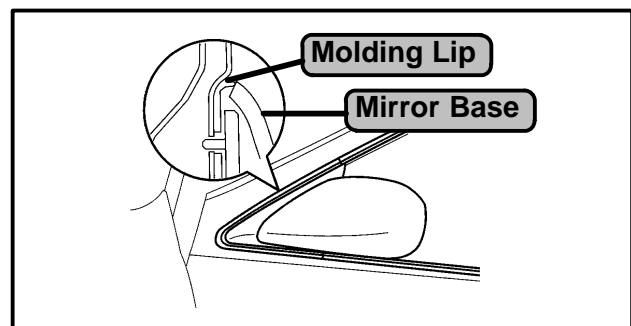
3. Push the door mirror against the door and check that the door mirror base edge is in contact with the door frame molding lip.

NOTE: This area is critical to wind noise reduction.

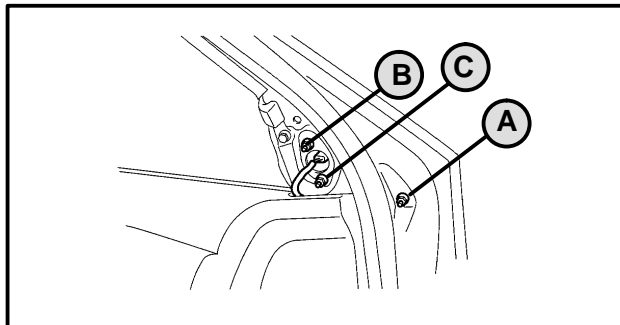
Torque: 5.5 N.m (56 kgf.cm, 49 in.lbf)

Connect the mirror wire.

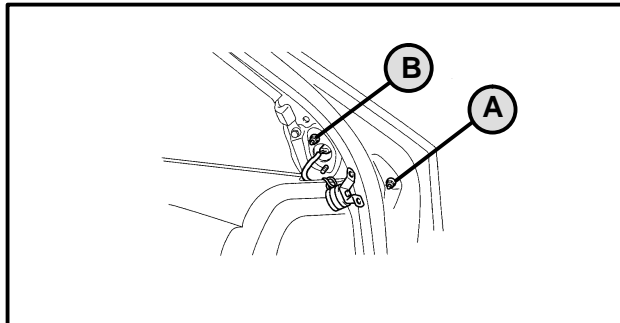
5. Tighten the two mirror mounting nuts **A** and **B** for vehicles with a tweeter.

Torque: 5.5 N.m (56 kgf.cm, 49 in.lbf)

Connect the mirror wire.

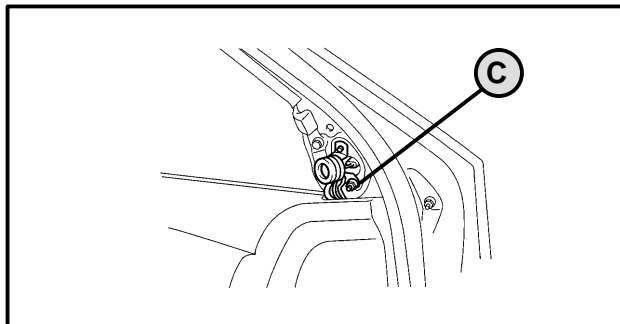
While lightly pulling the mirror wire backward, install the tweeter and tighten nut **C**.

Torque: 5.5 N.m (56 kgf.cm, 49 in.lbf)

NOTE: Check that the mirror wire is free from the tweeter bracket.

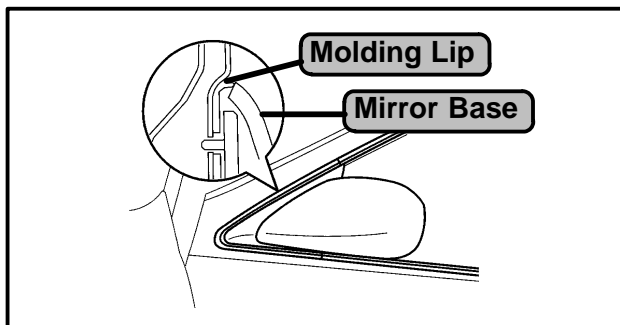
6. Check the following items:

- There is no clearance between the door mirror base and the door molding lip.
- The door frame molding lip is not tucked under the mirror base.

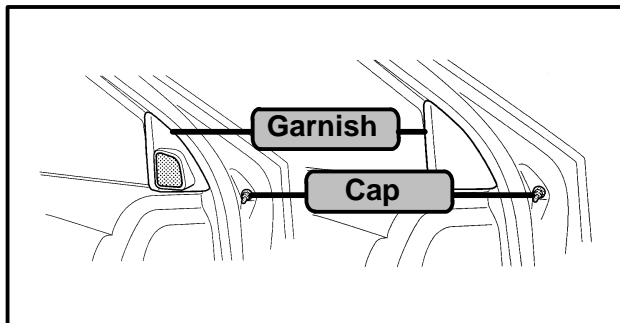
7. Install the front door lower frame bracket garnish.

8. Install the black cap onto the nut.

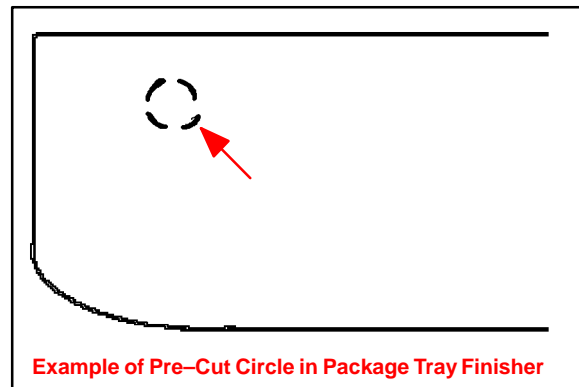
2. Remove a 20 mm diameter area of the carpet or trim material above the bracket mounting location. In some vehicles, a 20 mm circle is already pre-cut into the interior trim material. Once the interior trim material is removed, the nuts welded in by the factory should be visible.

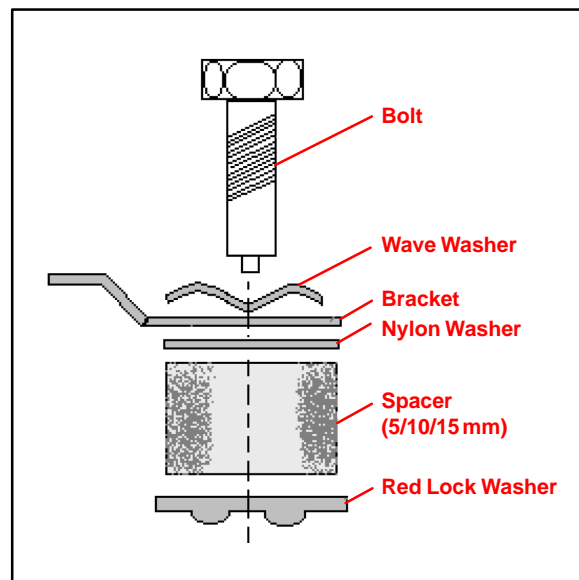
3. If a 5 mm or 15 mm spacer is specified, remove the red lock washer from the Bracket Sub-Assembly (P/N 73709–12010) and remove the 10 mm spacer. Assure the red lock washer is re-installed onto the bolt. If a 5 mm spacer is needed, use the 15 mm bolt from the CRS Kit (P/N 04731–22012).

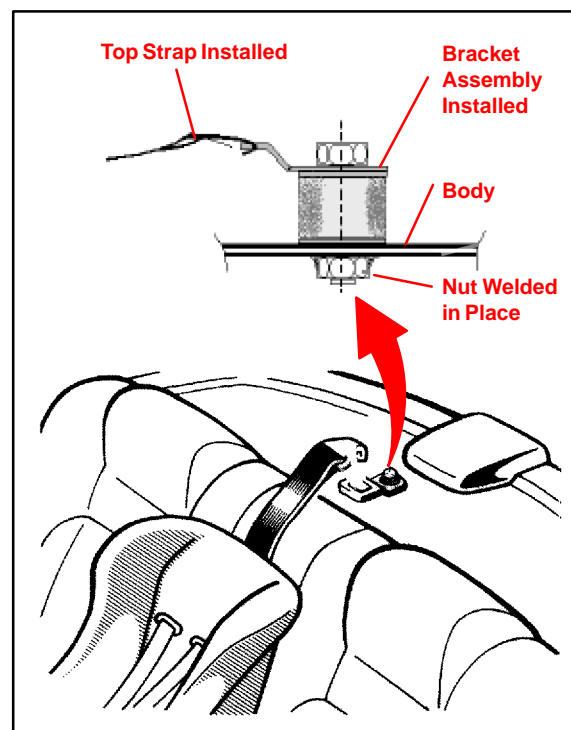
4. Install the bracket assembly, according to the directions in the Owner's Manual. Tighten the bolt to 16.5 – 24.7 N-m, (1.68 – 2.52 kgf-m, 12.2 – 18.2 ft-lbf).
 - Assure the top strap is attached to the child seat, according to the child seat manufacturer's instructions.
 - Assure the child seat is installed in the vehicle according to the Toyota Owner's Manual (seat section).

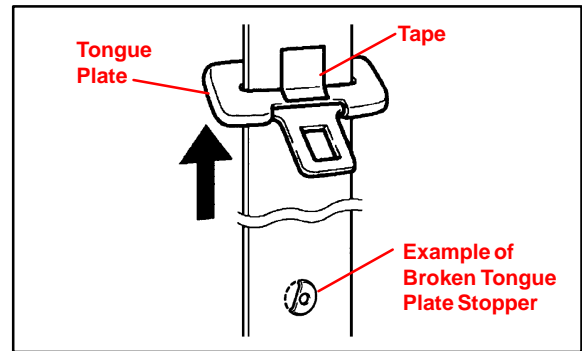
- A. Shift the Tongue Plate to the upper portion of the Tongue Plate Stopper, and temporarily hold it with a clip or tape.
- B. Remove any pieces of the original Tongue Plate Stopper in the webbing, with a pair of pliers.

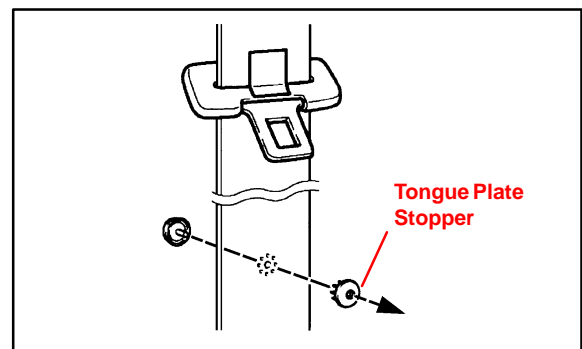
- A. Install a new Tongue Plate Stopper in the hole of the webbing.

Be aware of the installation direction of the Tongue Plate Stopper as shown in the illustration.

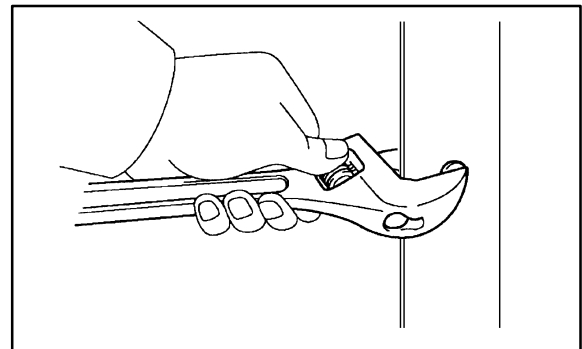
- B. Pinch the Tongue Plate Stopper into the webbing using an adjustable wrench, and turn and push the adjustment screw by hand.

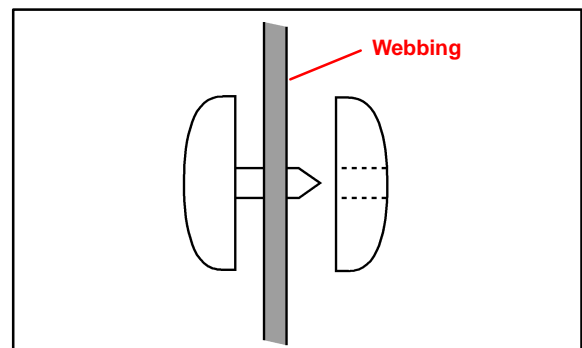
Press the adjustment screw in order to position the male and female parts of the Tongue Plate Stopper parallel to each other, as shown in illustration.

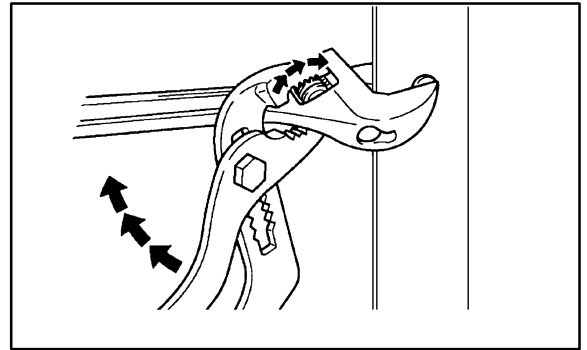
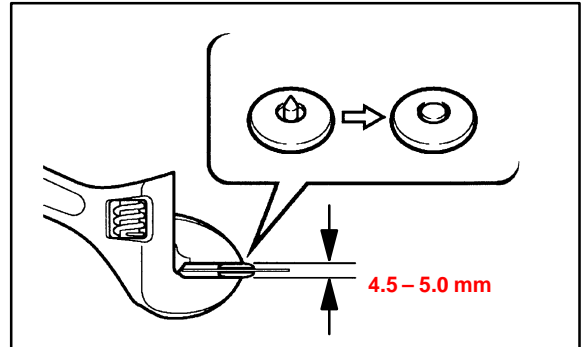
- C. When the adjustment screw for the adjustable wrench can't be turned by hand, tighten the adjustment screw using a pair of adjustable joint pliers until the space between jaws of the adjustable wrench is 4.5 – 5.0 mm. (See illustrations.)

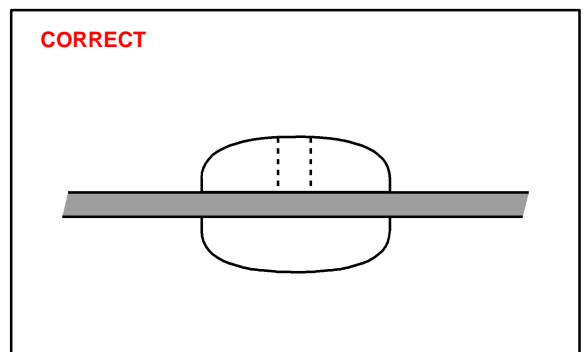
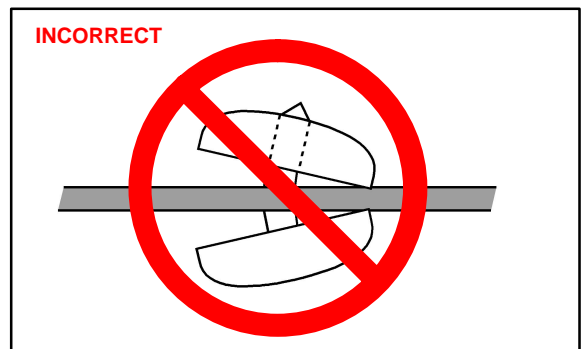
- D. Check to be sure that the male pin of the Tongue Plate Stopper has become deformed evenly in the hole of the female part and is firmly held to the belt webbing. (See illustrations.)

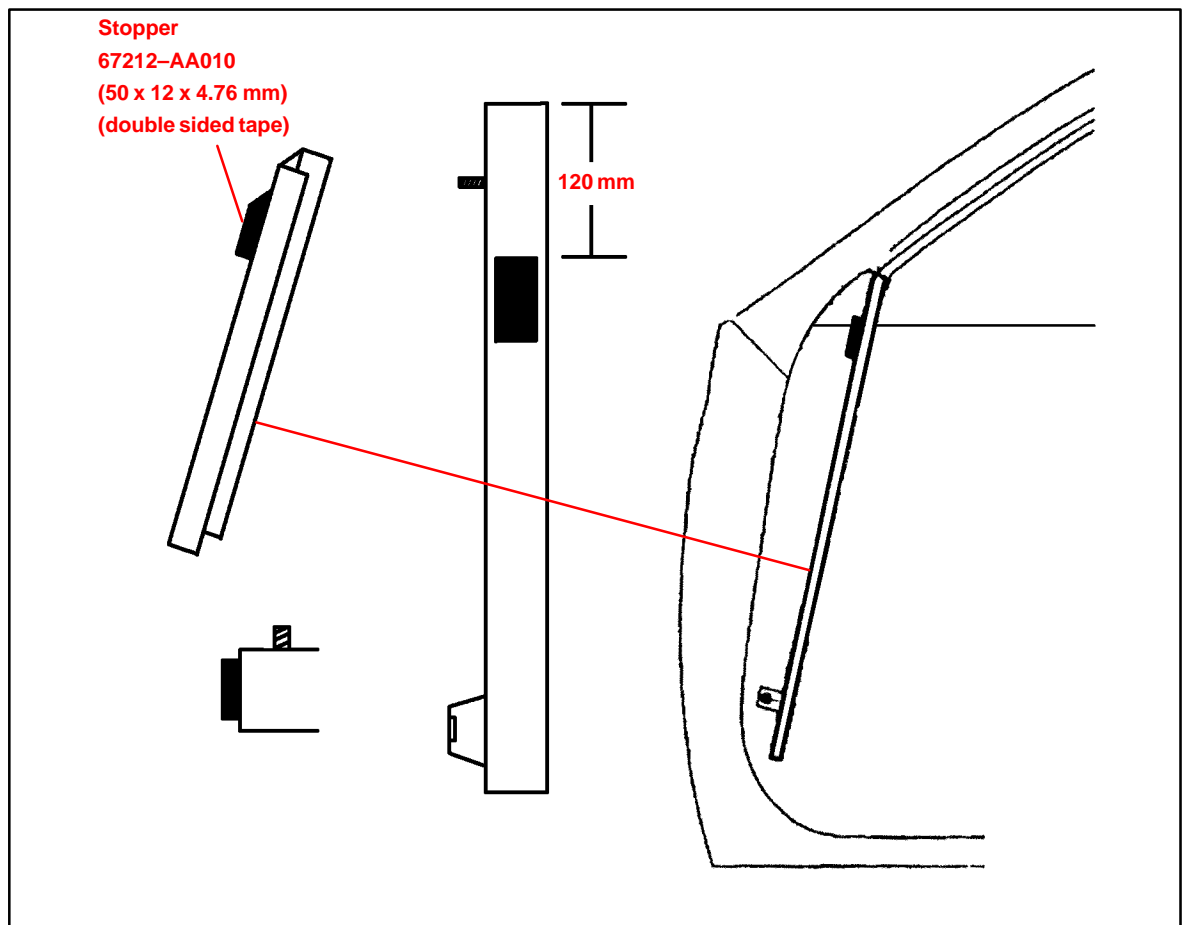
1. Remove the front door trim to gain access to the window components.
2. Inspect the front and rear lower frames and the door glass run for damage as a result of the glass being displaced.
 - In cases of slight deformation of window frames, reform as necessary. If significantly deformed or damaged, replace the frame.
 - Replace the window run if cut, torn, mutilated, etc.
3. Replace any damaged parts.
4. Remove front lower frame from the door and attach the self-adhesive rubber stopper (P/N 67212-AA010) 120 mm from the top of the frame as shown below.

To insure proper adhesion of the self-adhesive rubber stopper, the surface of the frame must be cleaned to remove any foreign material.

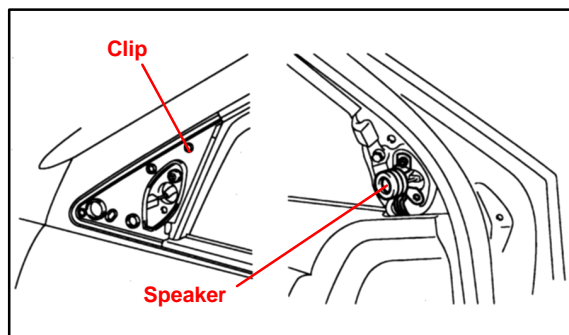
1. Remove the retaining clip and speaker (if applicable) from the door. Discard the removed clip.

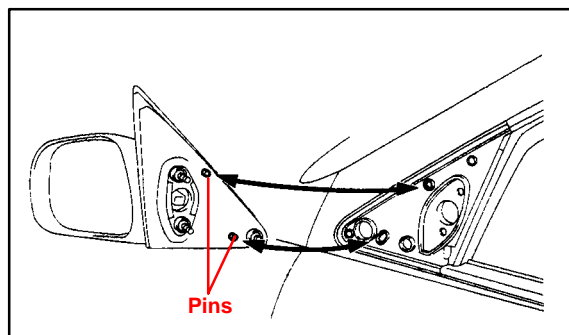
2. In order to secure the door mirror in the correct position, insert the 2 pins of the door mirror base into the holes of the door.

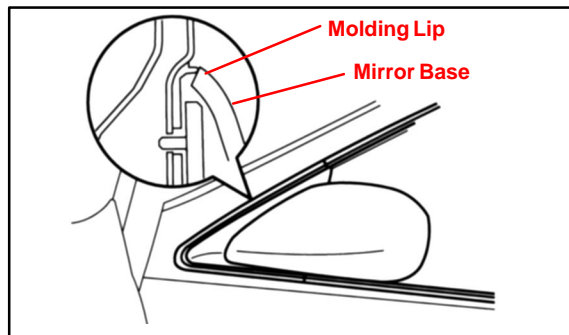
3. Push the door mirror against the door and check that the door mirror base edge is in contact with the door frame molding lip.

This area is critical to wind noise reduction.

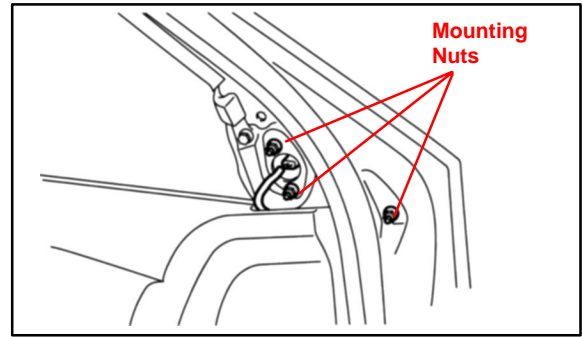
Torque: 5.5 N•m (56 kgf•cm, 49 in•lbf)

Connect the mirror wire.

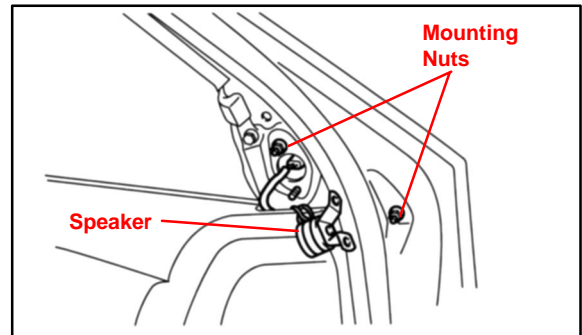
5. For vehicles with a speaker, tighten the two mirror mounting nuts.

Torque: 5.5 N•m (56 kgf•cm, 49 in•lbf)

Connect the mirror wire.

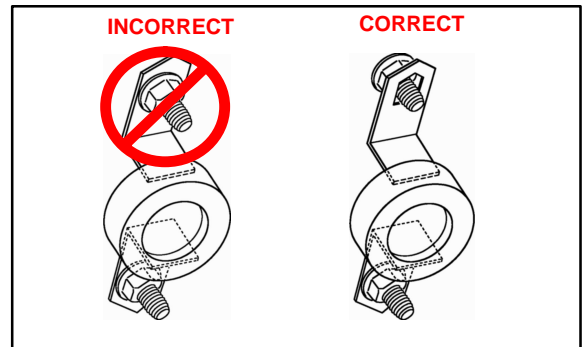
While lightly pulling the mirror wire backward, reinstall the door speaker (one nut at the lower bracket) onto the door as shown in the illustration.

Torque: 5.5 N•m (56 kgf•cm, 49 in•lbf)

- Do NOT mount the upper speaker bracket behind the nut.

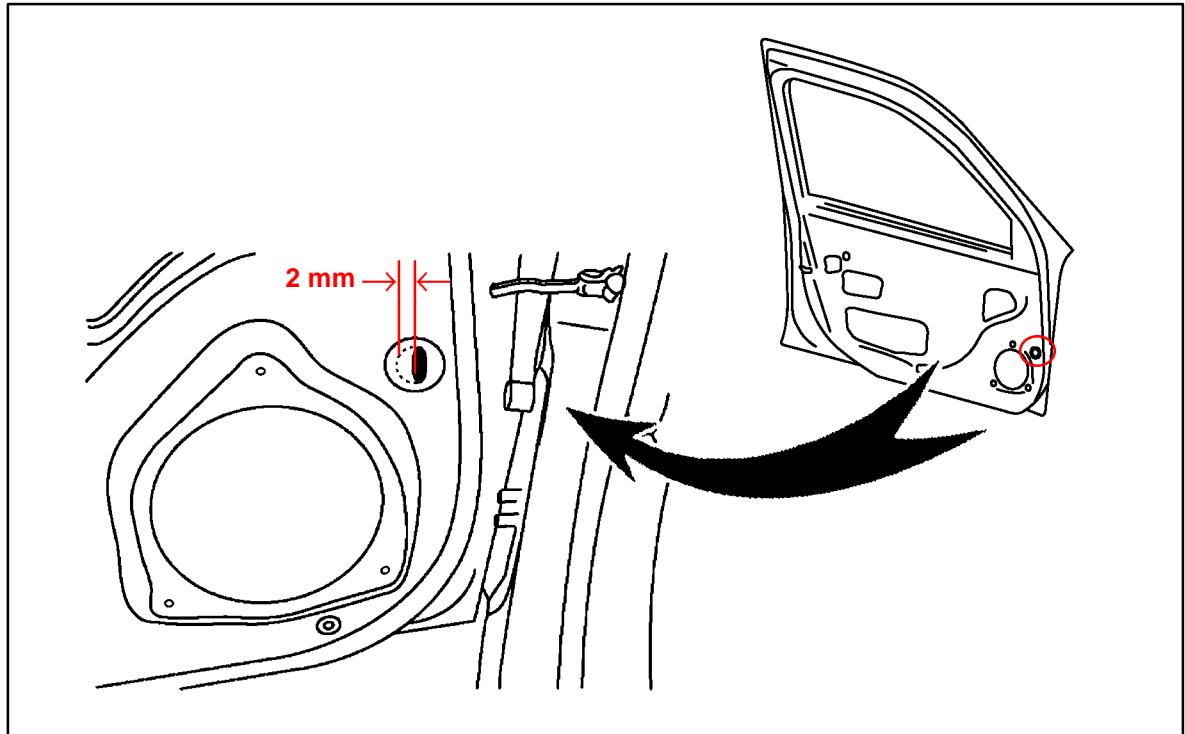
1. Lower the door glass, disconnect the power window switch, remove the front door trim panel, speaker, and loosen the door mirror mounts to gain access to the door glass and lower frames. Remove the front lower frame (2 screws).
2. Locate the lower window frame mounting hole on the door (see illustration). Place a towel or shop rag in the speaker hole to catch metal chips. Using a round file or die grinder, enlarge the hole 2 mm toward the speaker (rear of the vehicle). Remove the towel or shop rag and any metal chips in the door. Apply touch-up paint or rust preventative to the hole.

3. Install a rubber stopper to the lower window frame according to directions in TSB BO012–99.
4. Install the lower window frame. Assure the frame is tight against the glass and the run is fully inserted in the lower window frame channel.
5. Temporarily connect the power window switch and operate the window. Check to assure the door glass fully opens and closes easily.
6. Reinstall the door panel and components, check lock/unlock function and door opening handle function.

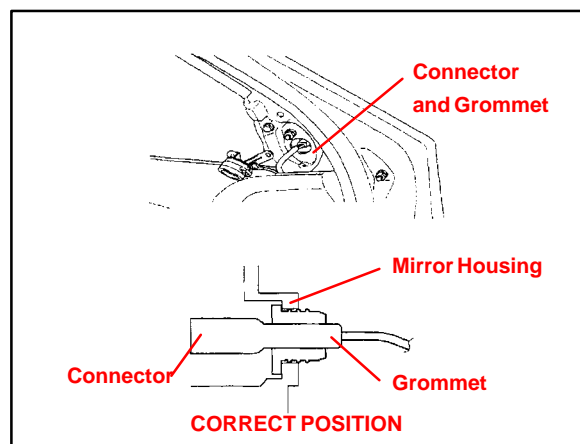
1. Carefully pry off the door speaker cover and remove the nut using a 10 mm socket that secures the speaker to the door.
2. Look through the door mirror harness access hole and check the position of the wire harness grommet and wire harness connector – the harness connector should be inside the grommet and the grommet should be fully seated in the mirror housing.

3. To reposition the grommet and/or harness connector onto the mirror housing:
 - Remove the mirror housing (3 nuts) from the door and carefully unclip the mirror from the housing. This will allow easier access and reinstallation of the grommet and/or harness connector.
 - Reposition the grommet so it is fully seated to the mirror housing. Assure the harness connector is inside the grommet.

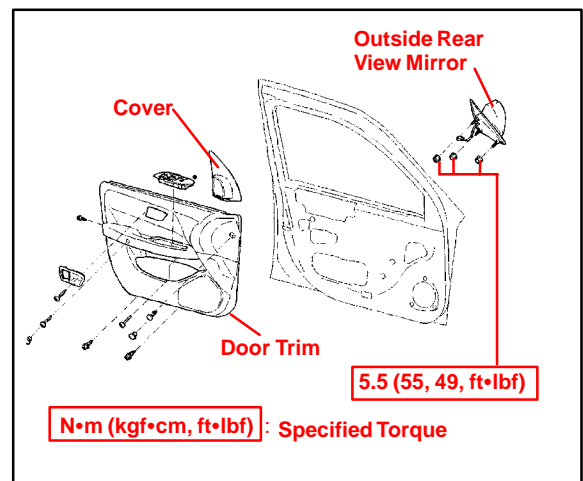
4. Reinstall the door mirror and speaker assembly:
 - Secure the mirror to the housing.
 - Properly align and reinstall the mirror assembly to the door. tighten the three nuts. Torque: 5.5 N•m (56 Kgf•cm, 49 in•lb)
 - Reinstall the door speaker (one nut) and speaker cover onto the door.
 - Assure the power mirror adjustment and the door speaker functions properly.

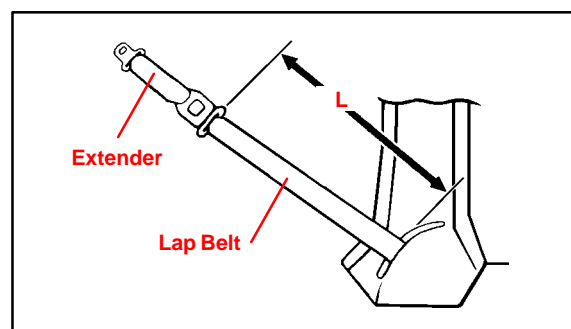
^{*1} If dimension "L" (length when in use) is under 24 inches the extender must not be used due to its design and construction (illustration).

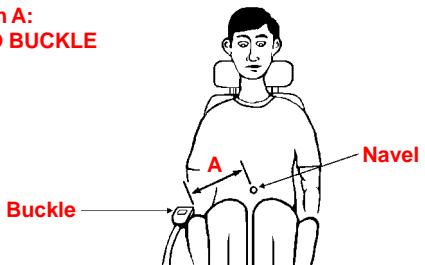
Dimension A: NAVEL TO BUCKLE

- Place the seat in the position the applicant normally uses
- With applicant in the seat, wearing thickest coat expected to be worn, pull belt all the way out and try to buckle belt
 - If the belt latches into buckle and feels comfortable against upper chest area, an extender is not needed.
 - If belt does not buckle continue with step 3
 - If buckle latches but belt has no slack remaining, continue with step 3
- Measure distance between applicant's navel and seat belt buckle (dimension A) and enter on worksheet
- With belt all the way out, measure distance between latch tip and buckle tip (dimension B) and enter on worksheet

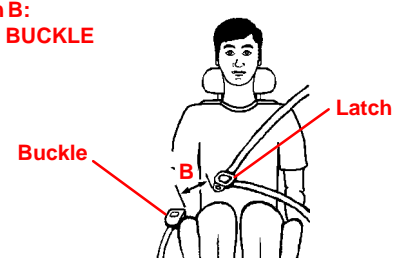
Dimension B:
LATCH TO BUCKLE

- Place the seat in the position the applicant normally uses
- With applicant in the seat, wearing thickest coat expected to be worn, pull belt all the way out and try to buckle belt
 - If the belt latches into buckle and feels comfortable against upper chest area, an extender is not needed.
 - If belt does not buckle continue with step 3
 - If buckle latches but belt has no slack remaining, continue with step 3
- Measure distance between applicant's navel and seat belt buckle (dimension A) and enter on worksheet
- With belt all the way out, measure distance between latch tip and buckle tip (dimension B) and enter on worksheet

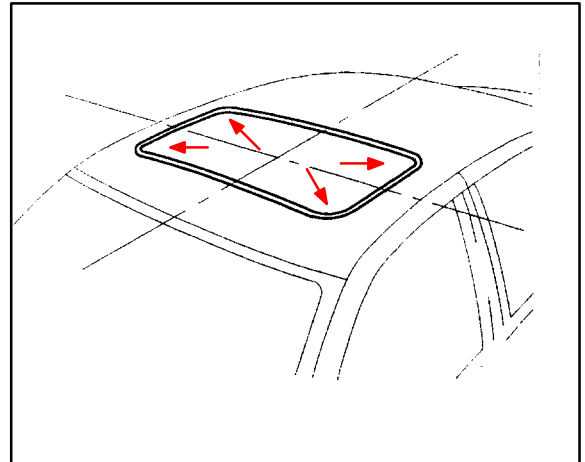
A long speedometer cable can be inserted into each drain, to determine if the drain tubes are exiting to the ground instead of inside the vehicle.

Do **NOT** blast air down the tube because this can cause the drain tube to become disconnected from the sliding roof.

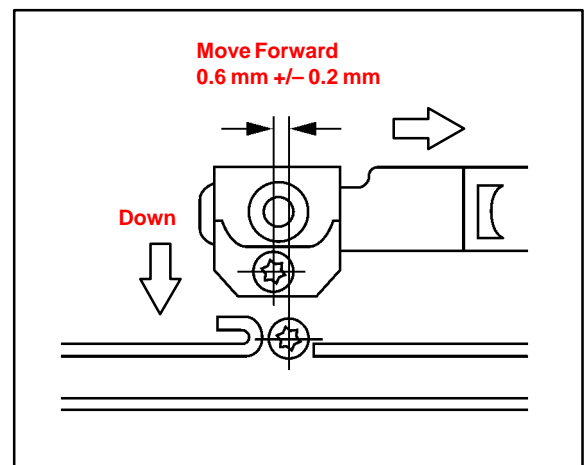
Guide Pin Adjustment

Adjustments are noted in the 2001 Camry Repair Manual, page BO–69.

In addition, when the guide pin roller moves up and down, the Lift Arm should be able to move forward–backward a distance of 0.6 mm \pm 0.2 mm.

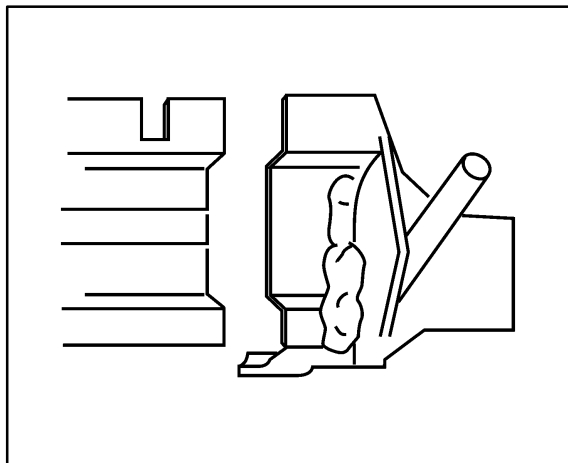
The Repair Manual recommends applying Seal Packing P/N 08826-00090 for installation of the drain cap. Since this product is not available through the parts department, the recommended product is:
3M Windo-Weld Sealer – Black
(3M Part Number 08606)

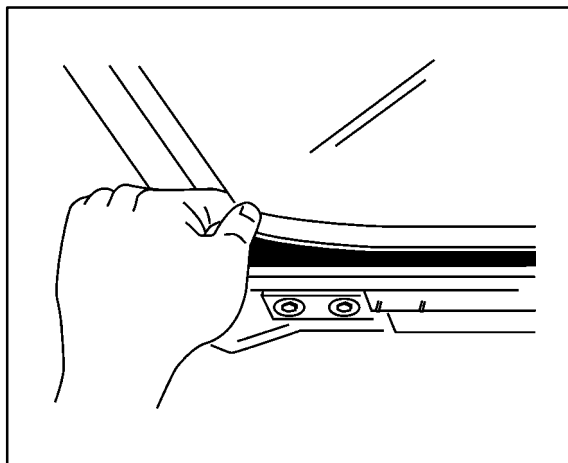
**Moon Roof Opening Trim Removal**

The opening trim has three integrated snaps.

First remove the front section in a perpendicular motion, then remove the other sections.

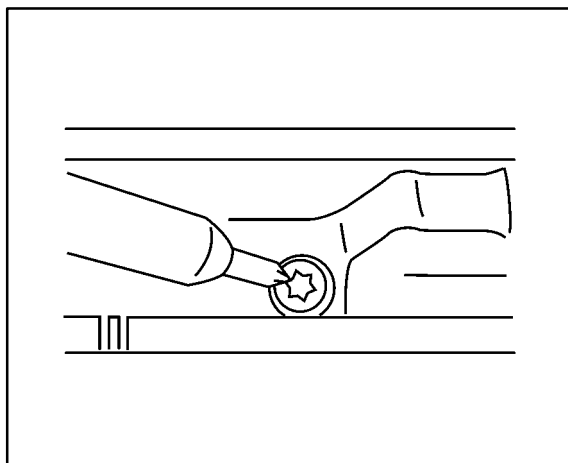
**Glass Panel Removal**

If the screws (4 screws, Torx Screw Driver) cannot be reached, move the sliding roof forward by turning the motor drive shaft with a hex wrench.

Assure the glass panel is adjusted according to the specifications in the 2001 Camry Repair Manual page BO-62.

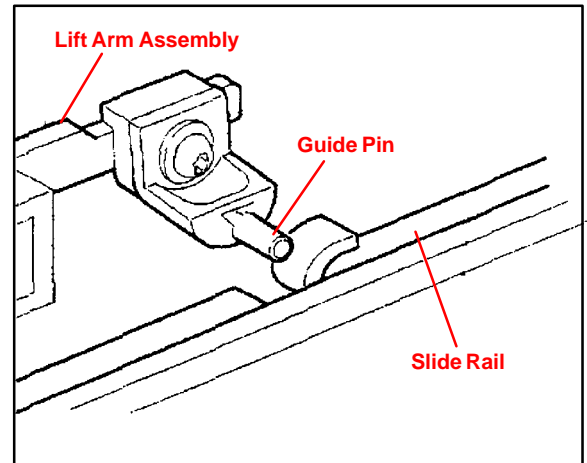
From the outside of the vehicle, loosen the guide pin.

Move the guide pin **rearward** in small increments, until glass closes evenly and exhibits no popping sound. Tighten the pin.

Cycle the sliding roof to verify proper adjustment.

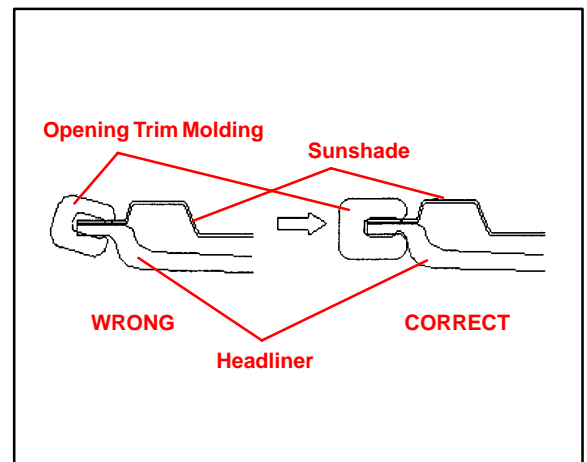
Confirm the opening trim molding is attached to the headliner so it does not contact the sunshade.

If the trim is pushed up, it will rub against the sunshade and cause the sunshade to drag.

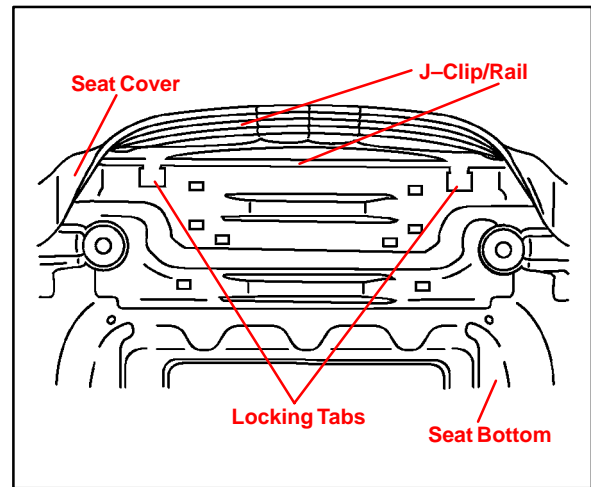
1. For easier repair remove the complete seat assembly.
2. If necessary, remove the manual seat adjuster handle.

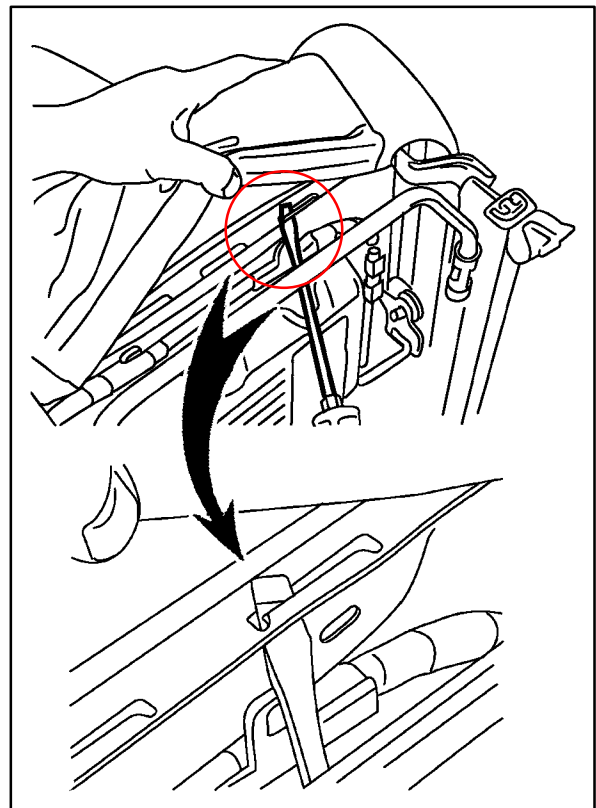
3. Bend the locking tabs down.
4. Completely disengage the J-clip from the seat adjuster frame (front area only).

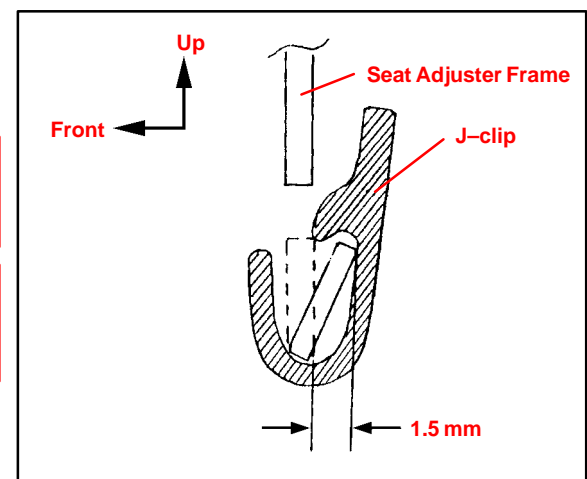
5. Using a screwdriver, bend the frame J-clip retention clips to the front. (Approximately 1.5 mm)

Original Condition: Retention clips are bent to the rear.

With a screwdriver, bend all 5 retention clips 1.5 mm forward.

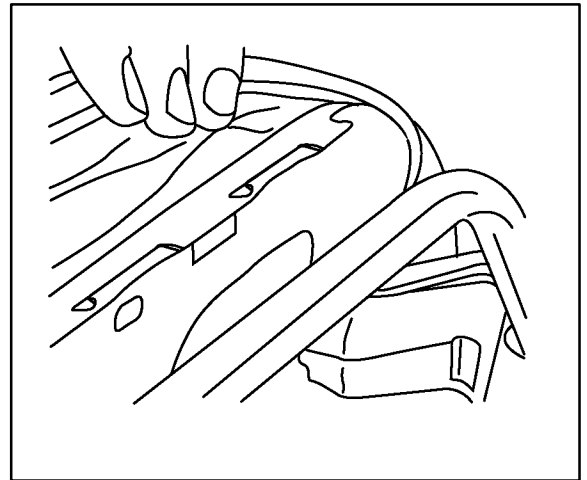
6. Reassemble the seat cushion.
