Technical Service BULLETIN

A/C COMPRESSOR MAINTENANCE FOR STORED VEHICLES

AC002-00

HEATING & AIR CONDITIONING

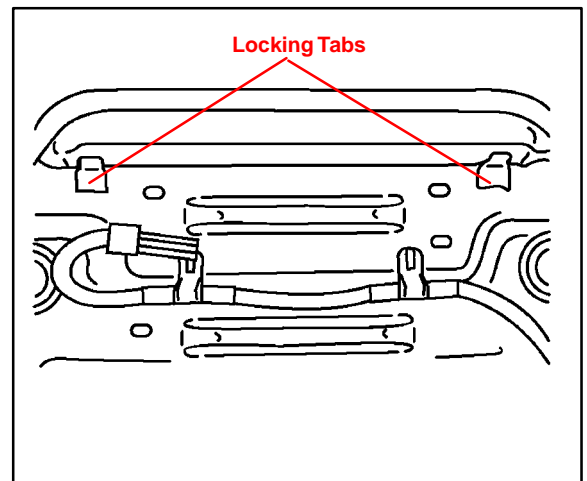
7. Bend the locking tabs over the cushion.
8. After reinstallation of the seat and manual seat adjuster handle (if removed), check the seat cushion retention and seat operation (sit on seat and push cushion down).
9. Tighten the seat mounting screws to the torque specifications in the Repair Manual.

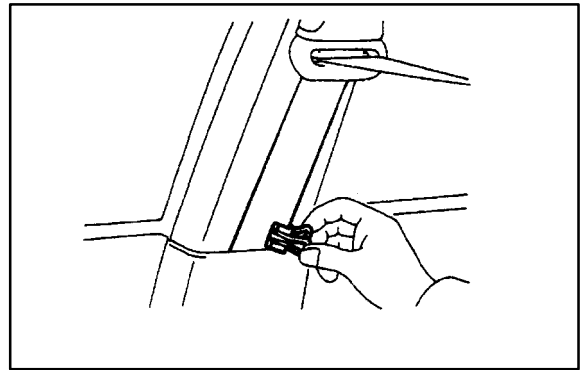
- A. Pull out the seat belt about 300 mm and attach a clip as shown in the illustration.

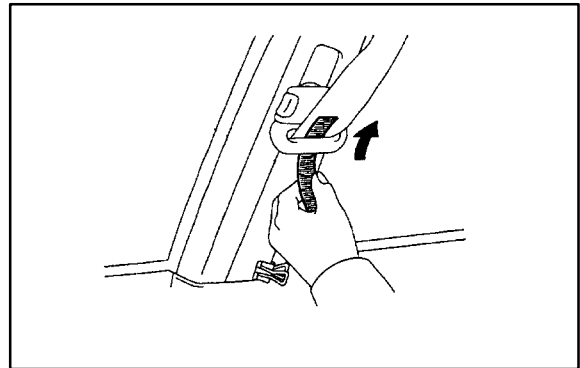
- B. Put the Velcro tape (in the parts kit) through the hole of the shoulder belt anchor, brush-shaped side to the anchor.

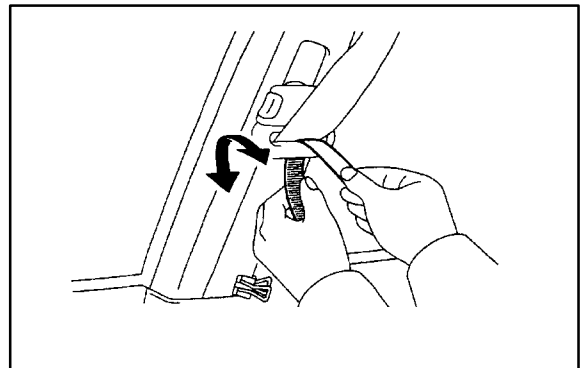
- C. Pull both ends of the Velcro tape with your hand and shave off the dirt on the shoulder belt anchor by moving the Velcro tape several times as shown in the illustration.

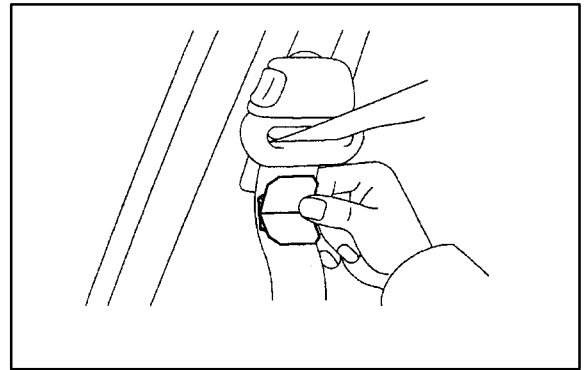
Before installation of the fluorocarbon resin tape, it is necessary to pre-release the colored film about 5 mm for each side. (Not fully released.)

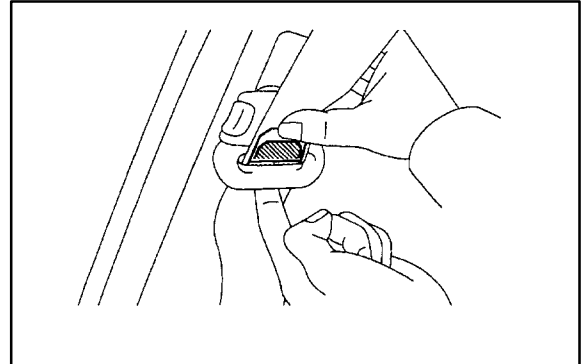
- B. By pulling up the seat belt, put the fluorocarbon resin tape through the hole of the shoulder belt anchor. Match the shoulder belt anchor to the center of the tape.

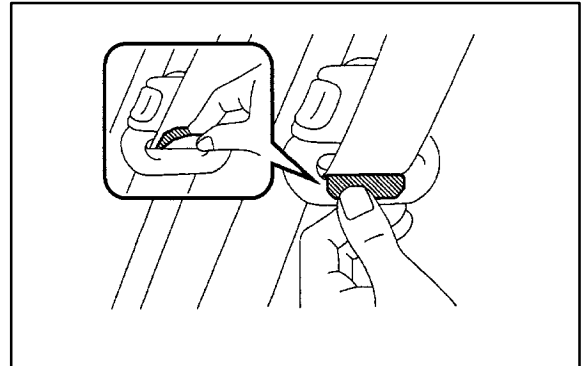
- C. Remove the upper side colored film from the fluorocarbon resin tape, and securely affix the tape to the outside of the shoulder belt anchor.

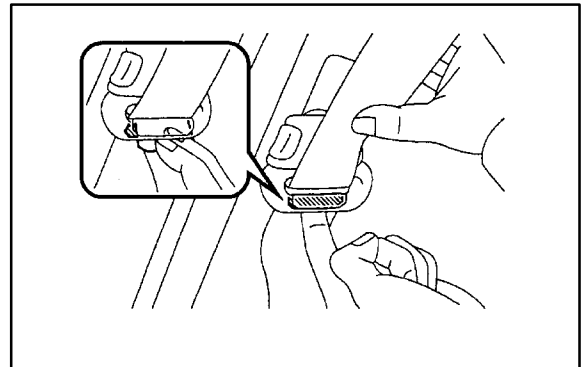
- D. Remove the lower side colored film from the fluorocarbon resin tape, and securely affix the tape to the outside of the shoulder belt anchor.

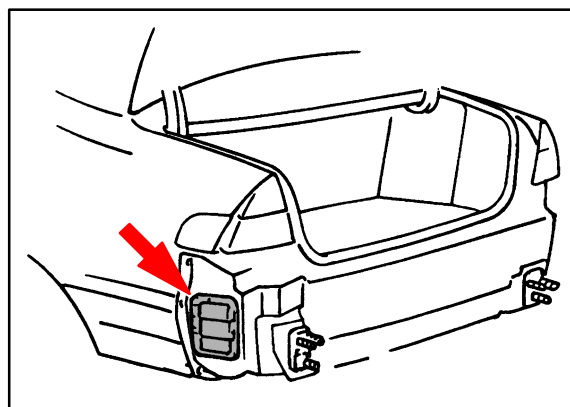
Replace the Quarter Panel Air Duct.

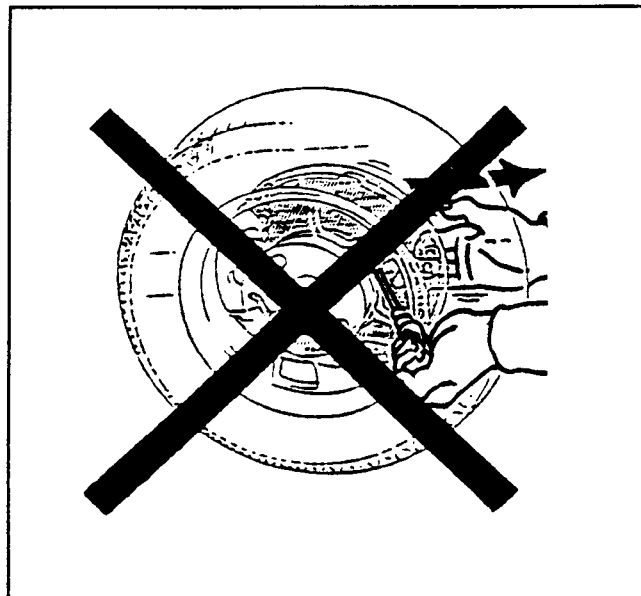
During the removal of the Anti-Rust Covers, **do not** use screwdrivers or other sharp objects. The use of such tools may result in the scratching of the outer rotor surface.

Unhook the Anti-Rust Cover from the disc brake dust cover, then pull the center of the Anti-Rust Cover toward the wheel. This separates the Anti-Rust Cover from the disc brake dust cover (see illustration below).

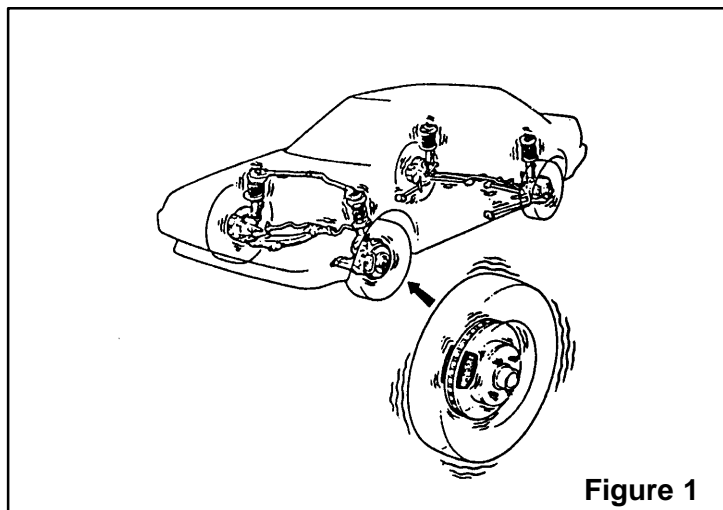
Applying brakes causes vibration to occur in the instrument panel, steering column, steering wheel, and/or body of the vehicle (**See Figure 1 below**).

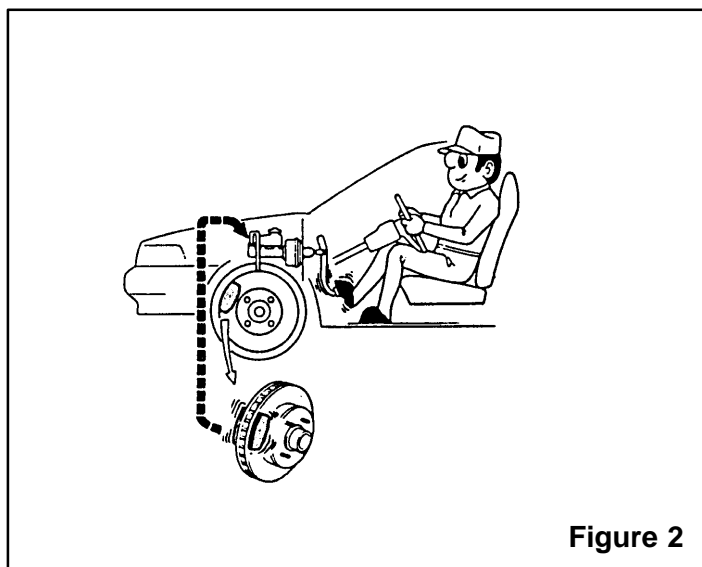
Applying brakes causes the brake pedal to pulsate. This brake pulsation sometimes causes the steering wheel to oscillate when the brakes are applied (**See Figure 2 below**).

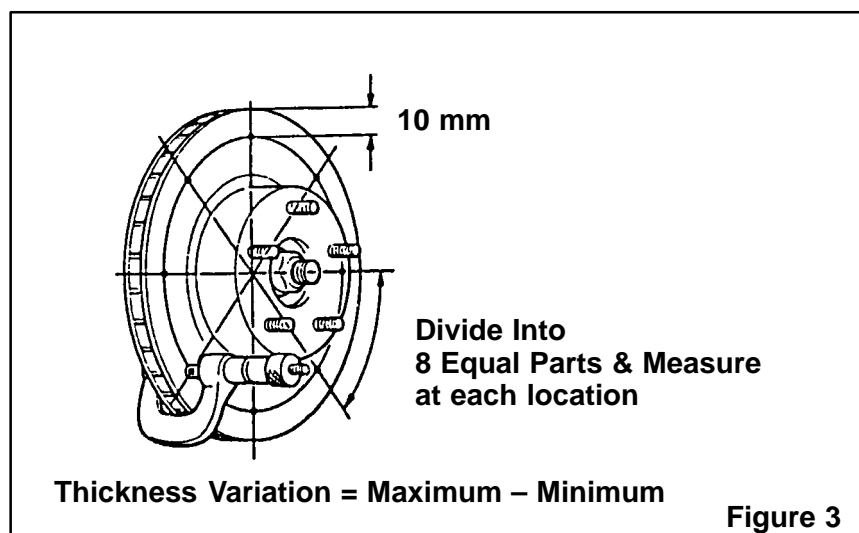
Brake rotor thickness variation causes brake vibration due to changes in the braking force as thick/thin portions of the rotor pass the pads. Brake rotor thickness variation can be measured with a micrometer as shown in **Figure 3** below.

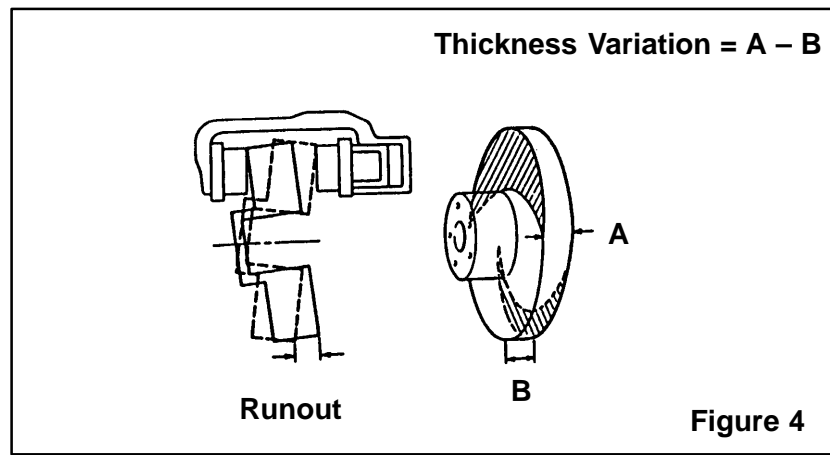
- **Rotor runout** can be caused by poor mating of flanges between the hub and rotor when assembled as a unit. Manufacturing tolerance stack-up of the rotor and hub may also cause excessive rotor assembly runout (**See Figure 4 below**).
- If there is rotor runout, a portion of the rotor comes into contact with the brake pad on each rotor revolution. If left like this, the portion of the rotor that contacts the brake pad becomes worn, creating **thickness variation**.

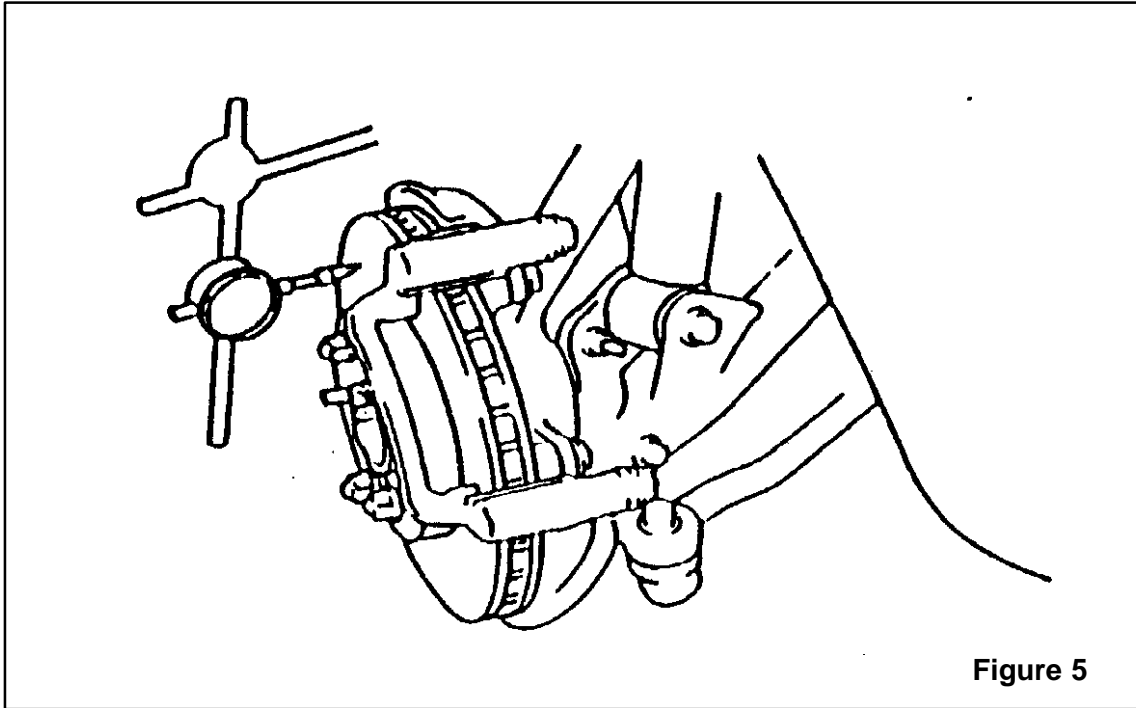
- Check wheel bearing pre-load. If excessive movement is found, adjust bearing pre-load.
- Using a dial indicator, measure the rotor 10 mm from the outside edge (**See Figure 5 below**).

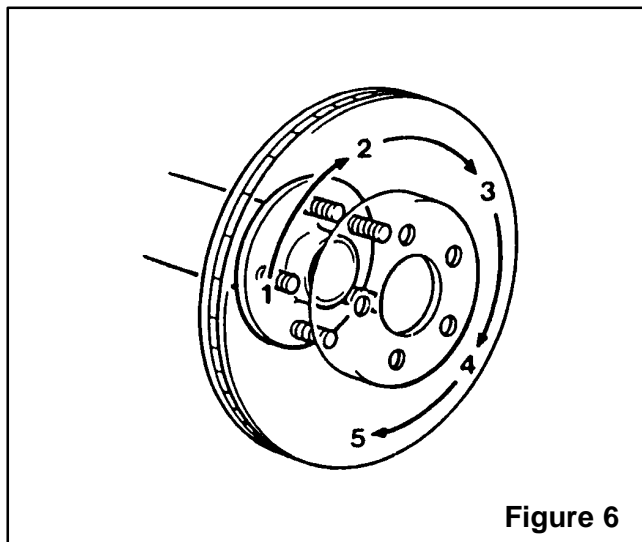
- If rotor runout is at the maximum value or greater, (refer to appropriate repair manual) index the rotor one lug and measure the runout again. Repeat this process, moving the rotor one lug each time, until the position is found where the runout is at the minimum and within the maximum value listed in the appropriate repair manual **(See Figure 6 below).**

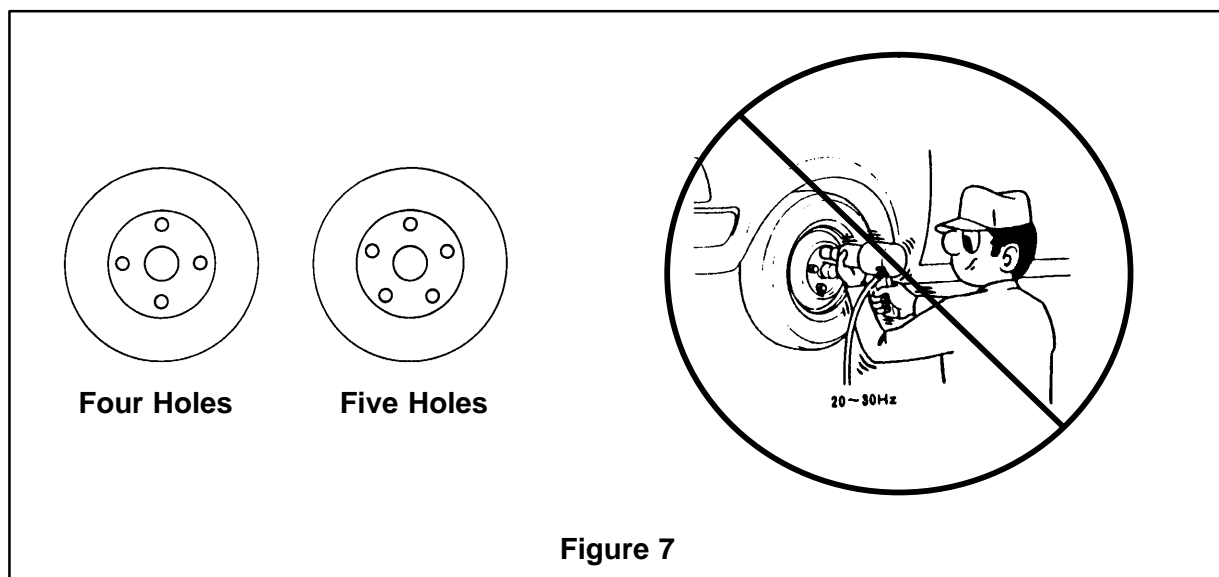
- Tighten lug nuts to the specified torque following a star sequence when installing wheel **(See Figure 7 below).**

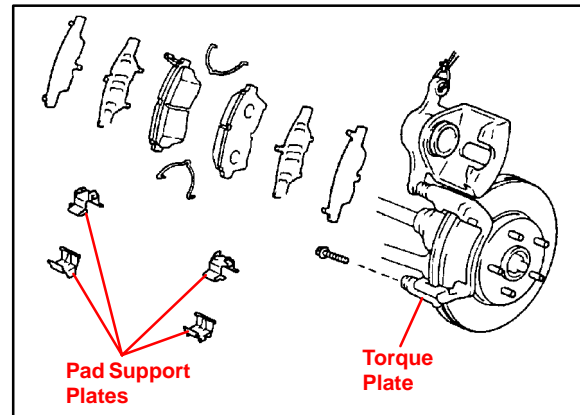
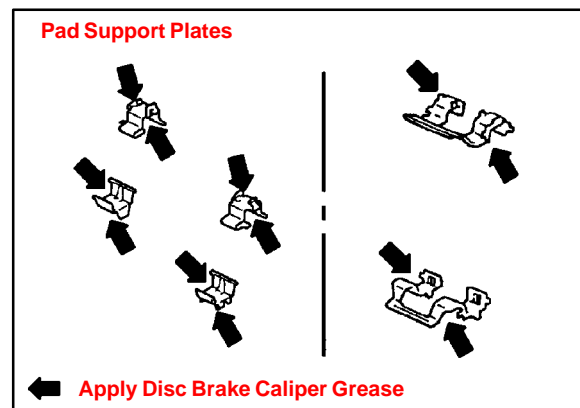
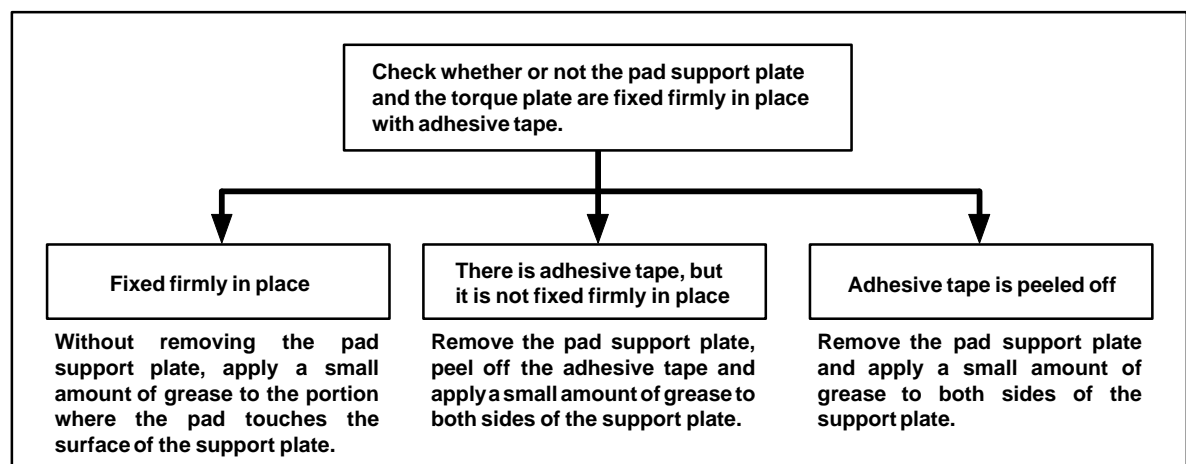
- F. If the pad support plate is fixed to the torque plate with adhesive tape, perform the operation according to the following flow chart.

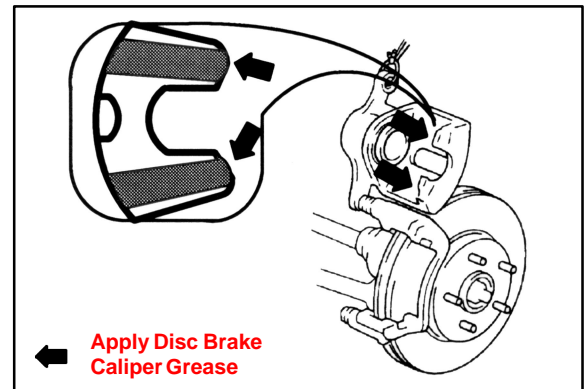
- G. Apply a small amount of the disc brake caliper grease (1–2 mm thick) to the caliper as indicated in the illustration.
- H. Install the brake pads with the anti-squeal shims.
- I. If equipped with anti-squeal spring: Install the anti-squeal springs.
- J. Press the piston in firmly and install the brake caliper.

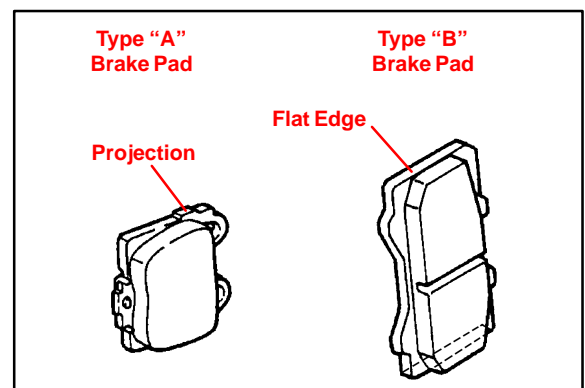
- Type “A”: Has a projection on the upper and lower side of the brake pad. (See illustration.)
- Type “B”: Has a flat upper and lower edge on the brake pad backing plate.

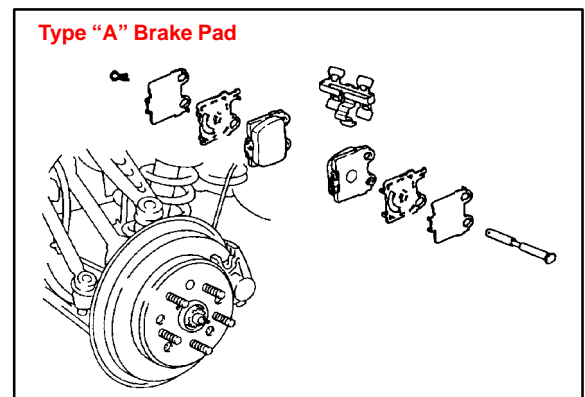
Type “A” Brake Pad

- A. Remove the anti-squeal spring, clip and pad guide pin.
- B. Remove the brake pads with the anti-squeal shims.
- C. Clean any dust from the brake pads.

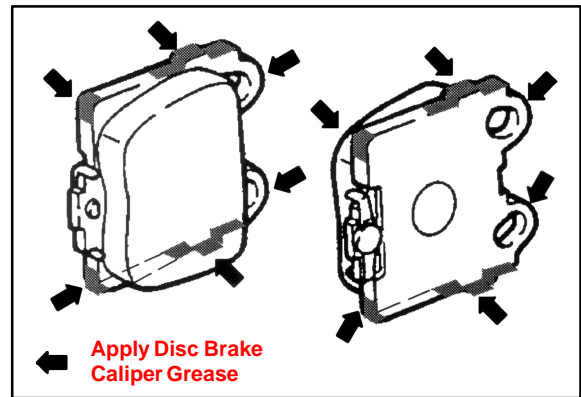
- D. Apply a small amount of the disc brake caliper grease (1–2 mm thick) to the areas indicated in the illustration.

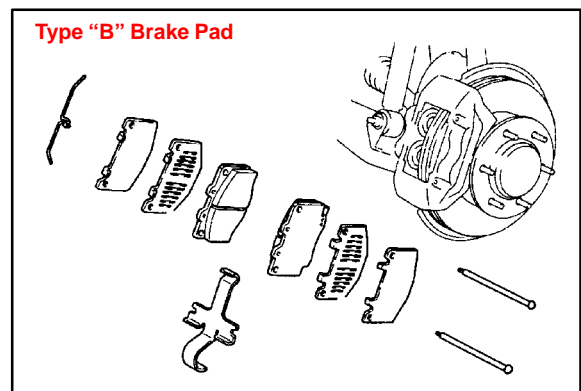
Type “B” Brake Pad

- A. Remove the clip, pins and anti-rattle spring/pad retainer clip.
B. Remove the brake pads with the anti-squeal shims.
C. Clean any dust from the brake pads.

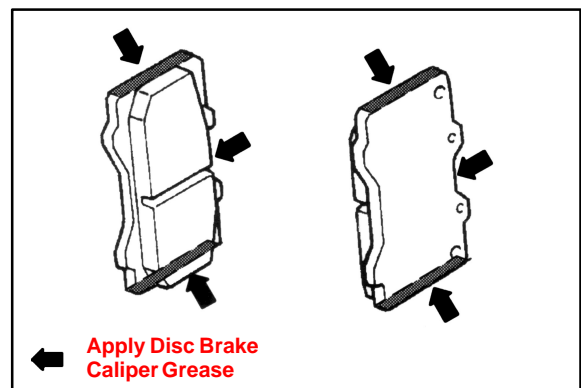
- D. Apply a small amount of the disc brake caliper grease (1–2 mm thick) to the areas indicated in the illustration.

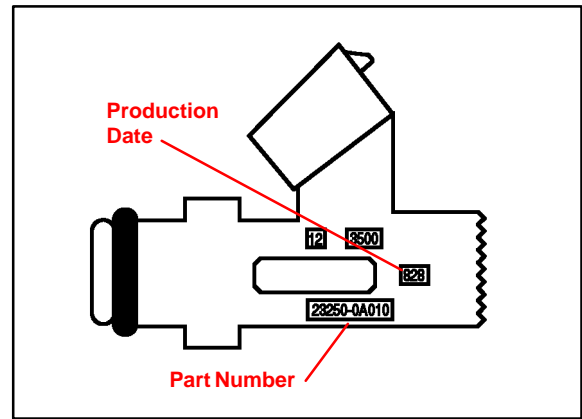
1. Remove all six fuel injectors for verification of production information. Affected injectors will be labeled with a vendor part number of “23250-0A010” and have a production date code number of “828” or lower (see illustration for number locations).
2. After determining that one or more of the injectors are affected, replace all six injectors with the above applicable part number.
3. Clear the DTC, if present, and verify that the vehicle now operates as designed.

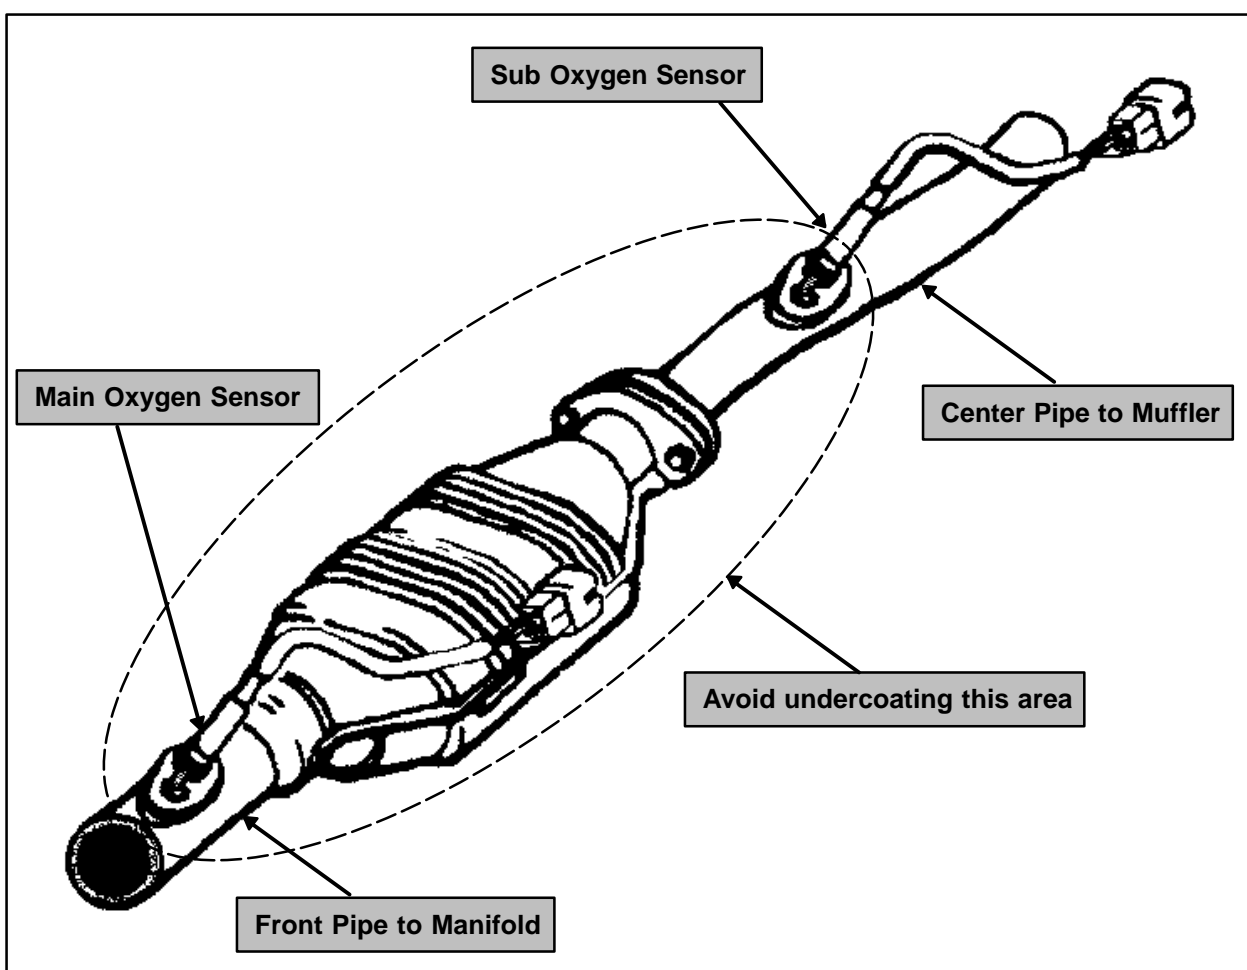
During vehicle processing by Dealers, care must be taken to avoid applying undercoating in the area surrounding the Oxygen Sensors. Application of undercoating on or near the Oxygen Sensors can cause insufficient air to flow around the sensor, and inaccurate information storage by the ECM. If this condition occurs, the Malfunction Indicator Light (MIL) may illuminate.

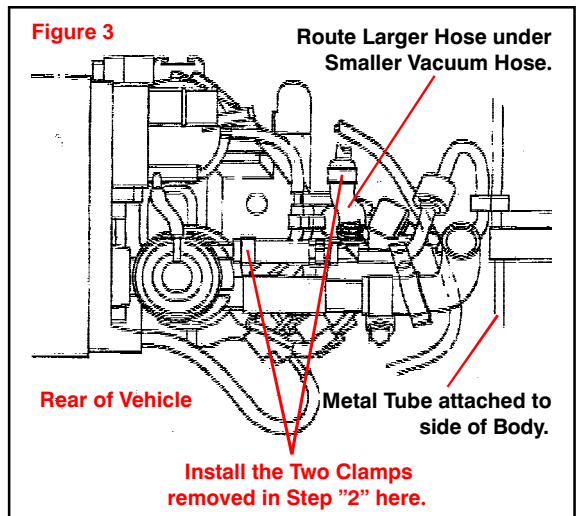
4. Verify that the Vacuum Hose Assembly is installed as shown in Figure 3.
5. After lowering vehicle verify that the Gas Cap is on securely.

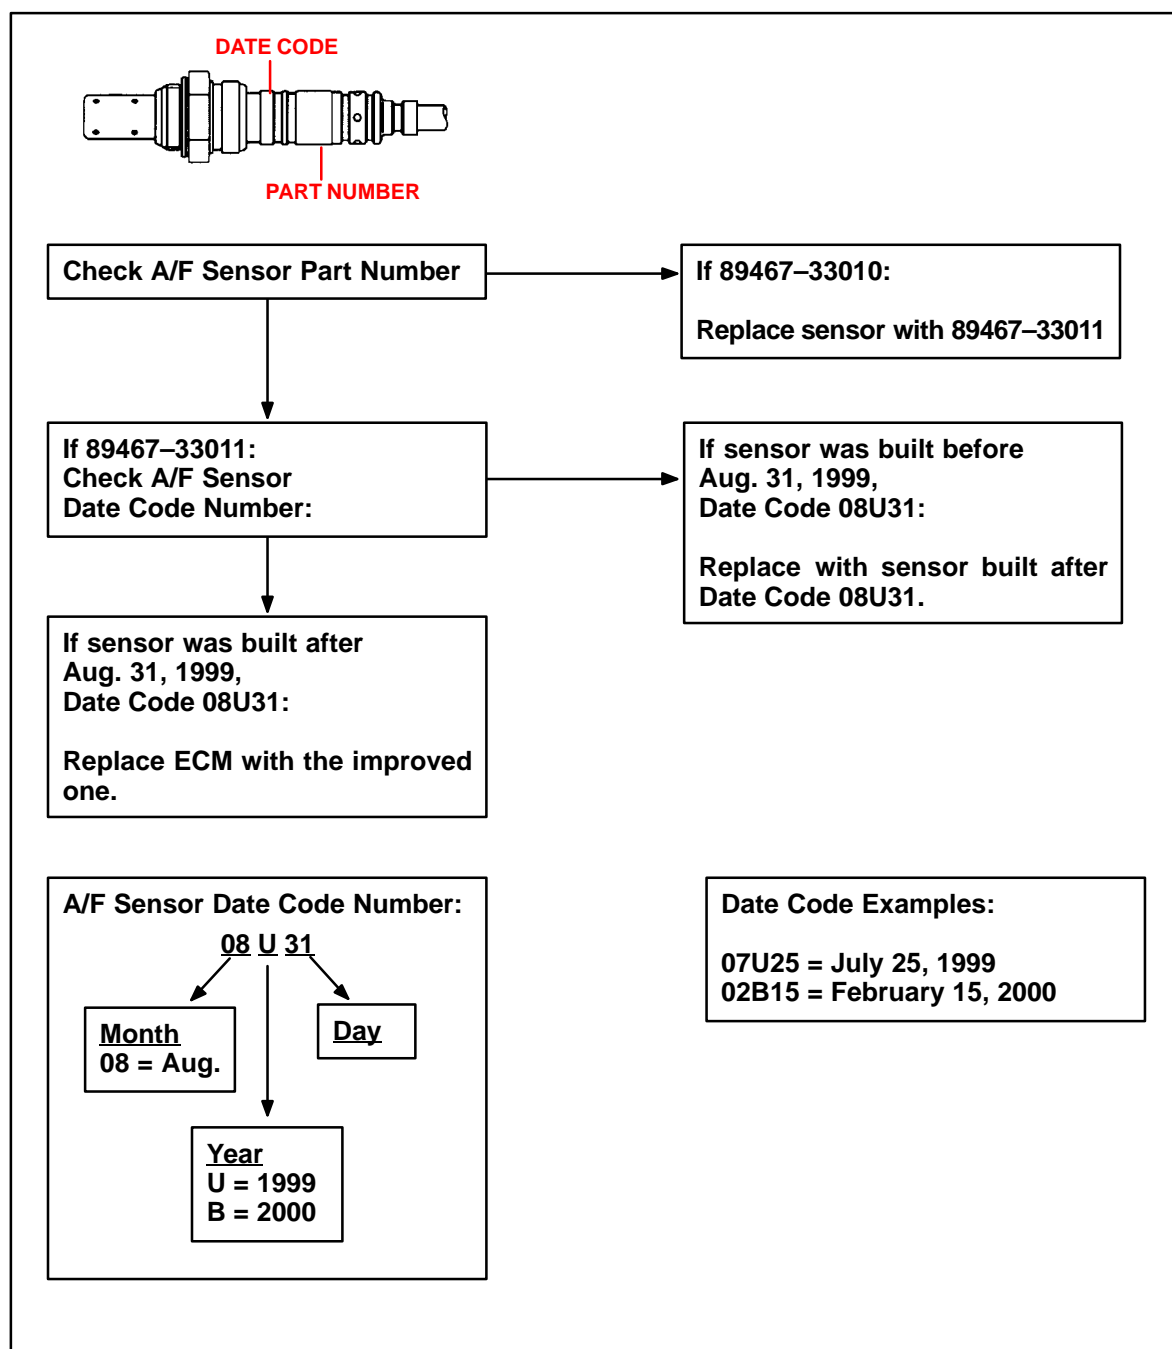
1. Should a M.I.L. "ON" condition with P1133 be encountered, perform diagnostic procedures as described in the Repair Manual.
2. If the problem source cannot be identified after checking all affected areas according to the Repair Manual, the cause may be an A/F Sensor or ECM logic malfunction. In this case, follow the procedure in the flowchart below to determine which part needs to be replaced.

Replace the ECM only if the A/F Sensor in the vehicle was produced after August 31, 1999.

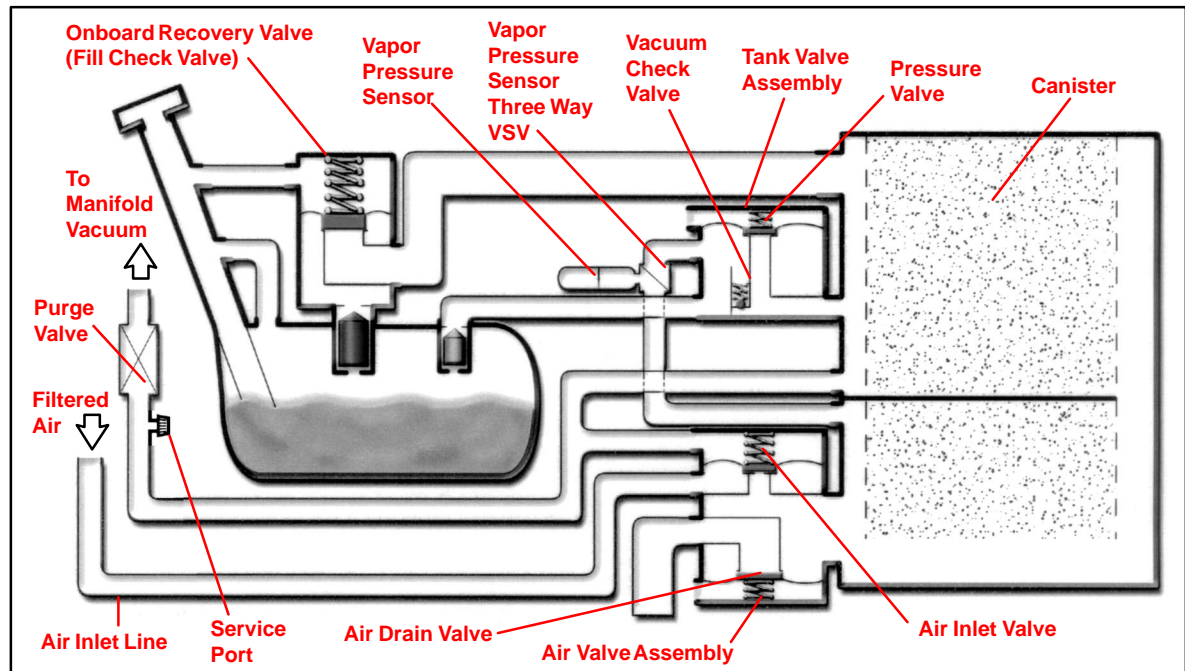
The first system described is the Early Type (Non-Intrusive) EVAP System. Refer to the Applicable Vehicles chart for applicability information.

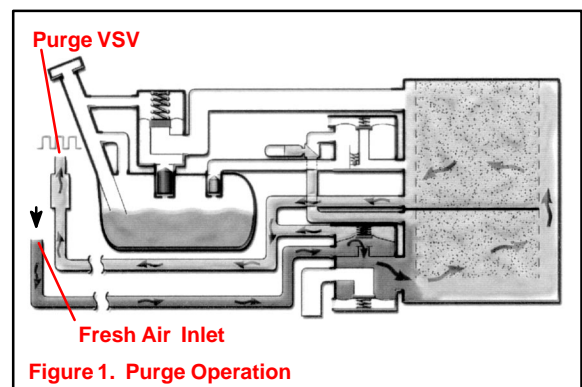
When the engine has reached predetermined parameters (closed loop, engine temp. above 125 F, etc.), stored fuel vapors are purged from the canister whenever the purge VSV is opened by the ECM. At the appropriate time, the ECM will turn on the purge VSV.

The ECM will change the duty ratio cycle of the purge VSV thus controlling purge flow volume. Purge flow volume is determined by manifold pressure and the duty ratio cycle of the purge VSV. Atmospheric pressure is allowed into the canister to ensure that purge flow is constantly maintained whenever purge vacuum is applied to the canister (see Figure 1).

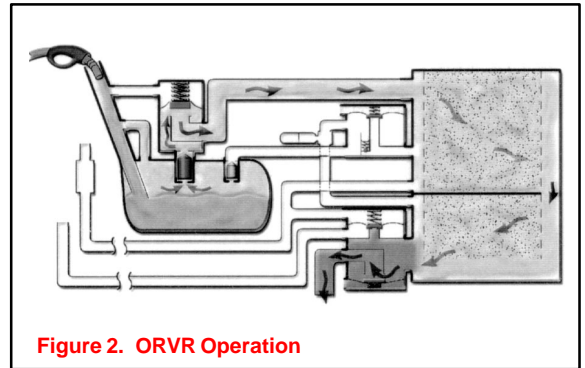
Figure 2. ORVR Operation

During refueling, low pressure above the diaphragm in the onboard recovery valve lifts allowing fuel vapors into the charcoal canister. At the same time, the air drain valve opens and the charcoal absorbs the fuel vapors (see Figure 2).

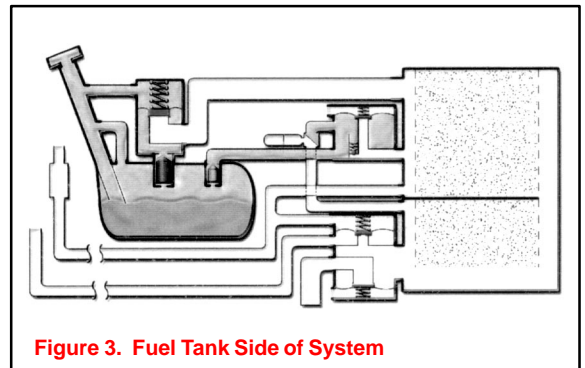
Figure 3. Fuel Tank Side of System

The ECM tests for leaks by measuring EVAP system pressure in the lines, charcoal canister, and fuel tank. When the EVAP pressure is higher or lower than atmospheric pressure, the ECM concludes that no leaks are present. EVAP pressure is measured by the vapor pressure sensor. If either the tank or canister purge side is at atmospheric pressure under specific conditions, the ECM determines there is a leak.

If DTC P0440 is present, the leak is on the fuel tank side of the EVAP system. This also includes the lines between the fuel tank and part of the canister. When the Vapor Pressure sensor is measuring tank pressure, the ECM is observing changes in pressure and comparing tank pressure to atmospheric pressure. No difference in pressure indicates a leak. The ECM may take 20 minutes or more to complete testing the fuel tank side (see Figure 3).

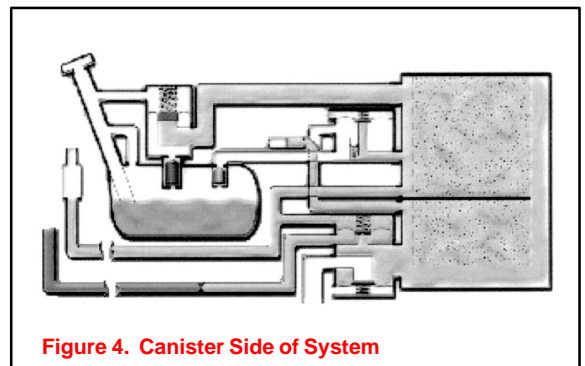
Figure 4. Canister Side of System

When the ECM switches the vapor pressure VSV to canister side, the ECM measures canister pressure. A leak on the canister side can set multiple DTCs (see Figure 4).

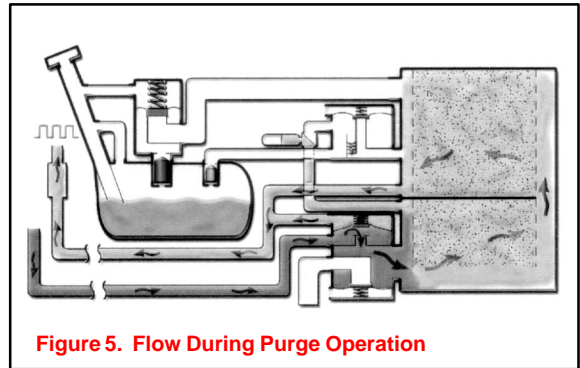
Figure 5. Flow During Purge Operation

- During purging, pressure pulsations generated by the purge VSV are not present in the canister as detected by Vapor Pressure sensor, the three-way VSV is judged to be defective.
- If there are pressure pulsations detected by the Vapor Pressure sensor present in the fuel tank, the three-way VSV is judged to be defective.

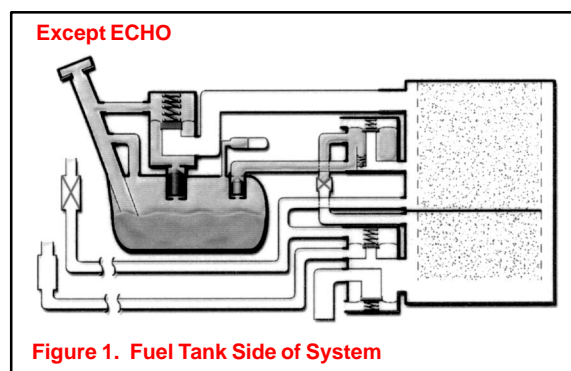
The bypass VSV and the fill check valve assembly isolates the tank pressure side from the canister side (see Figure 1).

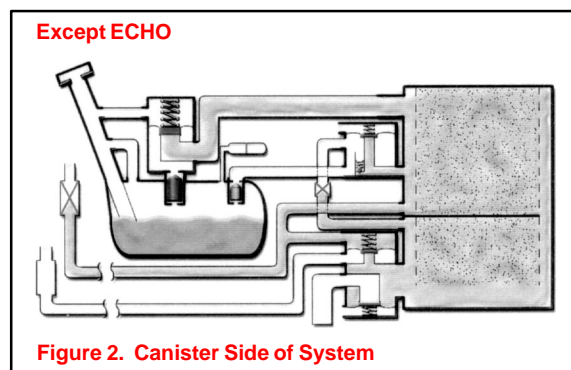
The bypass VSV and the Fill Check valve also isolate the canister side from the tank side (see Figure 2).

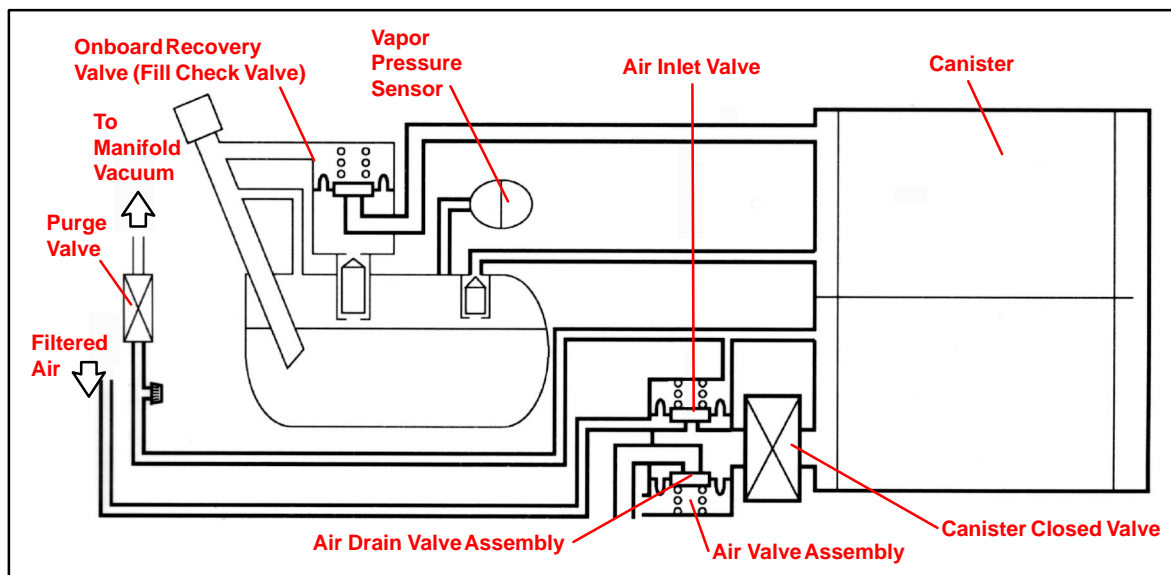
The ECHO uses a Late Type EVAP System but is configured with some small differences. For the ECHO, the Canister Closed Valve is located directly on the canister. Additionally, the bypass VSV has been eliminated.

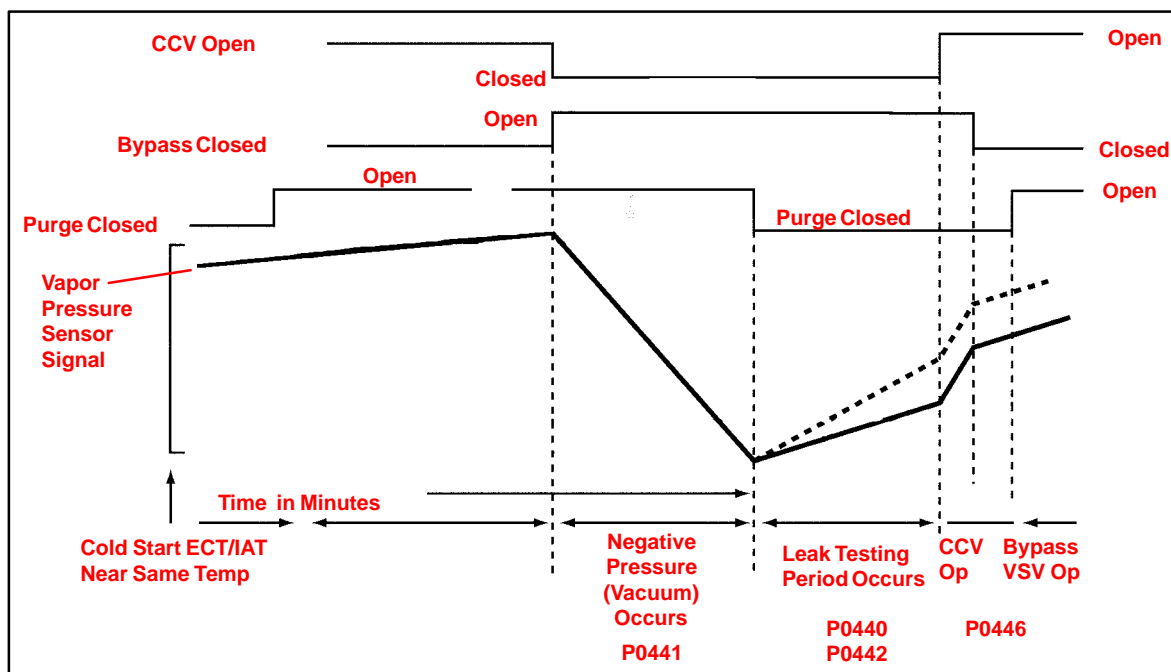
Monitor Sequence (Except ECHO)

The monitoring sequence for leak detection is different from that of the Early Type EVAP System. The Late Type applies a very small vacuum to the EVAP system. The ECM then determines if there is a problem in the system based on the vapor pressure sensor signal.

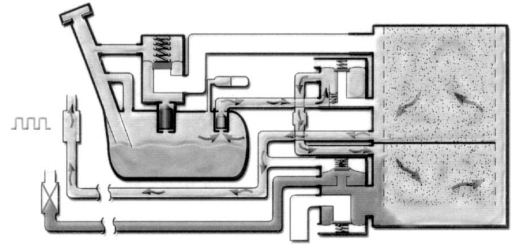
Figure 2. Vacuum Application

After purge VSV operation, the purge VSV is turned off sealing the vacuum in the system and the ECM begins to monitor the pressure increase (see Figure 3). Some increase is normal. A very rapid, sharp increase in pressure indicates a leak in the EVAP system and sets the DTC P0440.

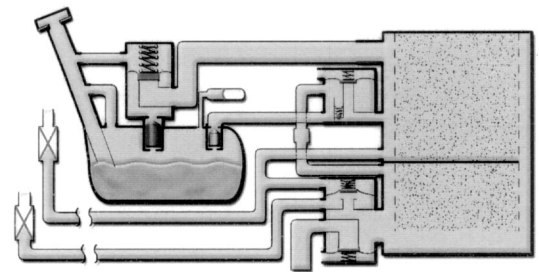
Figure 3. System Sealed

This monitoring method is also able to distinguish what is called the small leak detection. A pressure rise just above normal indicates a very small hole and will set the DTC P0442.

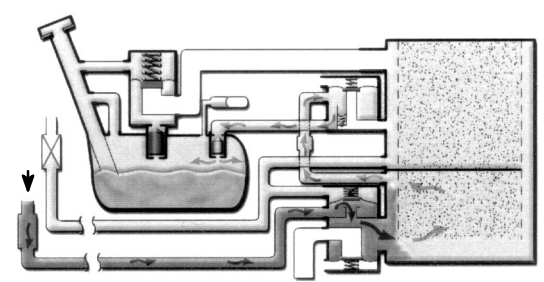
Figure 4. CCV Opens

This stage checks the CCV and vent (air inlet side) operation. When the vapor pressure rises to a specified point, the ECM opens the CCV. Pressure will increase rapidly because of the air allowed into the system. No increase or an increase below specified rate of pressure increase indicates a restriction on the air inlet side (see Figure 4).

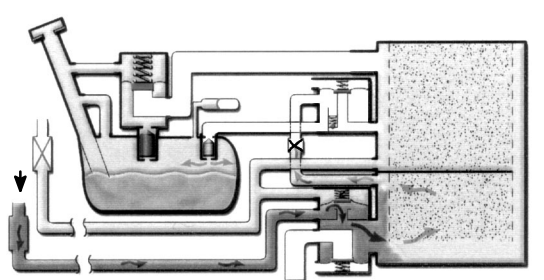
Figure 5. Bypass VSV Closes

In the next stage, the ECM closes the bypass VSV. This action blocks air entering the tank side of the system. The pressure rise on the fuel tank side is no longer as great. If there was no change in pressure, the ECM will conclude the bypass VSV did not close (see Figure 5).

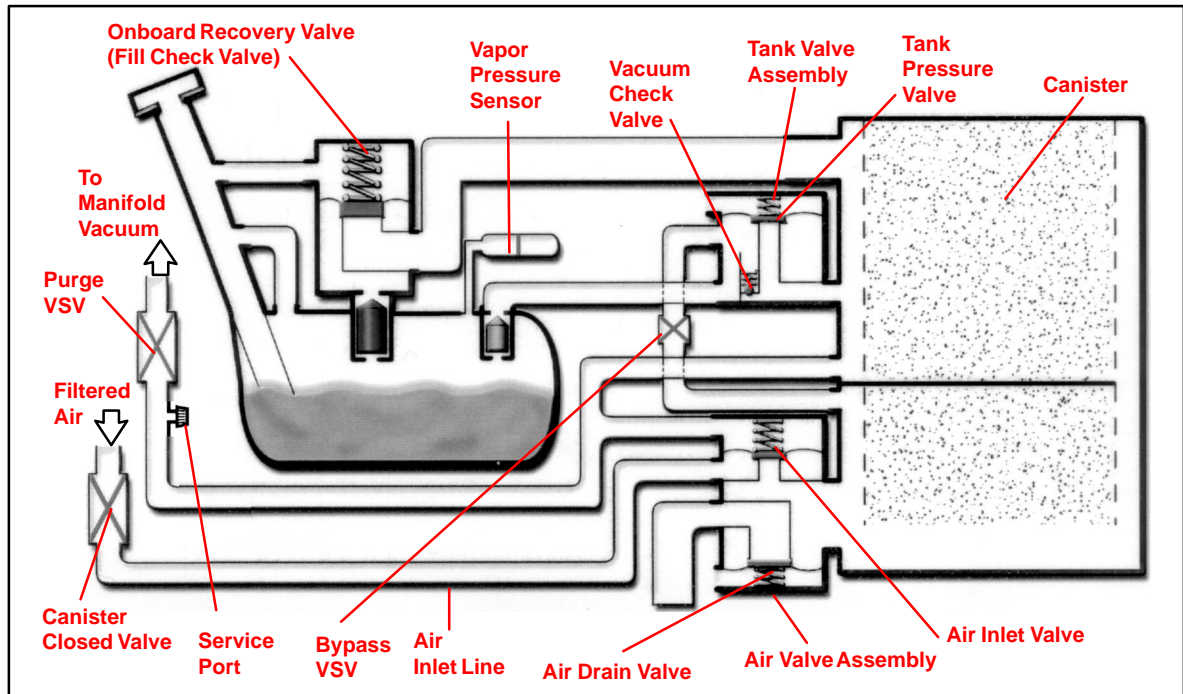
System Outline (Except ECHO)

The EVAP System Pressure Test Kit (P/N 00002–6872A) and the Scan Tool can be used to diagnose the EVAP System. Measuring EVAP System pressures using the EVAP System Pressure Tester Gauge and the Scan Tool can aid in the identification of leaks in the system.

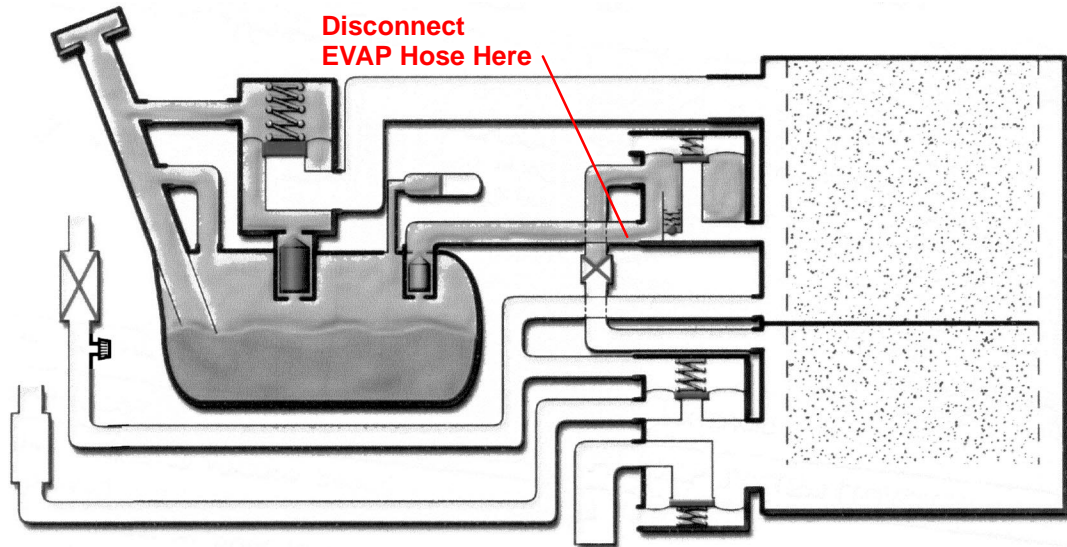
- A. Using the supplied brass step-down adapter, disconnect the EVAP hose from the charcoal canister side as indicated above. Connect Pressure Supply hose from Pressure Test Kit to the EVAP hose and pressurize the fuel tank to 30 mmHg (4 kPa / 0.58 psi).
- B. Check that the internal pressure of the tank will hold for 1 minute. Check shaded areas for leaks (soapy water can be used for leak detection). If pressure holds, then perform the Canister Leak Check.
- C. When done, reconnect the EVAP line hose to the charcoal canister.

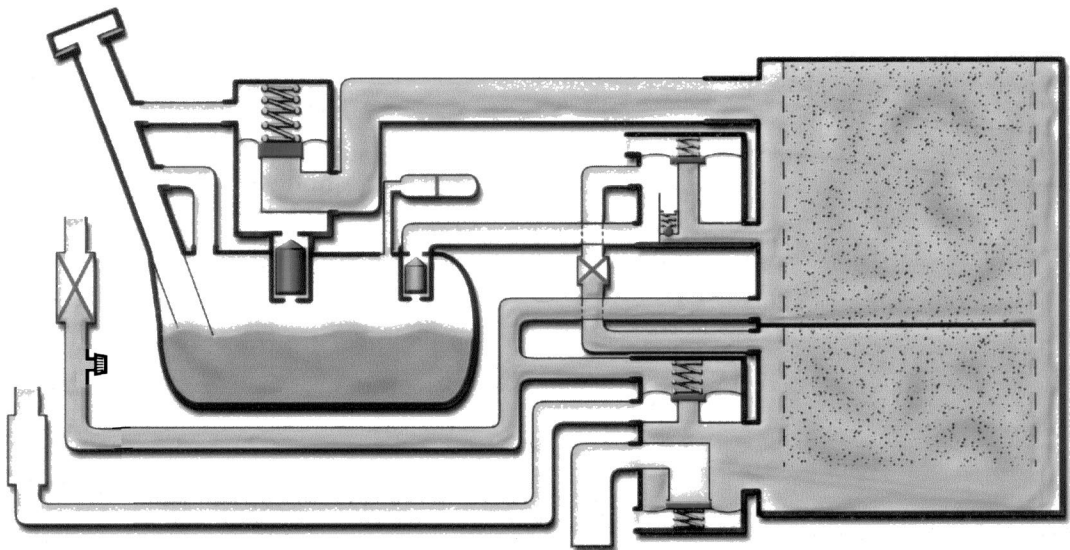
Canister Leak Check (Except ECHO)

- A. Connect the Pressure Supply hose from the Pressure Test Kit to the Green EVAP System Service Port located on the EVAP Purge VSV line in the engine compartment.
- B. Using the directions on the inside of the EVAP System Pressure Test Kit lid, pressurize the EVAP system. Once pressurized, turn off the pump and seal the system (Pressure Hold Switch to "Closed" and Vent Switch to "Closed")
- C. With system pressurized at EVAP Service Port, check shaded areas for leaks (soapy water can be used for leak detection).

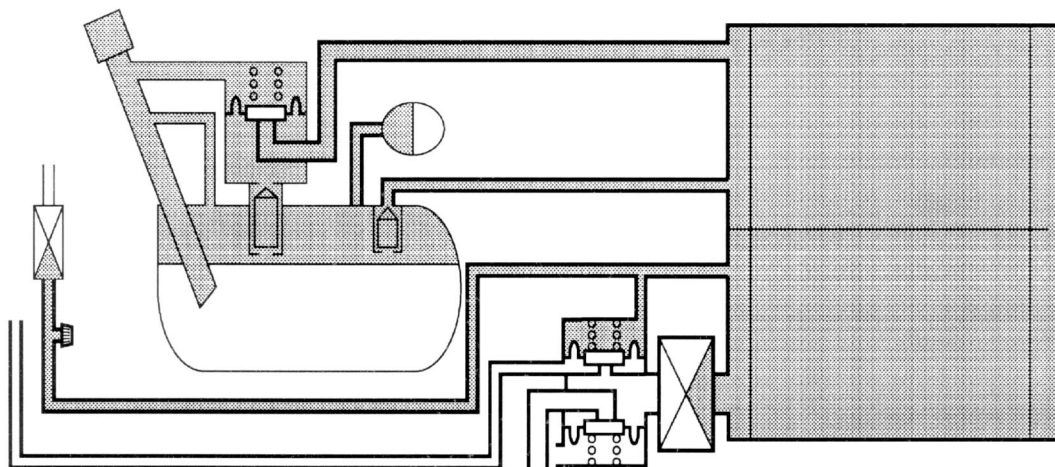
ECHO Canister and Tank Leak Check

- A. Connect the Pressure Supply hose from the Pressure Test Kit to the Green EVAP System Service Port located on the EVAP Purge VSV line in the engine compartment.
- B. Using the directions on the inside of the EVAP System Pressure Test Kit lid, pressurize the EVAP system. Once pressurized, turn off the pump and seal the system (Pressure Hold Switch to “Closed” and Vent Switch to “Closed”)
- C. With system pressurized, check shaded areas for leaks (soapy water can be used for leak detection).
