Technical Service BULLETIN

A/C COMPRESSOR MAINTENANCE FOR STORED VEHICLES

AC002-00

HEATING & AIR CONDITIONING

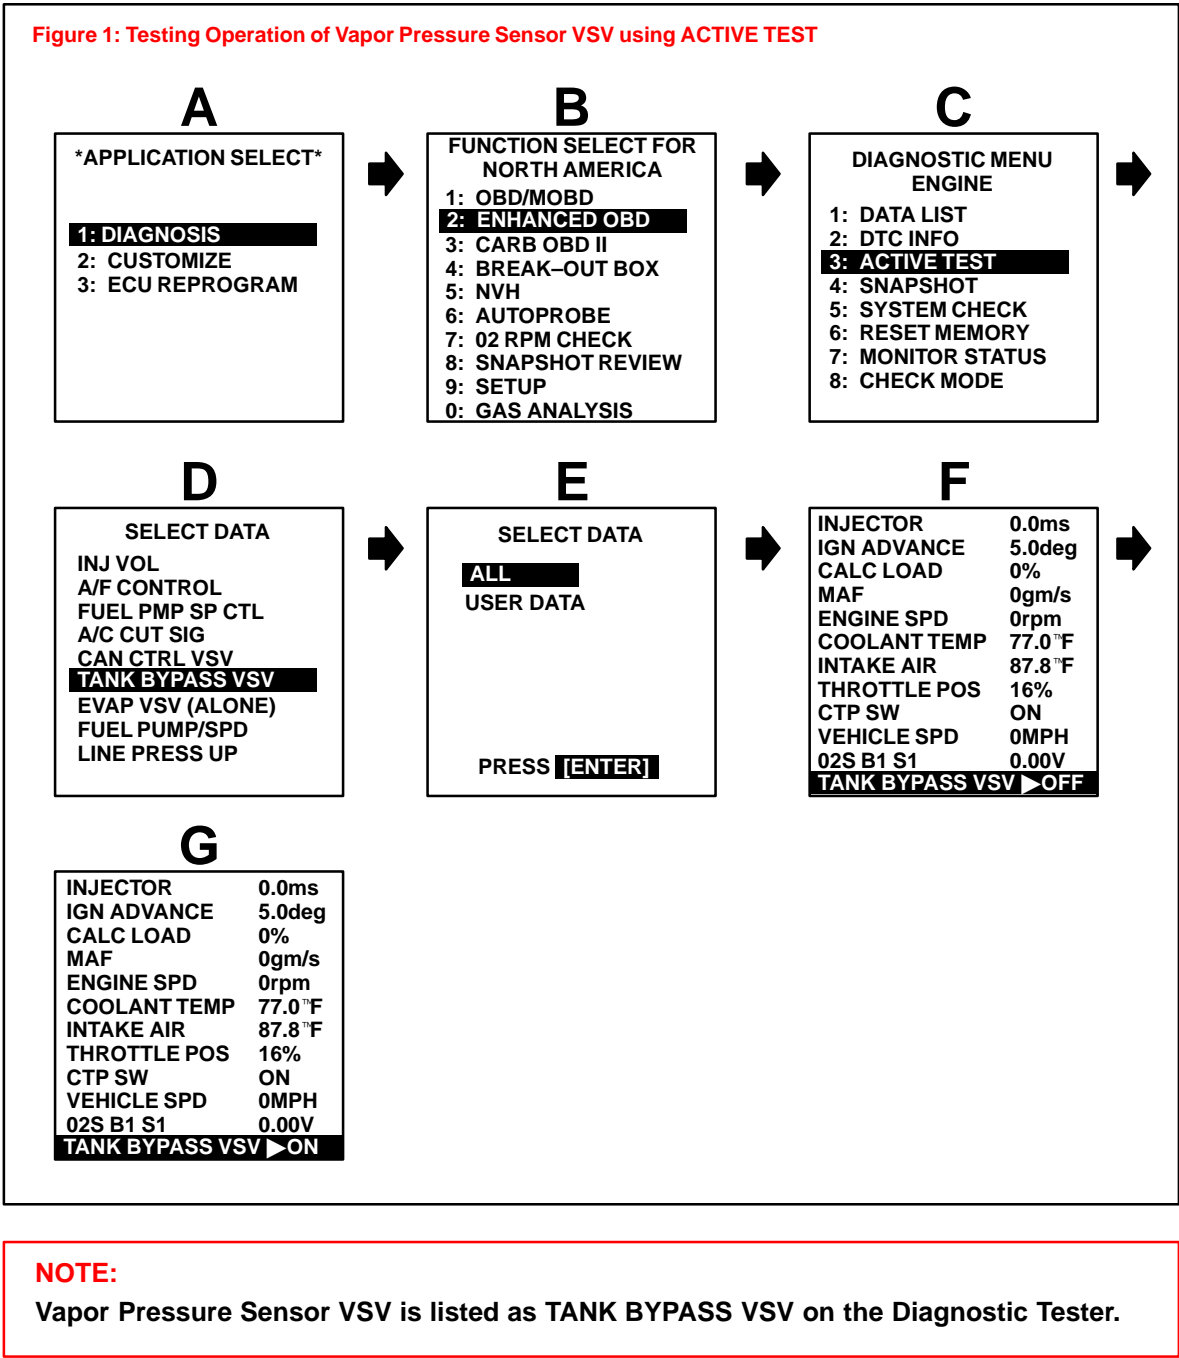
- Inspection & Repair Procedure
- Test VSV Operation Using ACTIVE TEST on the Toyota Diagnostic Tester
1. Test operation of the Vapor Pressure Sensor VSV using the Toyota Diagnostic Tester in ACTIVE TEST (see screen flow in Figure 1).

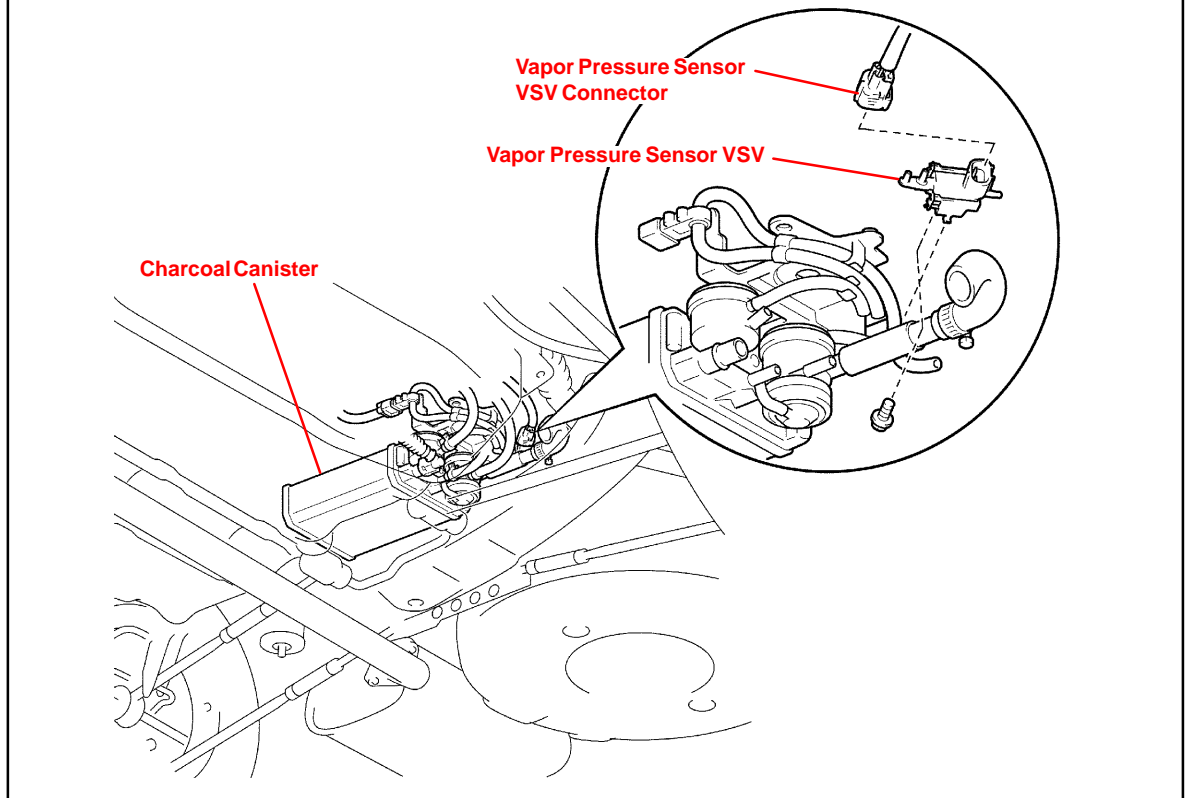
Figure 2: Vapor Pressure Sensor VSV Components

2. Locate Vapor Pressure Sensor VSV as shown in Figure 2 (or see **SFI** section of 1998 or 1999 Camry or Solara Repair Manual).

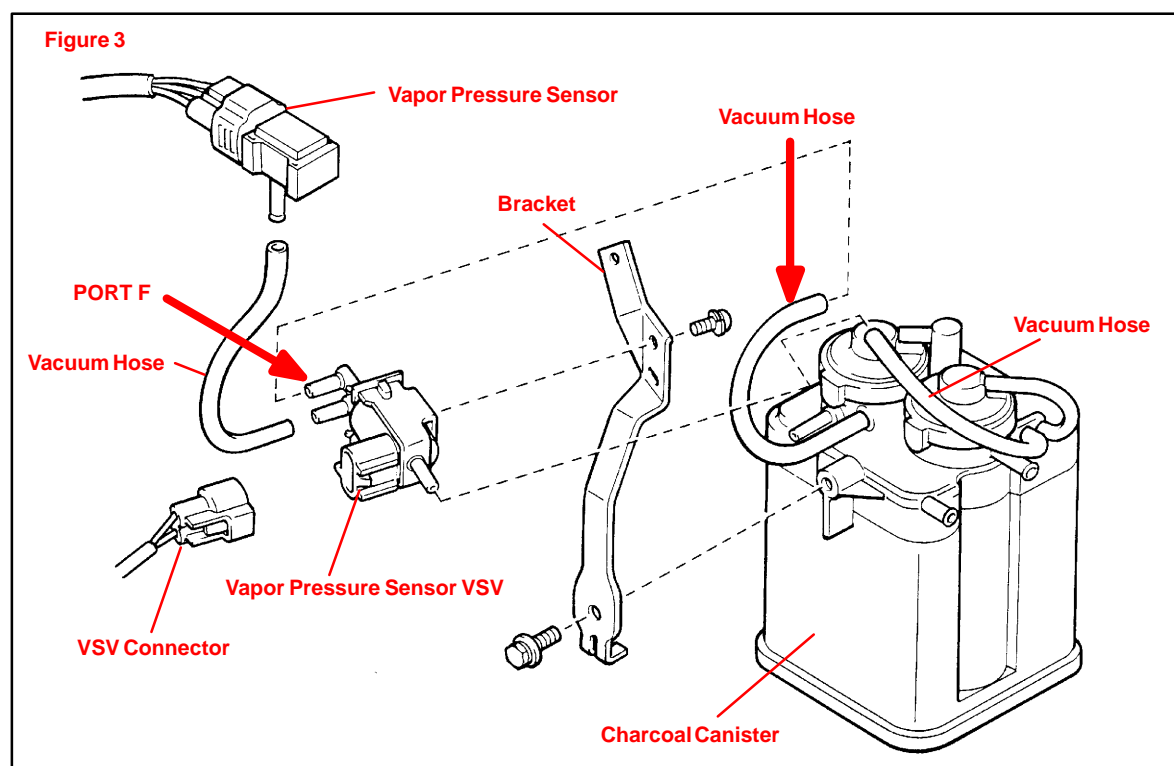
1. Locate the vacuum hose going from charcoal canister to Port F of the Vapor Pressure Sensor VSV (see Figure 3).

2. Remove vacuum hose from Port F of the Vapor Pressure Sensor VSV and connect a hand-held vacuum pump to Port F using a short length of vacuum hose.
3. Apply at least 10 mm Hg vacuum to the VSV.
Is a vacuum held for at least 1 minute?
- YES** ► Go to Step 4.
- NO** ► Replace the Vapor Pressure Sensor VSV.
4. Disconnect the hand-held vacuum pump and reconnect the vacuum hose from the canister to the Vapor Pressure Sensor VSV.

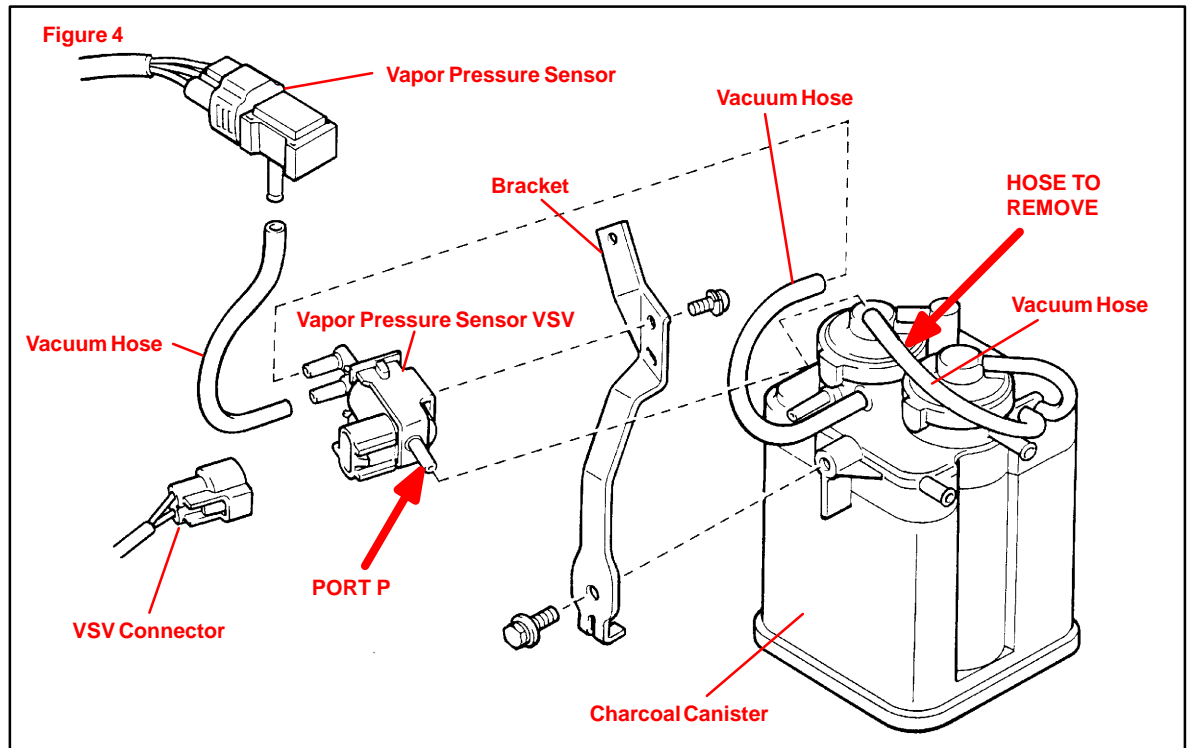
5. Locate the vacuum hose going from charcoal canister to Port P of the Vapor Pressure Sensor VSV (see Figure 4).

6. Remove the vacuum hose from Port P of the Vapor Pressure Sensor VSV and connect a hand-held vacuum pump to Port P using a short length of vacuum hose.
7. Apply at least 10 mm Hg vacuum to the VSV.
Is a vacuum held for at least 1 minute?
- YES** ► Go to Step 8.
- NO** ► Replace the Vapor Pressure Sensor VSV.
8. Disconnect the hand-held vacuum pump and reconnect the vacuum hose from the canister to the Vapor Pressure Sensor VSV.
9. Continue diagnosis of the EVAP system.
Reference TSB EG005-01, "EVAP System Operation Information."

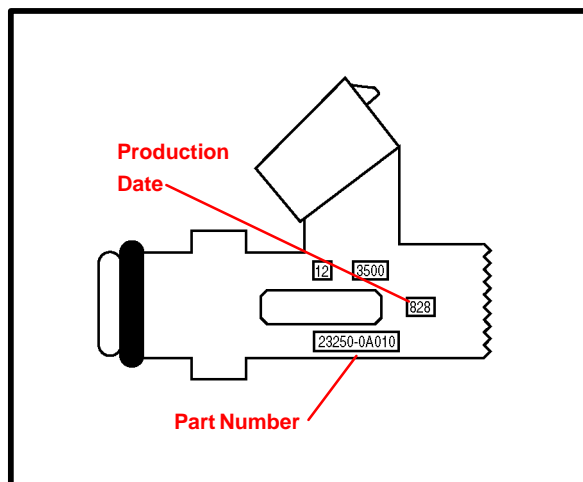
1. Remove all six fuel injectors for verification of production information. Affected injectors will be labeled with a vendor part number of “23250–0A010” and have a production date code number of “828” or lower (see illustration for number locations).
2. After determining that one or more of the injectors are affected, replace all six injectors with the above applicable part number.
3. Clear the DTC, if present, and verify that the vehicle now operates as designed.

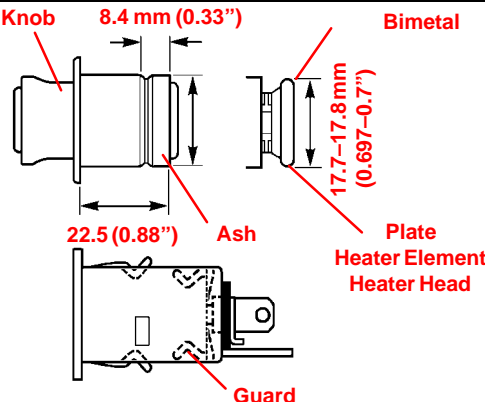
TYPE	DRAWING WITH DIMENSIONS	FEATURES
Genuine

No Problem to use.
Non-Genuine

1. Determine if the lighter is original equipment by using the specifications shown.
 - a. If the vehicle has a non-genuine lighter element, it has the possibility to cause a short circuit between the lighter element and the lighter socket, which can result in an open fuse.
 - b. A non-genuine lighter element may cause a rattle or bend the socket bimetal contacts.
 - c. If a non-genuine lighter element is being used, advise the customer to use an original equipment element.

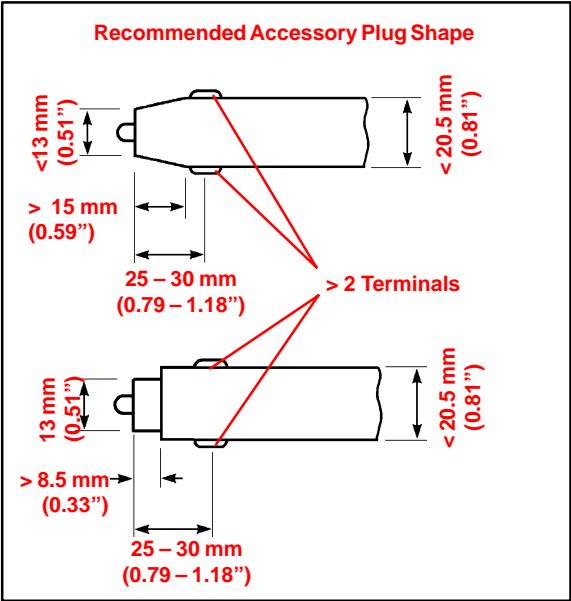
2. If the lighter element is original equipment and the lighter socket is bent or pulled out of the dash, please ask the customer about the accessory plug being used in the lighter socket.
- a. The attached specifications in the drawing provide the maximum recommended size of accessory plug. If the customer is using an accessory plug larger than recommended, please advise the customer to use a plug of appropriate size.
 - b. Using a power plug larger than the given dimensions may damage the lighter socket.
 - c. If the vehicle has a power point socket, advise the customer to use this socket instead of the lighter socket.

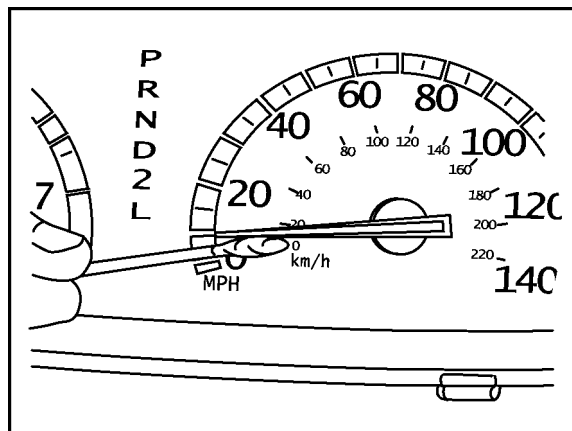
1. Remove the combination meter assembly per repair manual instructions.
2. Remove the window plate from the instrument cluster.
3. Clean the entire surface of the needle and needle stopper as illustrated. Using one end of a double sided cotton swab, clean the contact point between the pointer and the stopper pin on the speedometer and tachometer with distilled water.
 - Use only a **new, clean** cotton swab.
 - Use only **distilled** water.
 - Use a new swab each time a part is cleaned (one per speedometer, one per tachometer).

- After cleaning, do not touch the pointer needle or stopper pin.
 - Do not blow dry the pointer or stopper pin.
4. Use the opposite (dry) end of the cotton swab to dry the previously cleaned area.
 5. Reassemble parts and assemble to vehicle.
 6. Confirm proper working condition of speedometer and tachometer.
 - Confirm no foreign material entered the cluster while the window plate was removed.

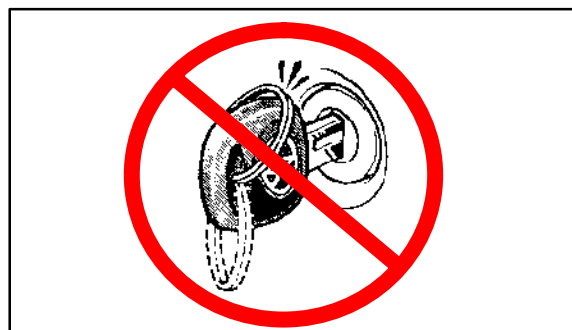
1. The key ring should **not** rest on or be pressed against the key grip.

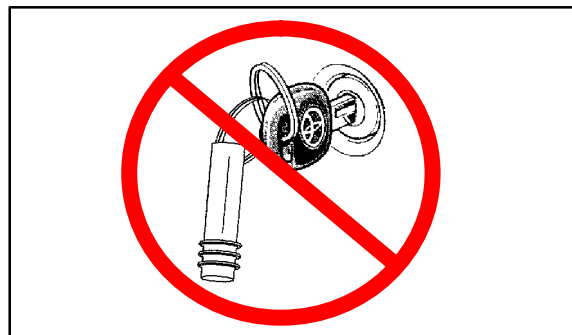
2. Do **not** place any other transponder devices on the same key ring. Such devices would include transponder equipped units used for charging fuel.

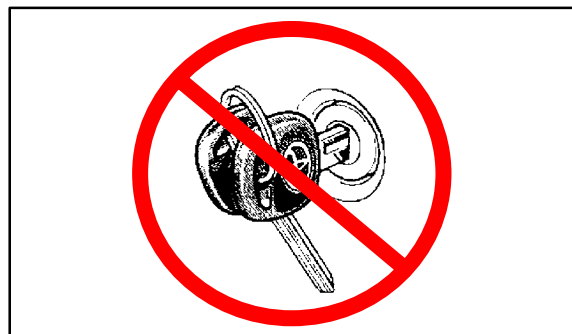
3. Do **not** place any other immobilizer keys on the same key ring with the key used to start the vehicle.
4. If the above precautions are not observed and an engine starting or running problem occurs, remove all items which may interfere with the ignition key transponder signal. Turn off the engine and then restart.

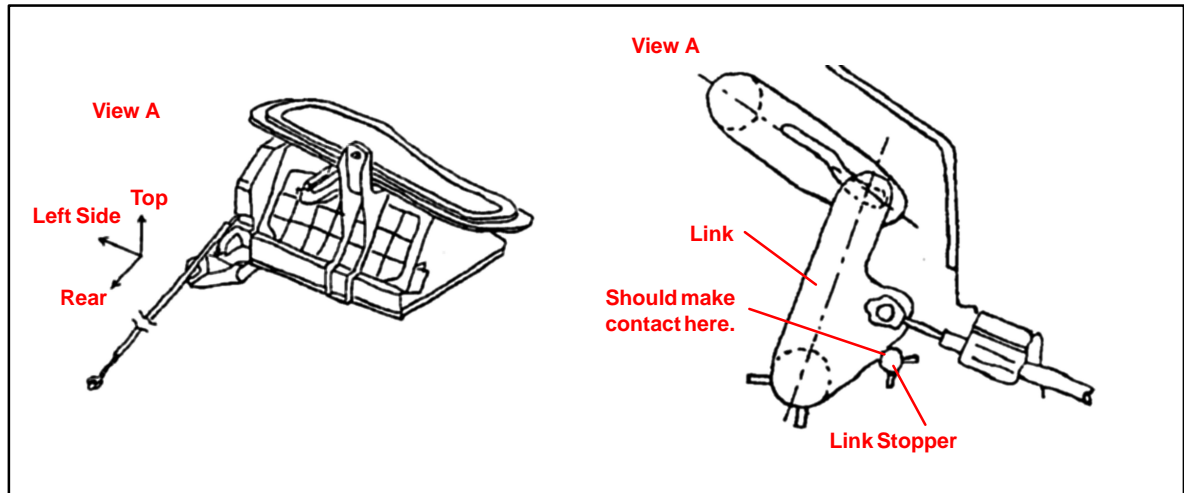
- A. Pull out the inner cable of the REC/FRE cable until the link of the A/C unit contacts the link stopper.

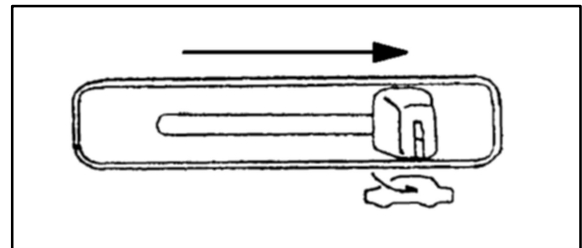
- B. Set the air intake selector of the heater control unit all the way to the “FRESH” position.

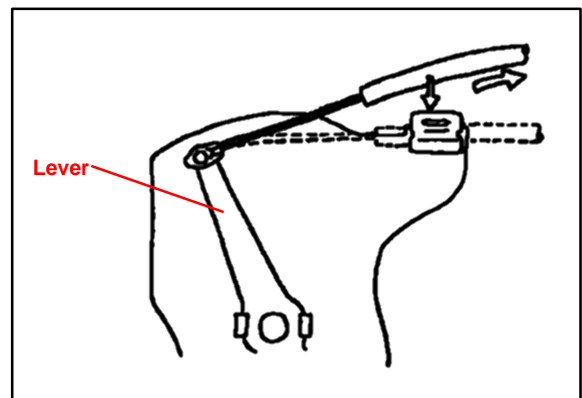
- C. Attach the REC/FRE cable to the heater control unit lever pin and clamp the outer cable to the secure clamp.

Clamp the cable while pushing the outer cable to the A/C unit assembly side.

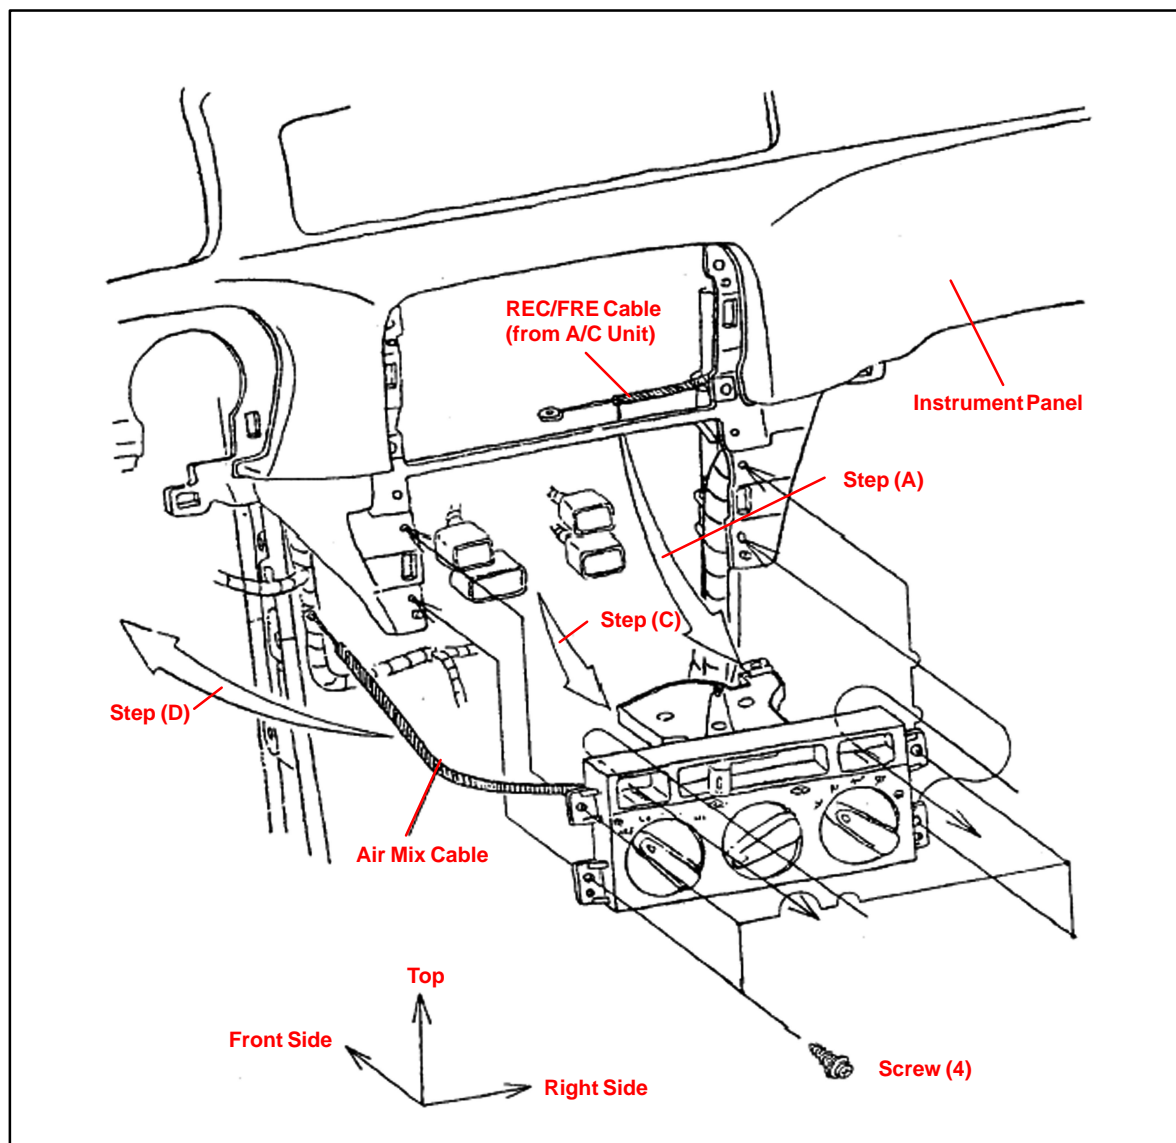
- D. Install the heater control panel to the instrument panel with 4 screws.

Make sure air mix cable is routed outside of the brace.

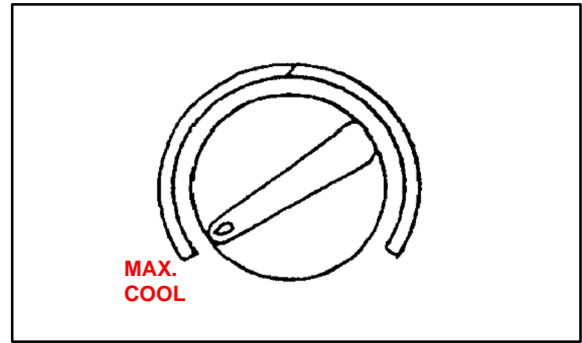
- E. Set the temperature selector of the heater control unit to the “MAX. COOL” position.

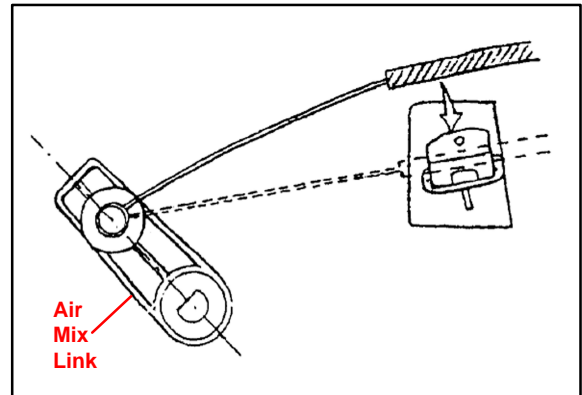
- F. Connect the air mix cable connector to the air mix link pin on the left side of the A/C unit and clamp the outer cable to the secure clamp.

- It is unnecessary to push or pull the outer cable.
- Do not bend the cable when setting the cable.
- Do not move the air mix knob until you are finished clamping the outer cable.

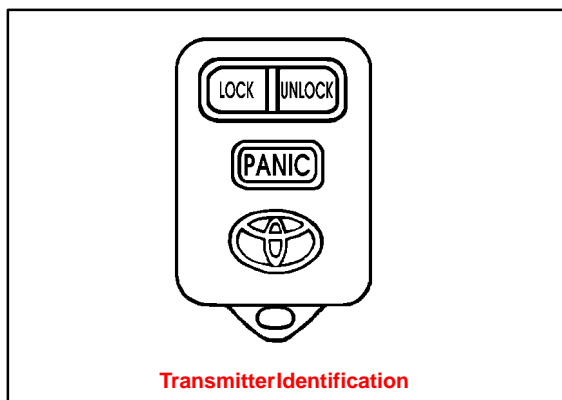
- The Remote Transmitter has LOCK, UNLOCK, and PANIC features.

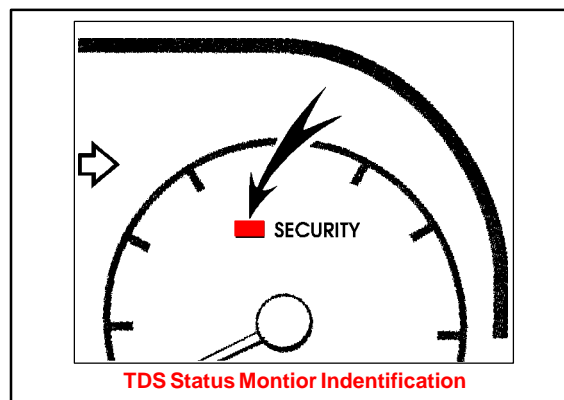
- The TDS Status Monitor is located in the Tachometer.

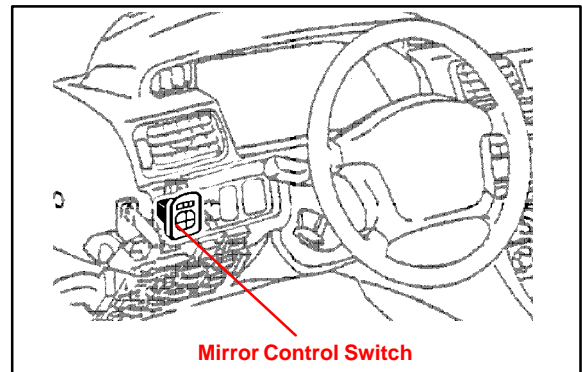
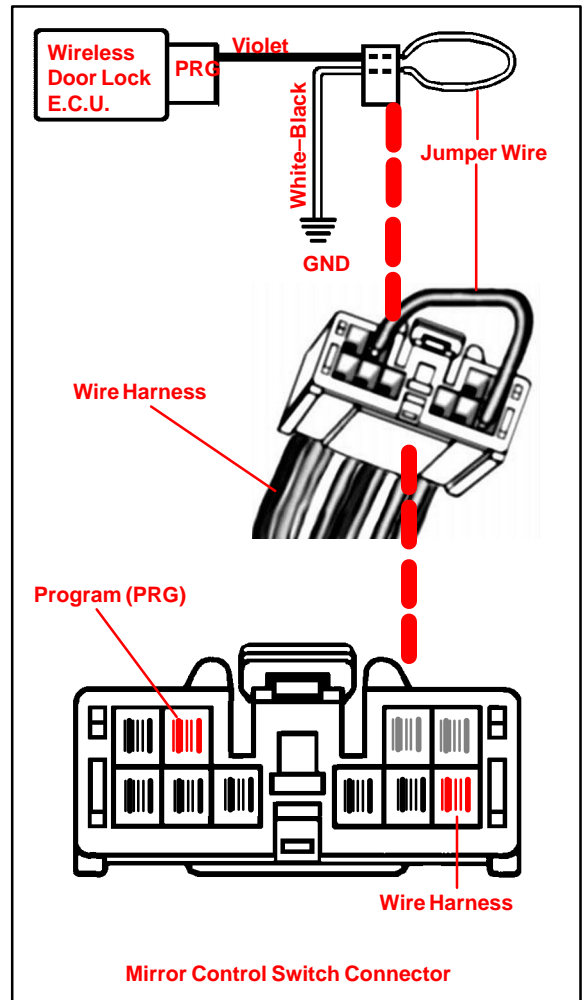
1. With the key **OUT** of the ignition switch, locate and disconnect the Mirror Control Switch from the vehicle harness.
2. Using a suitable jumper wire, connect terminal number 2, **PRG** (violet wire) to terminal number 10, **GND** (white/black) of the 10 cavity mirror control switch connector (illustrated). The vehicle confirms programming mode by requesting the power door locks to lock.
3. Depress, then release, any button on the remote. The vehicle confirms registration by requesting the power door locks to lock once again.
4. To program an additional remote, repeat step 3.
5. Disconnect the jumper wire to exit programming mode.

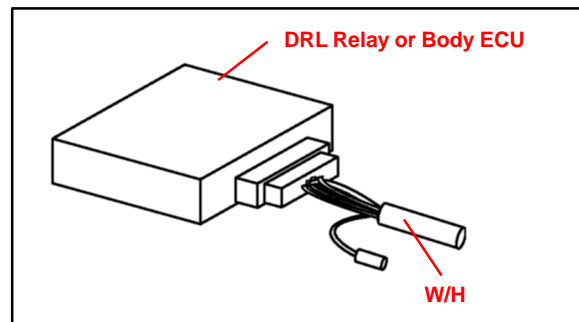
1. Disconnect the Battery.
2. Use the locking pick tool from the wire harness repair kit and back out the terminal from the appropriate connector for the DRL Relay or Body ECU. See the Reference Chart on Page 1 of this bulletin for pin and connector information.

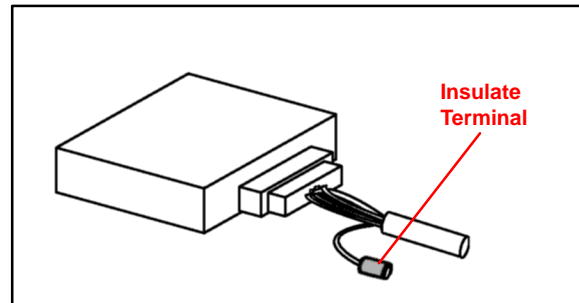
3. Insulate the removed terminal using vinyl electrical tape.

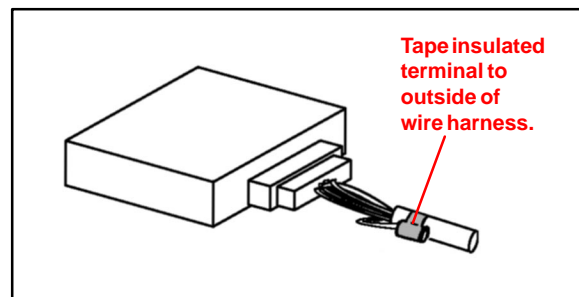
4. Secure the wire and terminal to the outside of the wire harness using vinyl electrical tape.

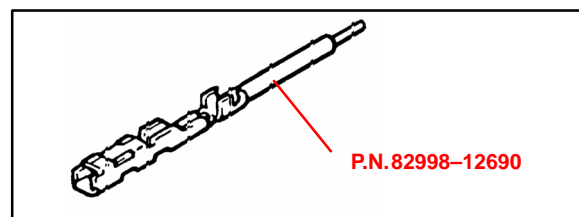
5. For 2000 model year Avalon:
 - A. Order a new terminal with lead that is the same size and type as the terminal previously removed from the connector. (PN 82998–12690)

- B. Securely attach a 45 cm/ 18 in wire with an outside diameter of 2.0 mm or larger to the tail of the new terminal.

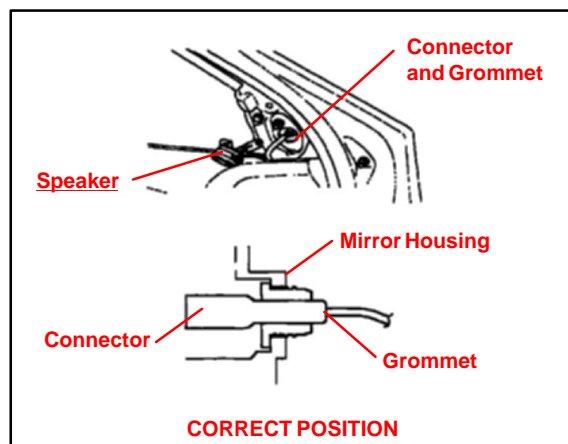
1. Carefully pry off the door speaker cover and remove the nut using a 10 mm socket that secures the speaker to the door.
2. Look through the door mirror harness access hole and check the position of the wire harness grommet and wire harness connector – the harness connector should be inside the grommet and the grommet should be fully seated in the mirror housing.

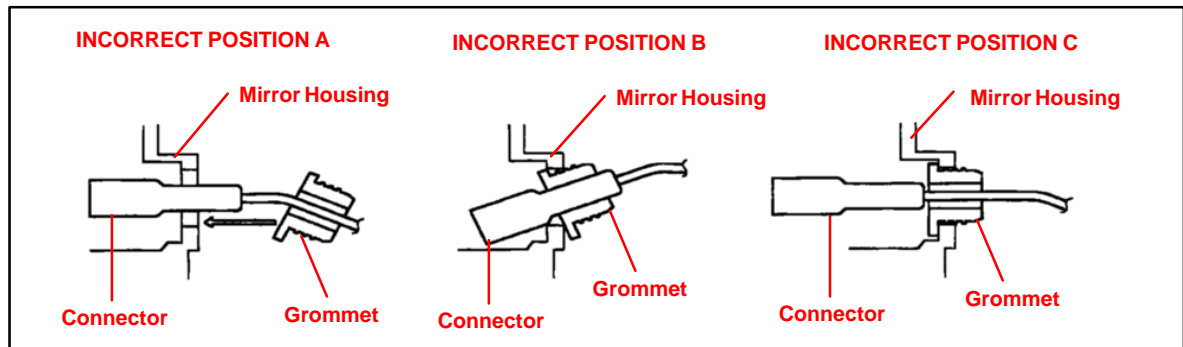
Examples of improperly installed assemblies are shown below:

3. To reposition the grommet and/or harness connector onto the mirror housing:
- Remove the mirror housing (the remaining 2 nuts) from the door and carefully unclip the mirror from the housing. This will allow easier access and reinstallation of the grommet and/or harness connector.
 - Reposition the grommet so it is fully seated to the mirror housing. Assure the harness connector is inside the grommet.

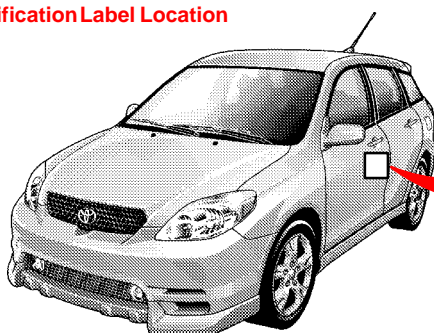
Certification Label Location

MFD.BY: TOYOTA MOTOR MANUFACTURING
CANADA INC. 10/01
GVWR 3935LB GAWR FR 1970LB RR 1985LB
THIS VEHICLE CONFORMS TO ALL APPLICABLE
FEDERAL MOTOR VEHICLE SAFETY, BUMPER, AND
THEFT PREVENTION STANDARDS IN EFFECT ON
THE DATE OF MANUFACTURE SHOWN ABOVE.
XT0XX00X0X000000 PASS.CAR

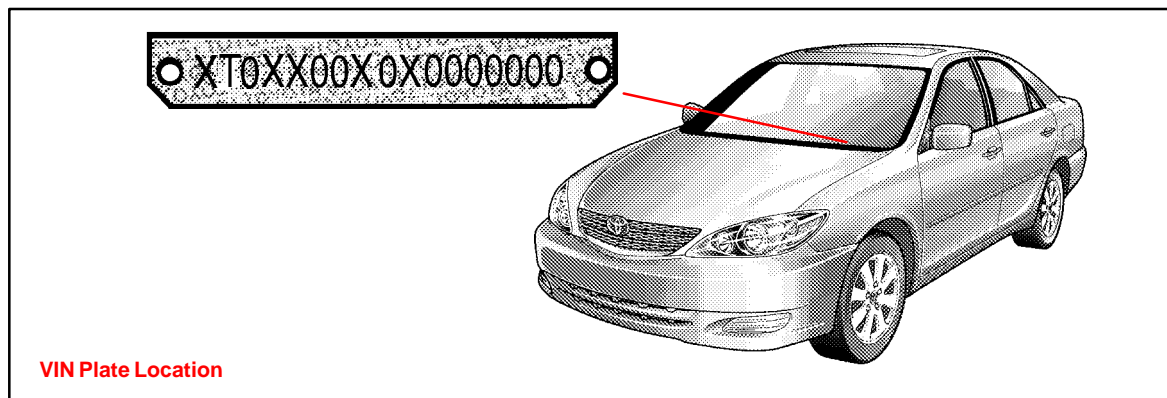
VIN Plate Location

Replacement **VIN** plates (metal plates riveted to dashboard) **may be** available from Toyota providing the request meets the criteria listed below.

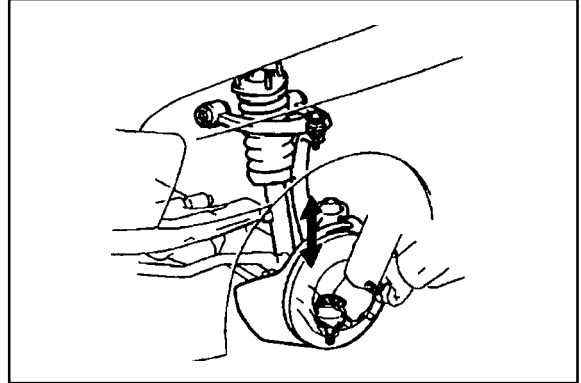
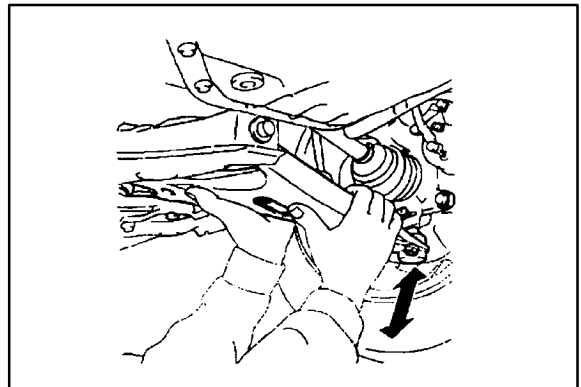
1. Inspect Lower Ball Joint Free Play

- A. Move the hub up and down by hand (most models with wishbone suspension):
 - a. Remove the tire.
 - b. Install the 2 lug nuts.
 - c. Inspect the free play while moving the lug nuts up and down at a force of 67 lbf (294 N, 30 kgf).
- B. Move the lower arm using a lever (some models with double wishbone type suspension):
 - a. Lift up the vehicle.
 - b. Place the tip of the lever to the wheel and inspect the free play while moving the lower arm up and down.
- C. Move the lower arm by hand (all models with strut type suspension and some models with wishbone type suspension):
 - a. Lift up the vehicle.
 - b. Inspect the free play while moving the lower arm up and down at a force of 67 lbf (294 N, 30 kgf).

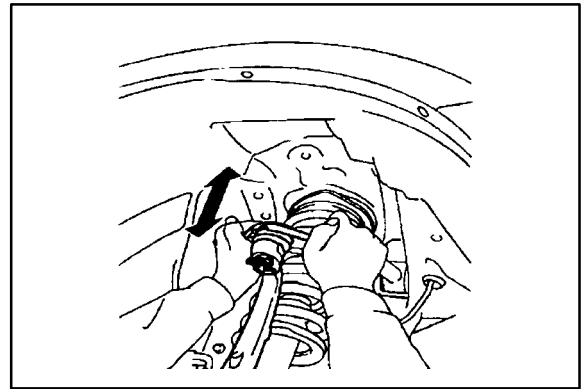
**On-Vehicle
Inspection**
(Continued)**2. Inspect Upper Ball Joint Free Play**

- A. Move the upper arm by hand (models with the LOWER control arm linked by a torsion bar, and all models using a coil spring).
 - a. Remove the front tire.
 - b. Inspect the free play while moving the upper arm up and down at a force of 67 lbf (294 N, 30 kgf).
- B. Move the tire with a lever (models with the UPPER control arm linked by a torsion bar).
 - a. Lift up the vehicle.
 - b. Place the lever under the tire, and inspect the free play while lifting the tire using a wooden stick, etc., as a fulcrum.

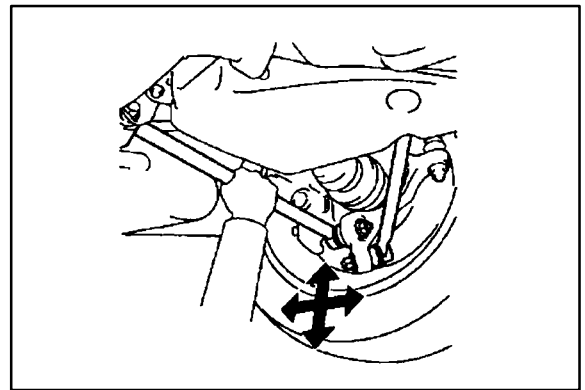
**3. Inspect the Suspension Arm Ball Joint Free Play**

- A. Lift up the vehicle.
- B. Inspect the free play while moving the control arm by hand.

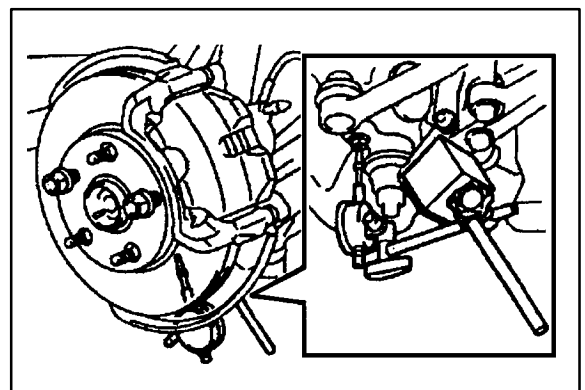
**(Reference)****Free Play Inspection Method
(Gauge Installation)**

- Position the dial gauge between the arm (upper or lower) and the knuckle, and measure free play.
(This illustration shows how to measure free play for vehicles with double wishbone type suspension with coil spring.)

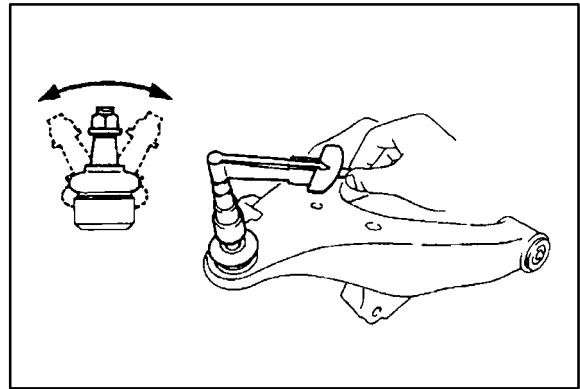
Refer to the table for standard values for the turning torque.

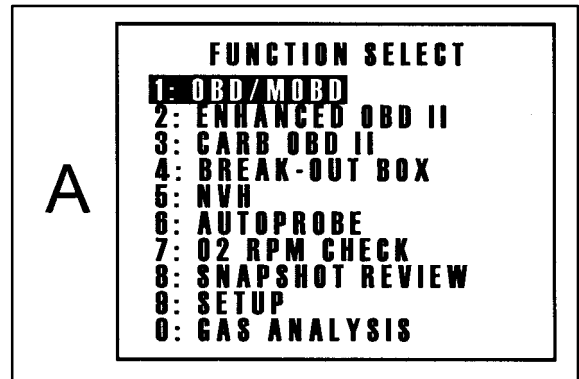
3. "From the "FUNCTION SELECT" menu (Screen A), select [1: OBD/MOBD].

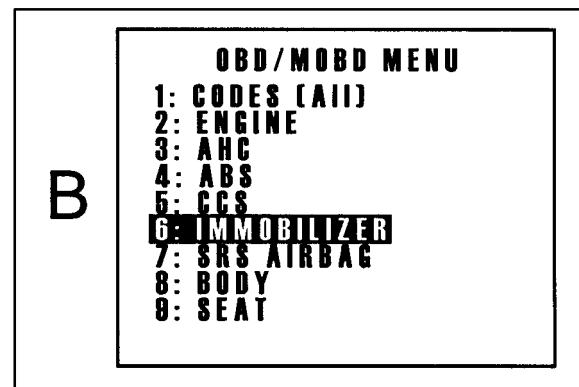
4. From the "OBD/MOBD MENU" (Screen B), select [6: IMMOBILIZER].

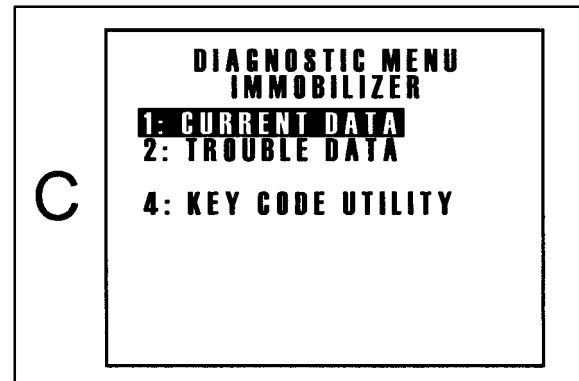
5. From the "DIAGNOSTIC MENU IMMOBILIZER" (Screen C), select [1: CURRENT DATA]

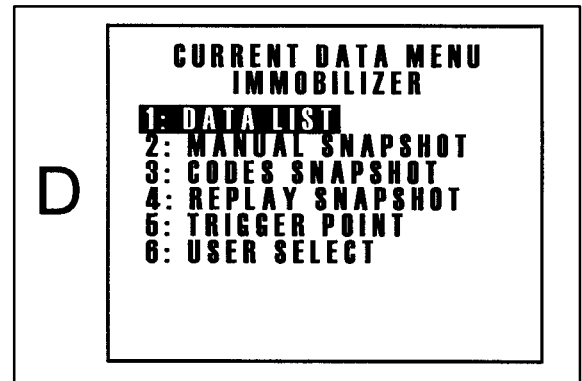
6. From the “CURRENT DATA MENU IMMOBILIZER” (Screen D), select [1: DATA LIST].

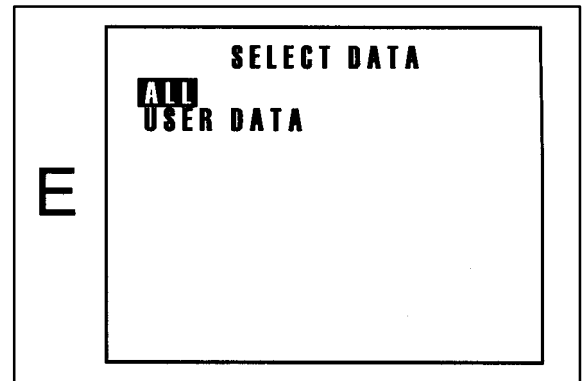
7. From the “SELECT DATA” menu (Screen E), select [ALL].

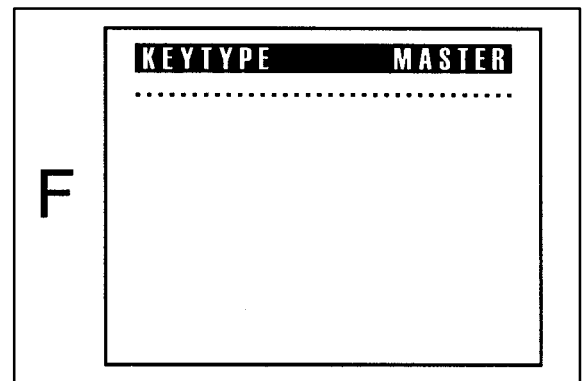
8. The Transponder Key Type in the ignition cylinder will be displayed (Screen F).

[MASTER] = Registered Master Key
[SUB] = Registered Sub Key
[NO] = Not a Registered Key,
or Vehicle is not
equipped with
Immobilizer.

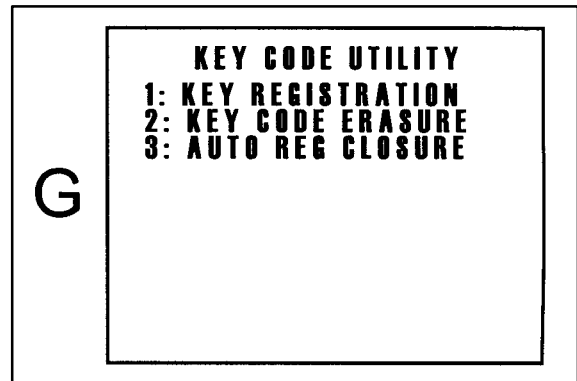
9. From the “KEY CODE UTILITY” menu (Screen G), the functions listed are outlined in the next sections.

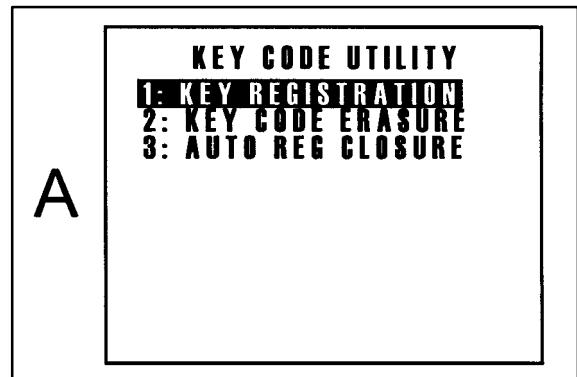
1. From the “KEY CODE UTILITY” menu (Screen A), select [1: KEY REGISTRATION].

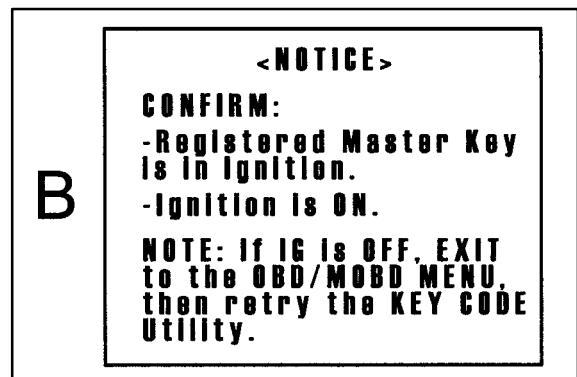
2. Confirm the instruction on Screen B and press the (ENTER) key.

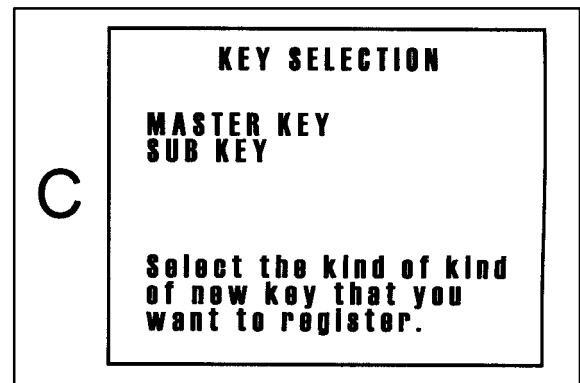
3. From the “KEY SELECTION” menu (Screen C), select the Transponder Key type to be registered and press the (ENTER) key.

Do not register a SUB KEY as a MASTER KEY. The SUB KEY is typically left with an attendant when the vehicle is parked. A Registered Master Key allows the user to add/erase transponder keys.

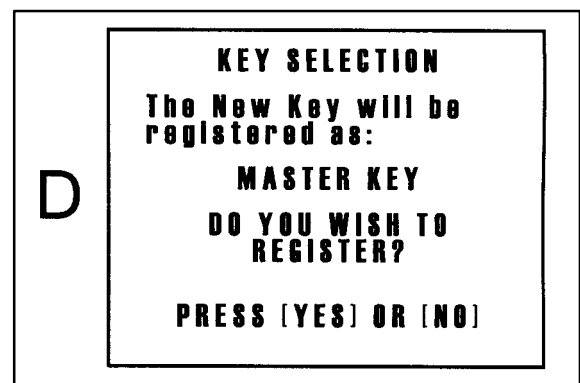
4. From “KEY SELECTION” (Screen D), confirm the type of Transponder Key to be registered and press the (ENTER) key.

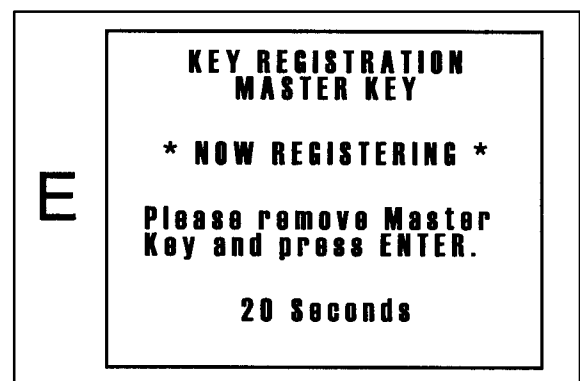
5. After pressing the (YES) key, remove the Registered Master Key from the Ignition Cylinder within 20 seconds. After removing the key, press the (ENTER) key.

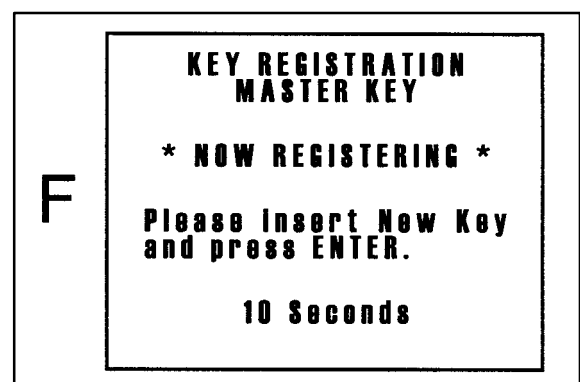
6. Insert the New Transponder Key into the Ignition Cylinder within 10 seconds and press the (ENTER) key.

Look at the Security Indicator Light. It will begin to flash as the New Transponder Key is inserted.

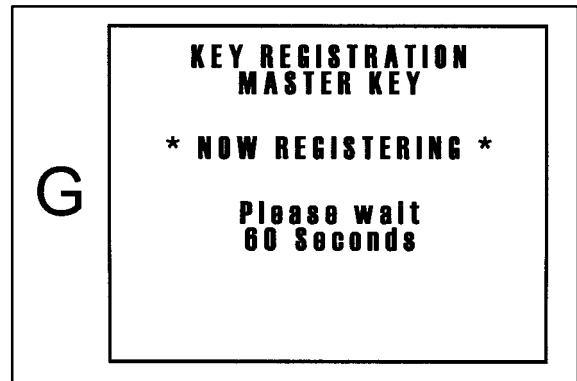
7. The registration of the New Transponder Key will be completed in approximately 60 seconds.

The Security Indicator continues to flash during registration.

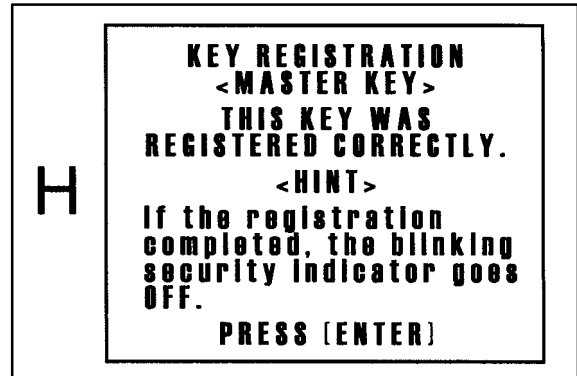
8. Screen H will be shown at completion of registration. Confirm the Security Indicator turns OFF and press the (ENTER) key.

The Security Indicator will stop flashing when Key Registration is complete.

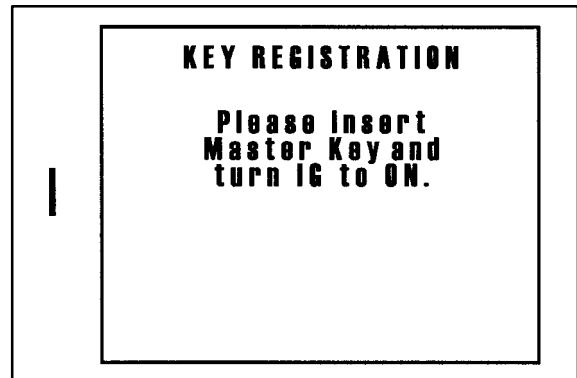
9. Insert the New Registered Master Key into the Ignition Cylinder and turn to the ON position and press the (ENTER) key.

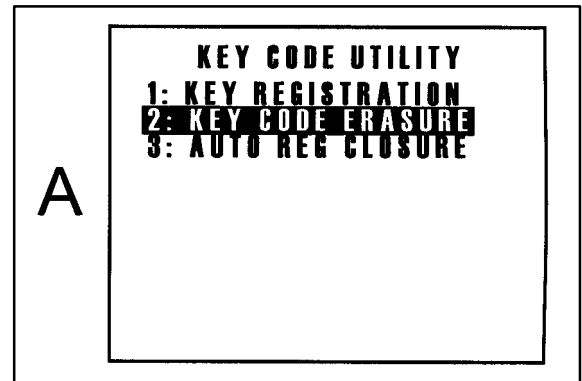
1. From the “KEY CODE UTILITY” menu (Screen A), select [2: KEY CODE ERASURE].

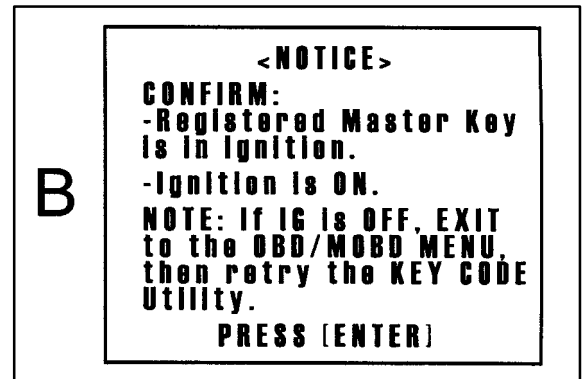
2. Confirm the instruction on Screen B and press the (ENTER) key.

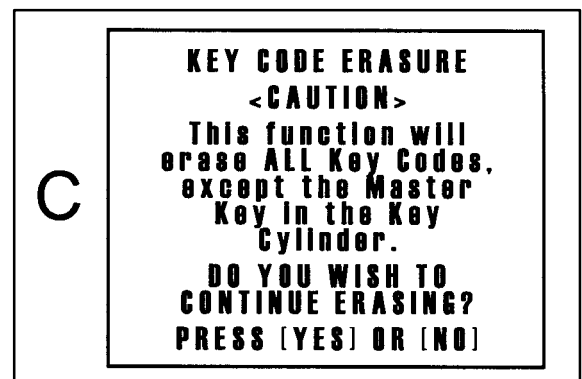
3. Confirm the instruction on Screen C and press the (YES) key.

By pressing the (YES) key, all Transponder Key Codes will be erased except the Registered Master Key in the Ignition Cylinder.

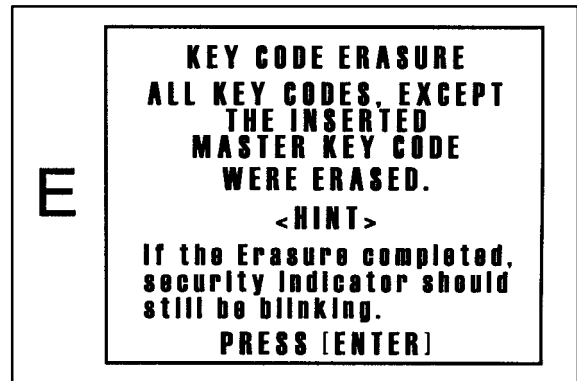
5. If Step 4 was completed correctly, Screen E will confirm ERASURE was successful.

If the Erasure completed, the security indicator should still be blinking.

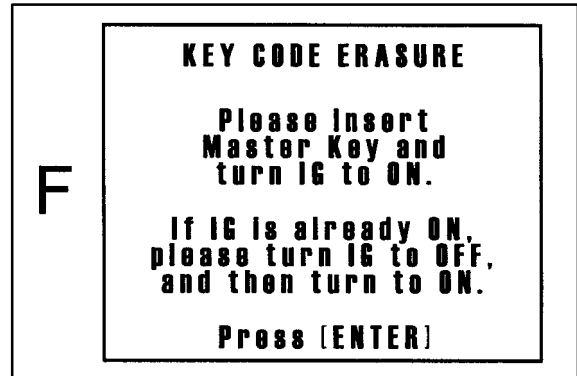
6. Insert the Registered Master Key into the Ignition Cylinder and turn to the ON position and press the (ENTER) key.

Look at the Security Indicator Light. Inserting a Registered Master Key causes the Security Indicator to immediately stop blinking.

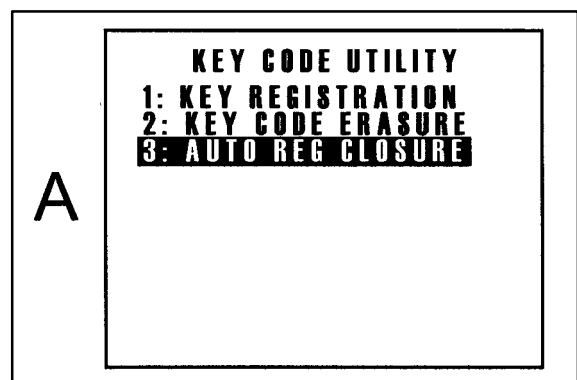
1. From the “KEY CODE UTILITY” menu (Screen A), select [3: AUTO REG CLOSURE].

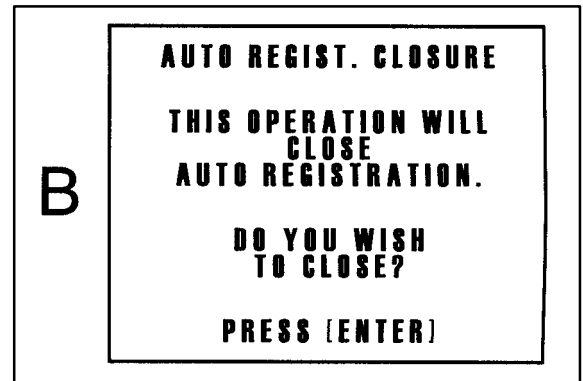
2. Confirm the instruction on Screen B and press the (ENTER) key.

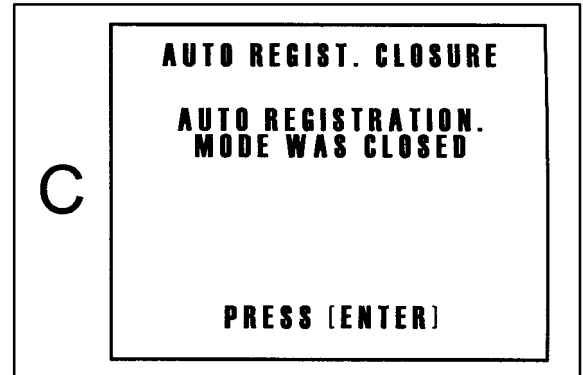
3. At "AUTO REGIST. CLOSURE" (Screen C), the Auto Registration Closure Information will be displayed. Press the (ENTER) key to finish.
