Technical Service BULLETIN

A/C COMPRESSOR MAINTENANCE FOR STORED VEHICLES

AC002-00

HEATING & AIR CONDITIONING

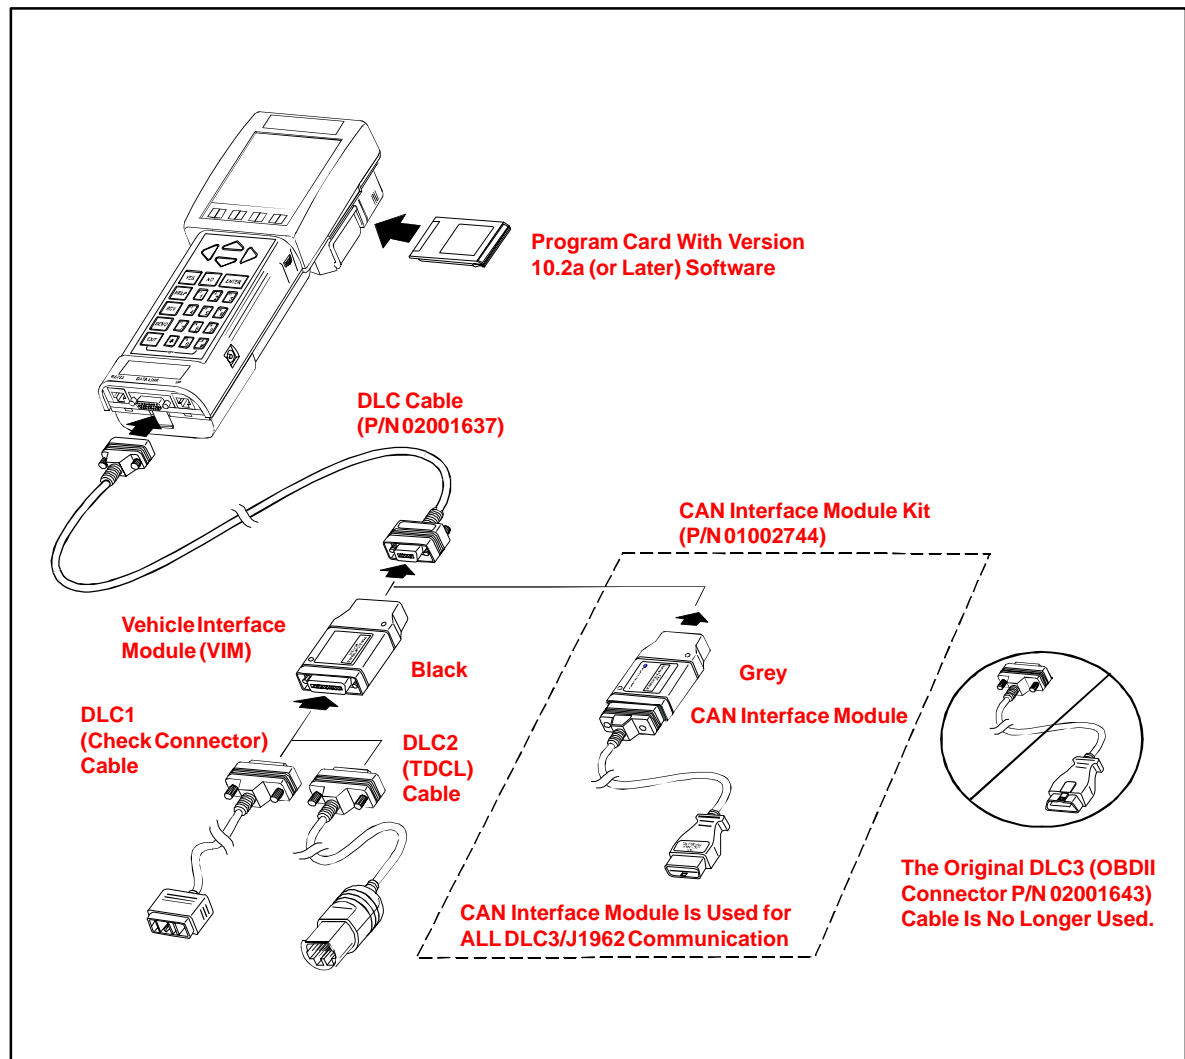
1. Remove the original DLC3 Cable and store it in the Diagnostic Tester storage case.
2. Connect the CAN Interface Module to the DLC Cable.
3. Use the Diagnostic Tester with the CAN Module installed for all DLC3/J1962 based vehicle communication.
4. If you experience problems with the Diagnostic Tester or CAN Interface Module, please contact Toyota Special Service Tool Customer Support at 1-800-933-8335.

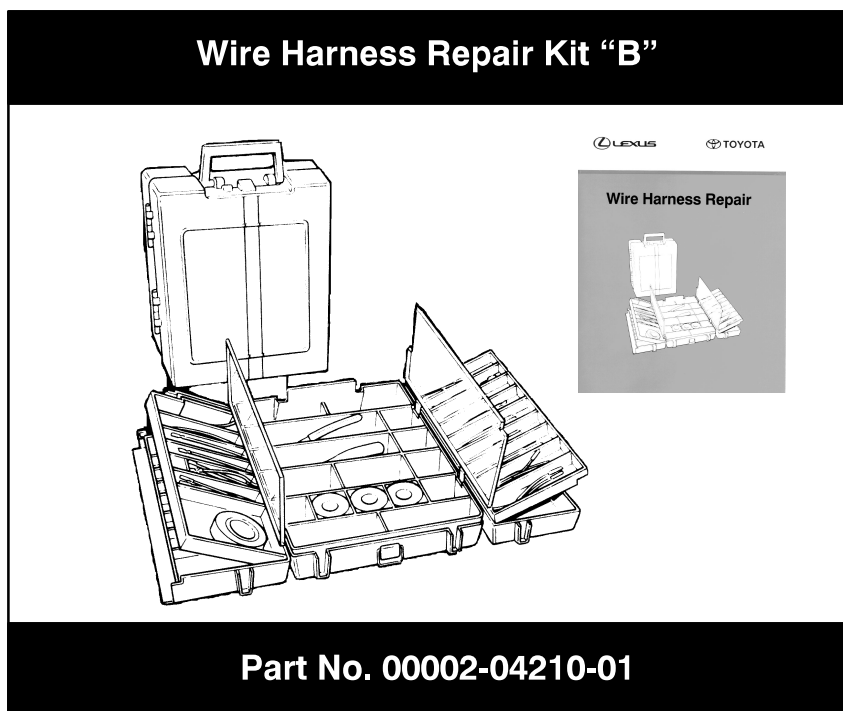
The new Wire Harness Repair Kit "B" has been released as an essential Special Service Tool (SST) to supplement the original Wire Harness Repair Kit. This kit holds an initial supply of 21 new type electrical terminals and connectors as well as the necessary supplies and small tools for most electrical repairs.

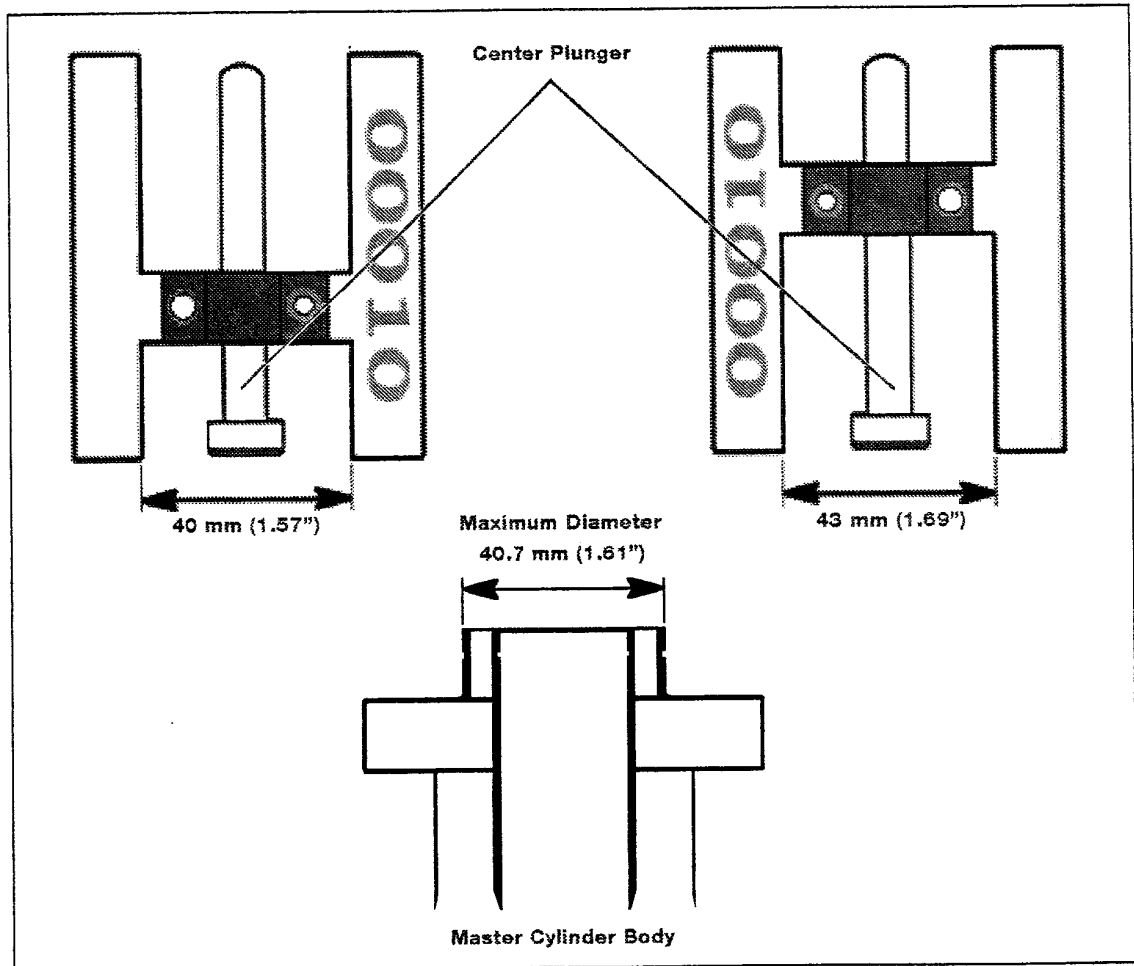
When inspecting or making brake booster push rod adjustments with SST 09737-00010, it is necessary to assure proper tool configuration prior to use. The SST has a reversible center plunger that allows it to function on a wide range of Toyota vehicles. Prior to using, verify that it is configured correctly for the application by checking the master cylinder outer diameter at the point illustrated below. The dimensions for the SST, Part Number 09737-00010, are also shown in the illustrations below.

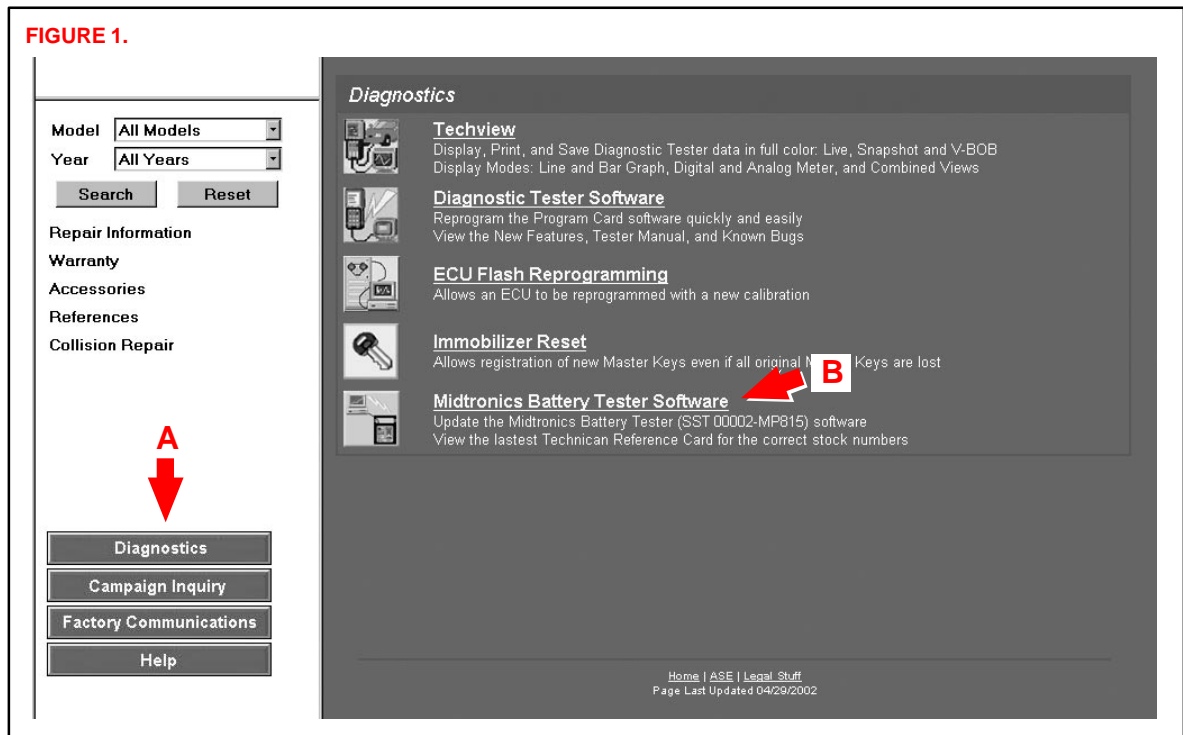
FIGURE 1.

- A. Open TIS (Technical Information System) and go to the “Diagnostics” section.
- B. Click on the text “Midtronics Battery Tester Software.”

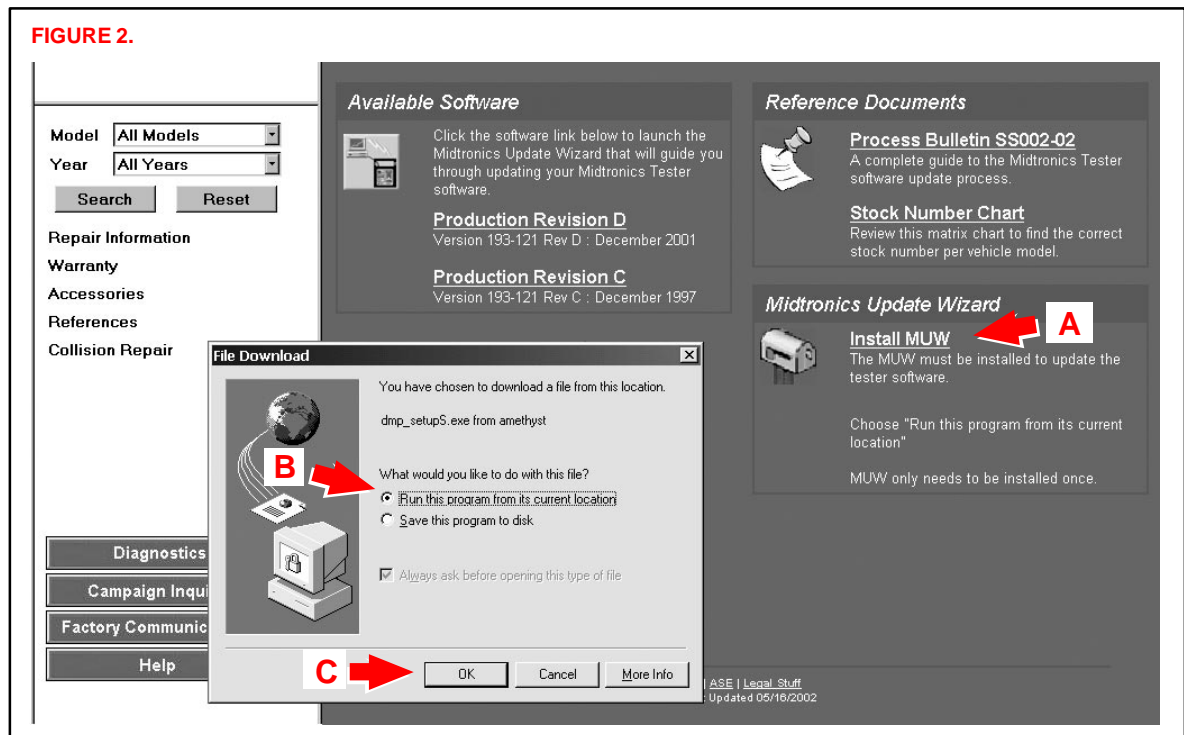
FIGURE 2.

- A. Click on the text “Install MUW.” (Figure 2.)
- B. The file download window will appear. Click on “Run this program from it’s current location.”
- C. Click the “OK” button.
- D. Allow the Update Wizard to perform its self–installation. This will take only a few minutes.

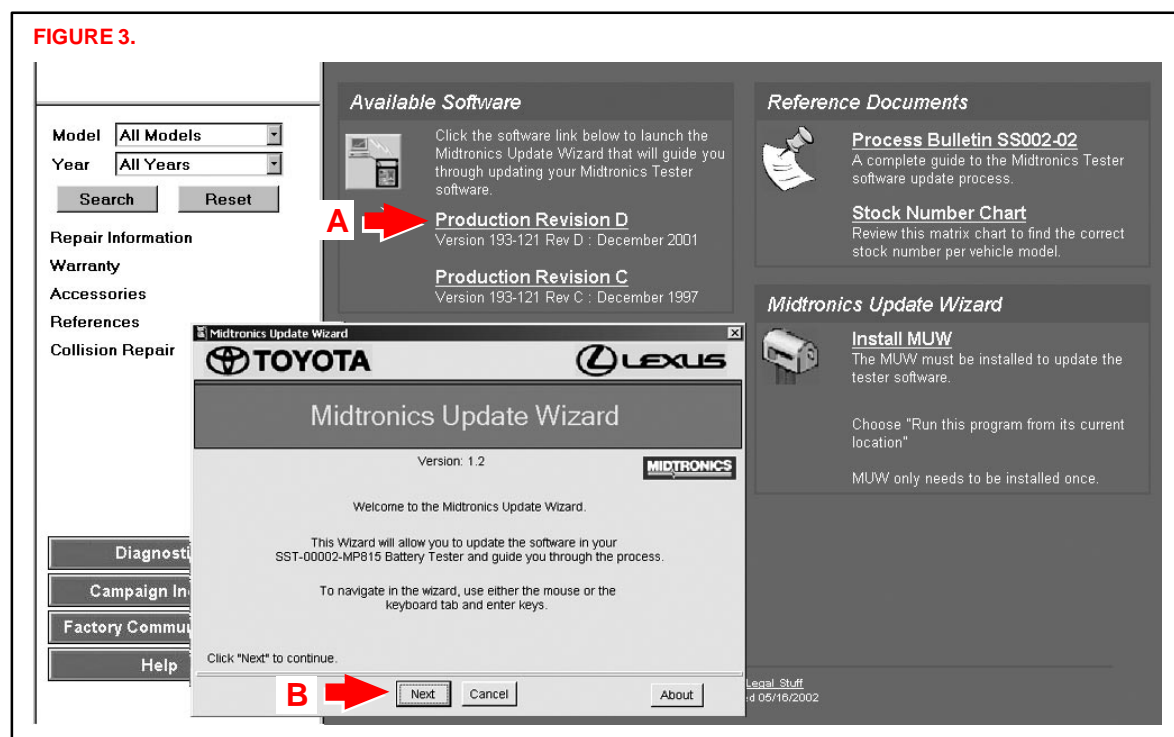
- A. Click on the latest version of production software. (Figure 3.) This will begin the software update process.
- B. The next screen to appear will be the first screen of the software update. Click “Next” to continue.

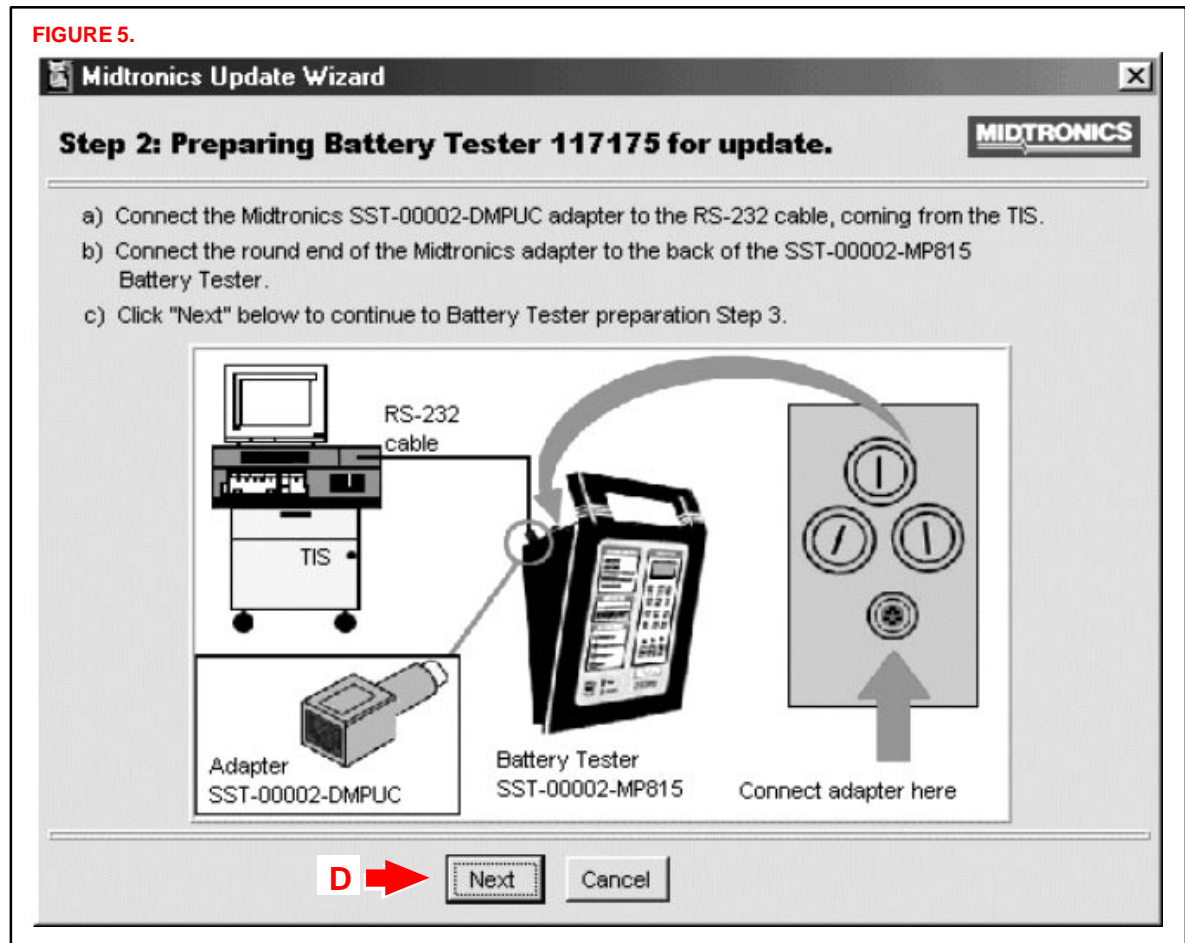
FIGURE 5.

Connecting the Midtronics Battery Tester to the TIS station will require the use of SST 00002–DMPUC. This is an adapter that allows the TIS RS–232 cable to plug into the Battery Tester. (Figure 5.)

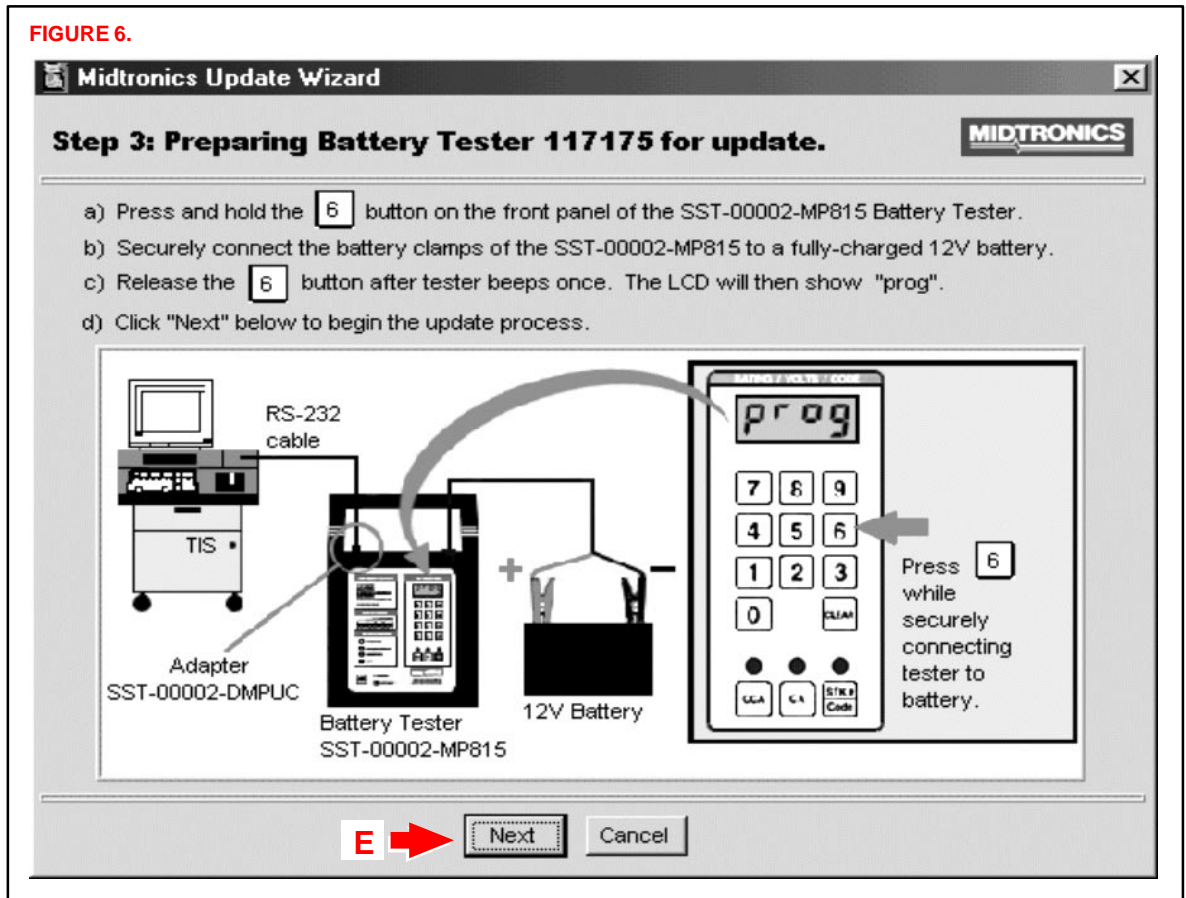
FIGURE 6.

- E. Follow the instructions to put the Midtronics Battery Tester into the correct mode (Figure 6), then click “Next.”

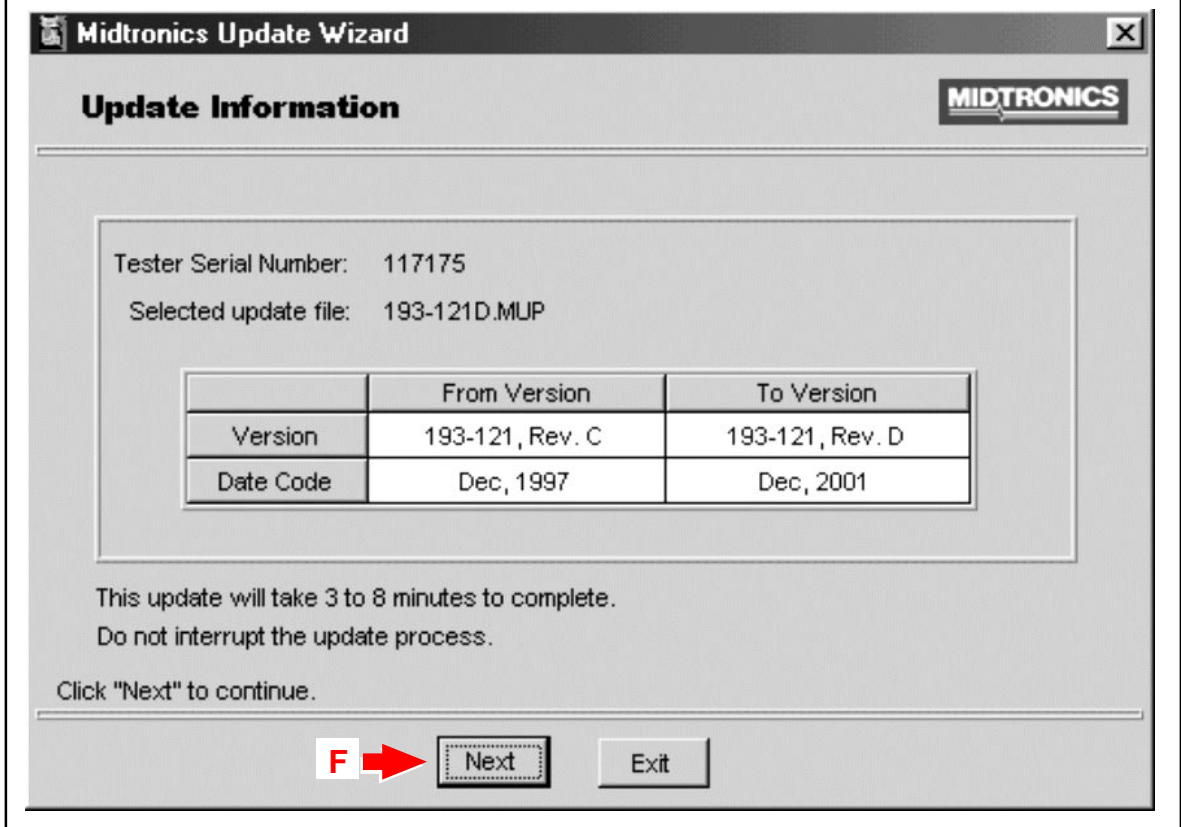
FIGURE 7.

F. Confirm the software version and click “Next.” (Figure 7.)

Figures 7–1 and 7–2 are confirmation dialogs that will pop up over the Update Information window (Figure 7) when:

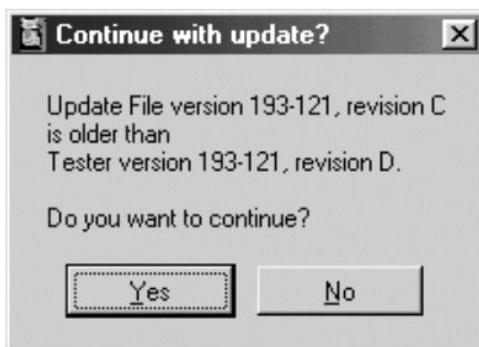
FIGURE 7–1.

- The update file is an older revision level than that found in the battery tester (Figure 7–1) or
- The update file is the same revision level as that found in the tester (Figure 7–2).

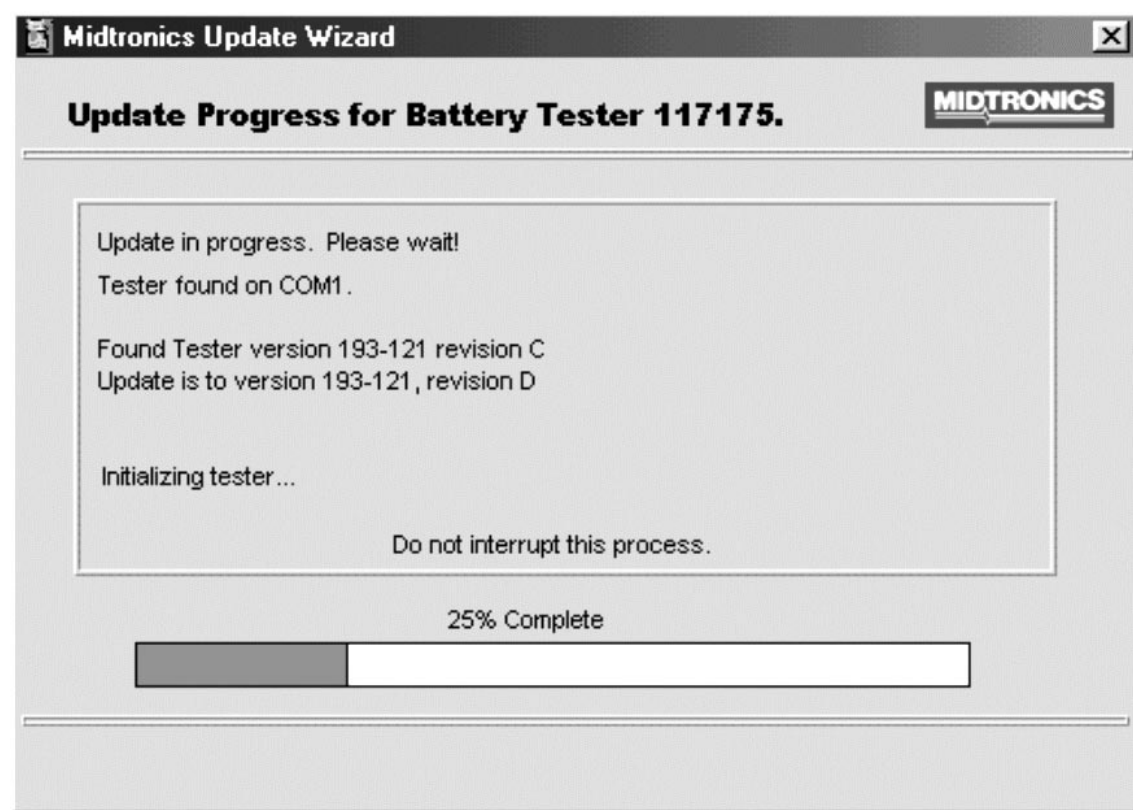
FIGURE 8.

- G. The Midtronics Update Wizard (MUW) will now update the Midtronics Battery Tester software. (Figure 8.)

Do not interrupt this process (it will take approximately 5 minutes).

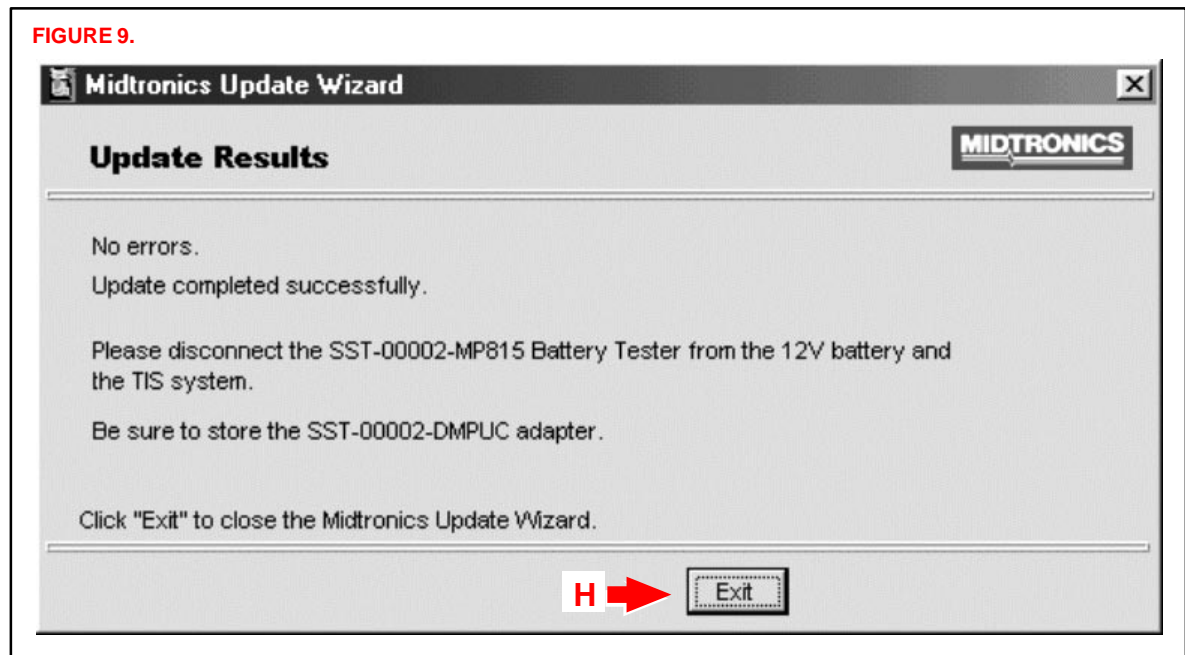
- H. Upon successful completion, the Update Results screen will display “No errors” and the update is now complete. Click on the “Exit” button. (Figure 9.)

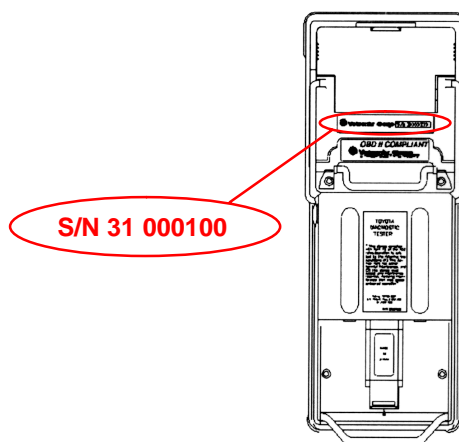
Figure 1
Back View of Diagnostic Tester

Introduction Certain Diagnostic Testers (SST P/N 02002019) may experience a communication error with the Technical Information System (T.I.S.). To correct this condition, the tester manufacturer, Vetronix Corporation, will recall and update affected units. The following explains how to determine which Diagnostic Testers may exhibit this problem and outlines the procedure to return the tester for repair.

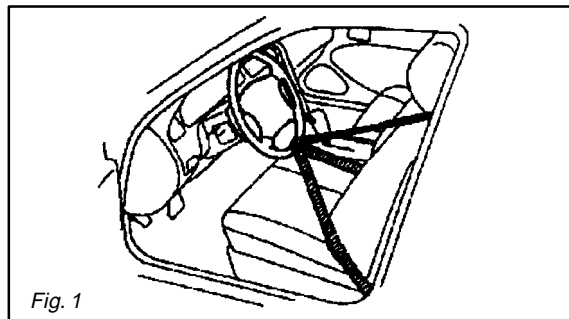
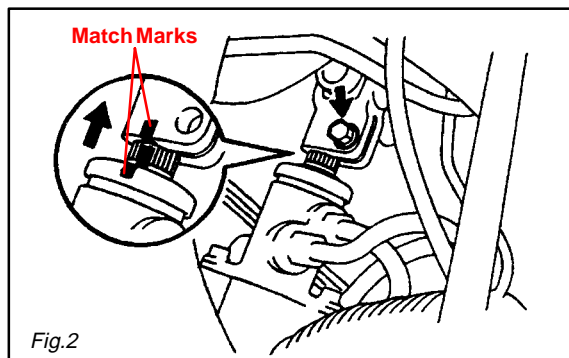
1. Position the front wheels facing straight ahead.
2. Using the driver's seat belt, set the steering wheel so that it does not turn (see Fig. 1).
3. Paint match marks on the intermediate shaft and control valve shaft (see Fig. 2).
4. Remove the intermediate shaft retaining bolt and disconnect the intermediate shaft (see Fig. 2).

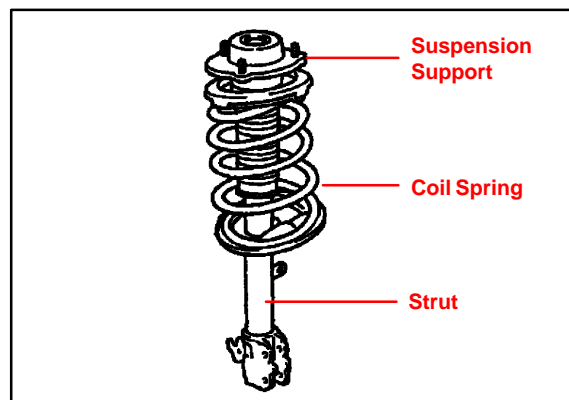
The rubber bushing shape of the suspension support has been changed.

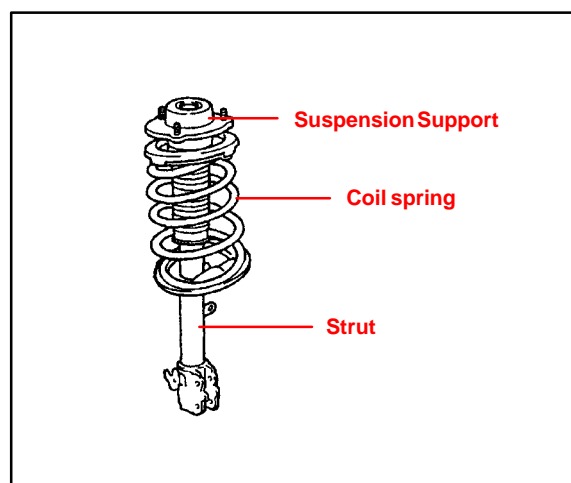
Modification Information The rubber bushing shape of the suspension support has been changed.

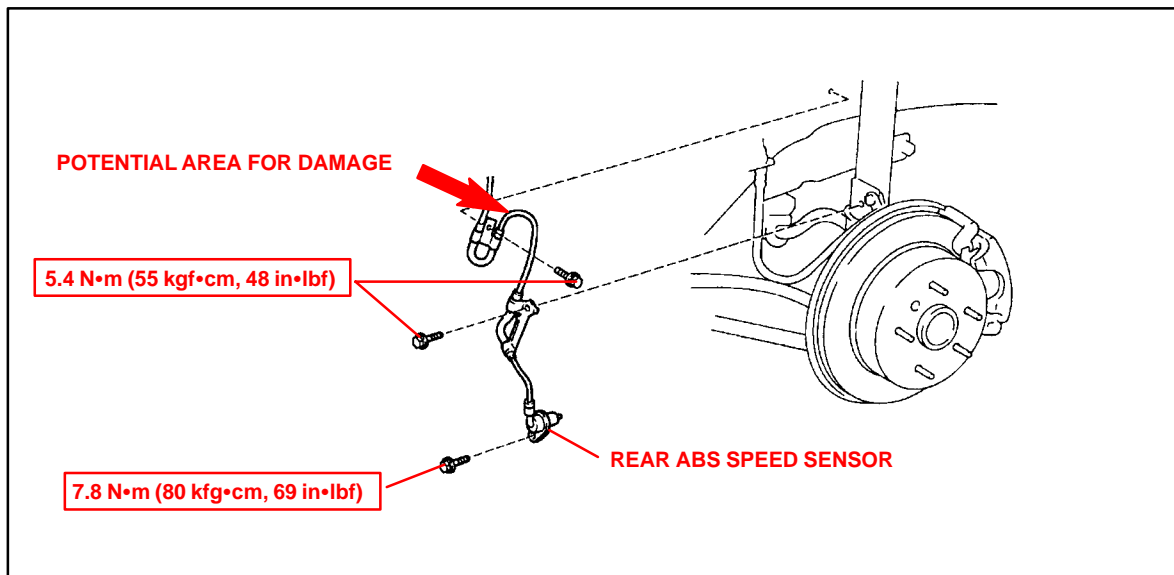
Prior to removal/replacement of the rear axle, rear coil spring and rear shock absorber, be sure to remove the rear ABS speed sensor from the rear axle by removing the 3 bolts shown above. Check the speed sensor signal after installation.

Failure to remove the ABS speed sensor prior to removal of the rear axle or suspension may cause the ABS warning light to illuminate or damage the ABS speed sensor wire harness.

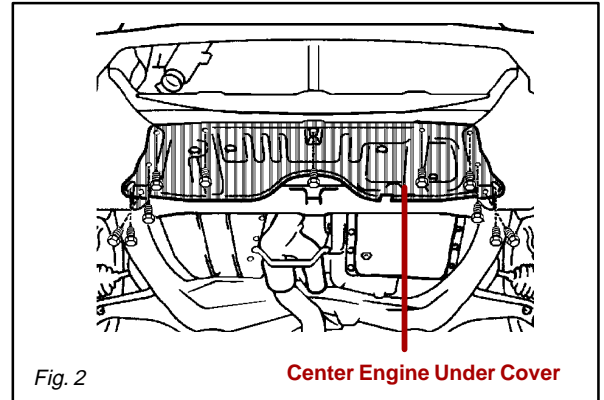
- A. Remove the **9** bolts, **2** screws and the center engine under cover.

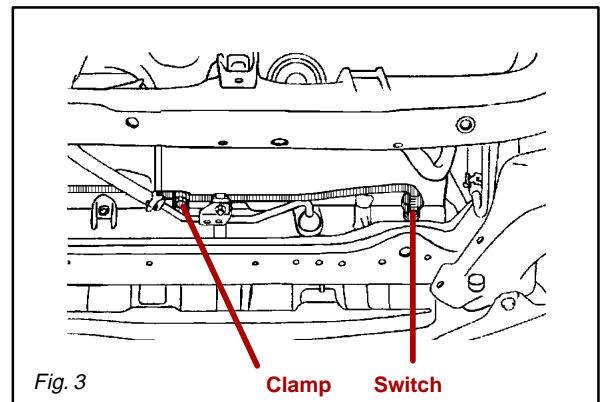
- B. Remove the engine coolant temperature switch connector and the wire clamp.

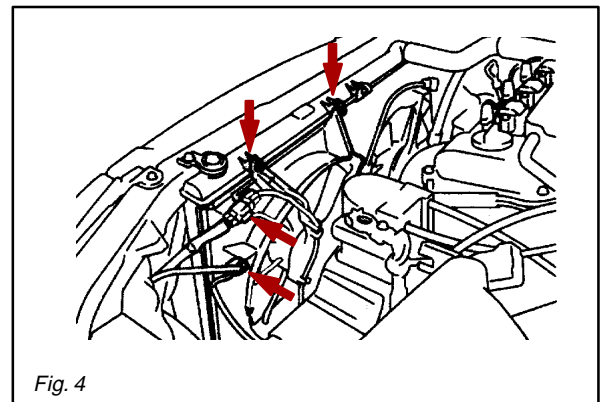
- C. Remove battery and tray.
- D. Disconnect the cooling fan connector.
- E. Disconnect the No.1 engine coolant temperature switch wire connector.
- F. Remove the **2** bolts and then the cooling fan.

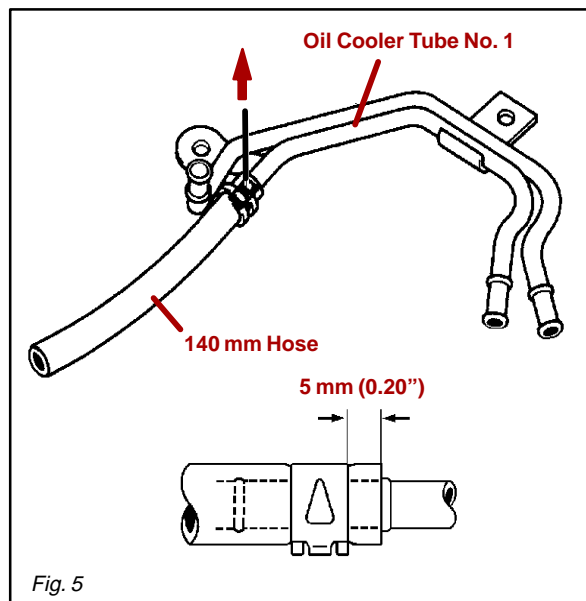
Install the hose clamp with the hose clamp clip at the position shown, and use pliers to pull off the clip in the direction indicated by the arrow.

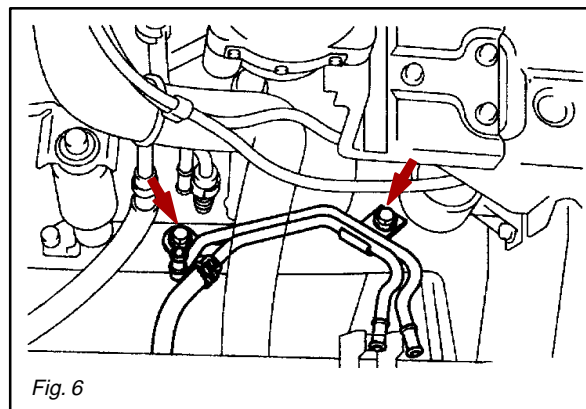
- B. Install the tube bracket onto the left side of the front suspension member with the 2 bolts as shown.

Torque: 62 in-lbf
(7 N-m / 71 kgf-cm)

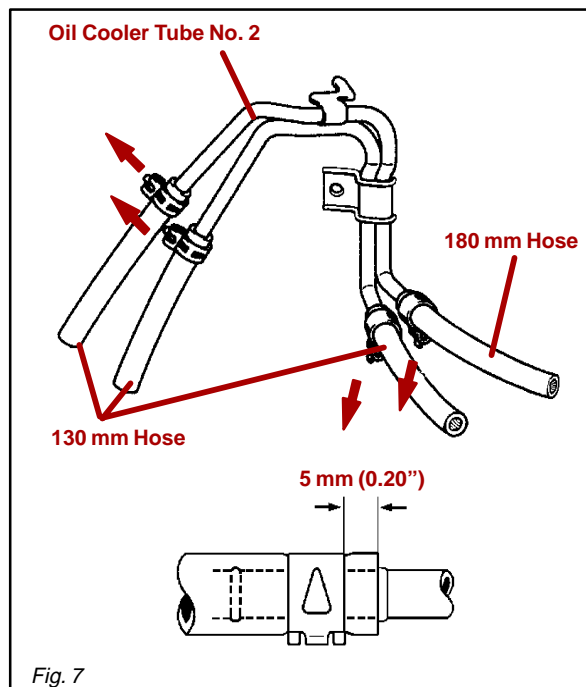
- C. Install the 130 mm (5.12") hoses and the 180 mm (7.09") hose to the oil cooler tube No. 2 as shown.

Install the hose clamps with the hose clamp clips at the positions shown, and use pliers to pull off the clips in the direction indicated by the arrows.

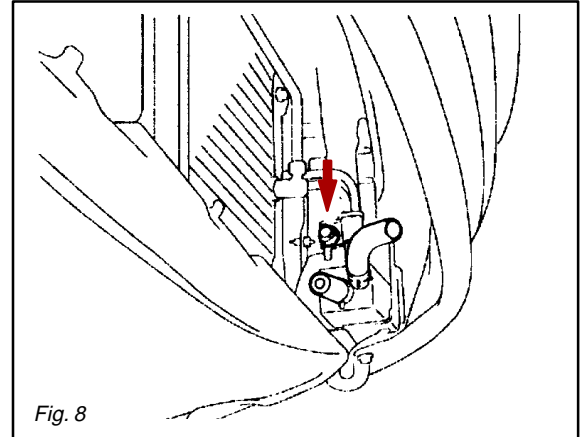
- D. Remove the lower side clip of the radiator side LH deflector.
- E. Install the tube bracket with the bolt on the side member.

Torque: 62 in-lbf
(7 N-m / 71 kgf-cm)

- F. Reinstall the lower side clip of the radiator LH deflector.

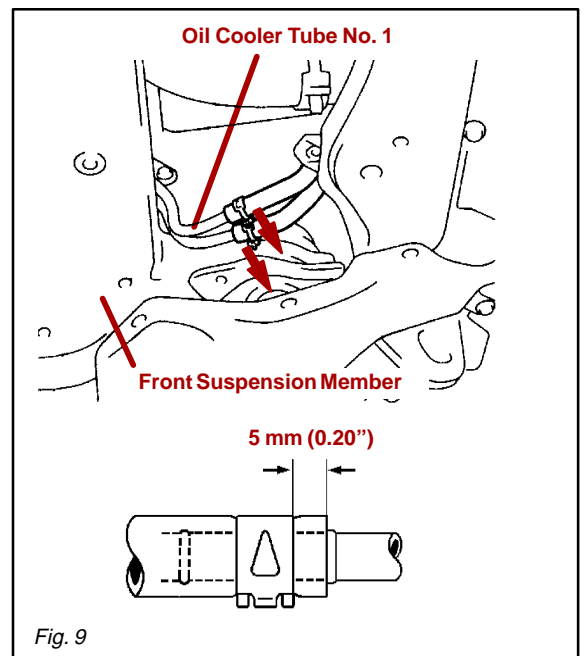
- G. Connect the hoses from the oil cooler tube No. 2 to the oil cooler tube No.1.

Install the hose clamps with the hose clamp clips at the positions shown, and use pliers to pull off the clips in the direction indicated by the arrows.

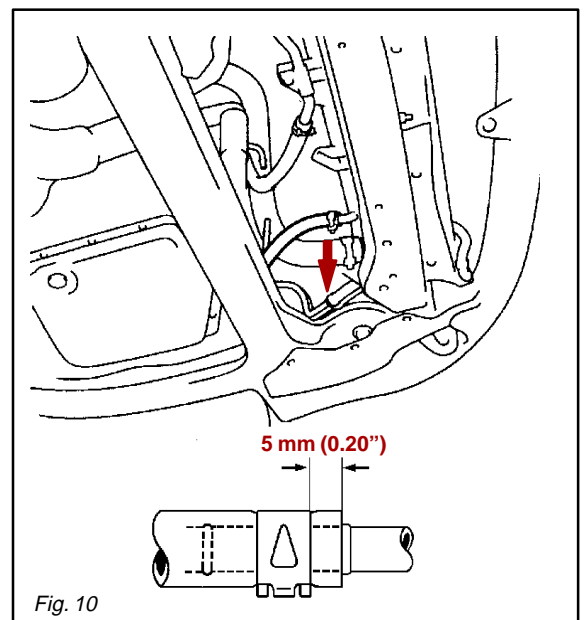
Install the hose clamps with the hose clamp clips at the positions shown, and use pliers to pull off the clips in the direction indicated by the arrows.

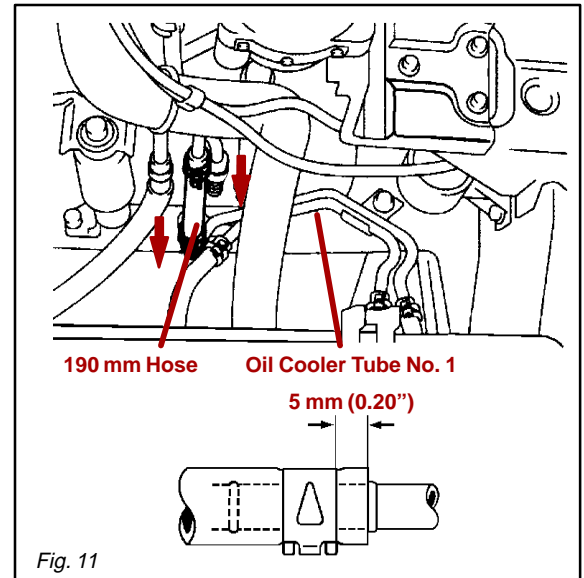
- J. Install the 190 mm (7.48") hose between the oil cooler tube No.1 and transaxle oil cooler tube.

Install the hose clamps with the hose clamp clips at the positions shown, and use pliers to pull off the clips in the direction indicated by the arrows.

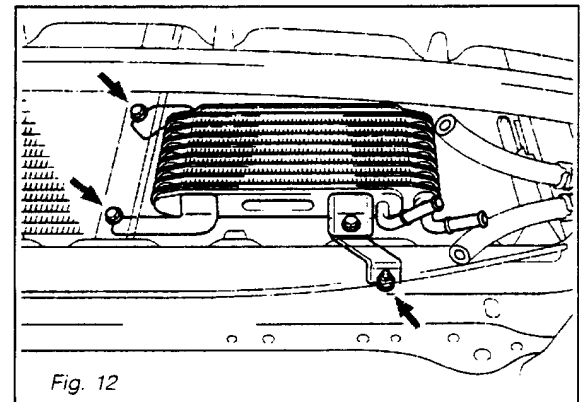
- K. Install the oil cooler onto the center brace and front cross member using the two bolts and nut as illustrated in figure 12.

Torque: 65.5 in-lbf
(7.4 N-m/75.5 kgf-cm)

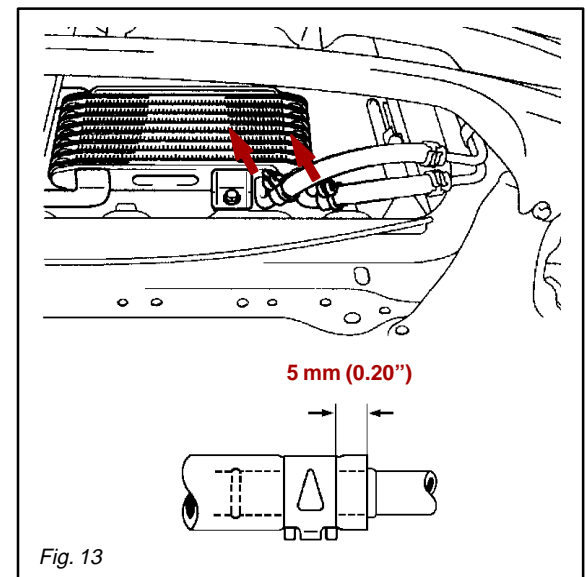
- L. Connect the hoses to the pipes.

Install the hose clamps with the hose clamp clips at the positions shown, and use pliers to pull off the clips in the direction indicated by the arrows.

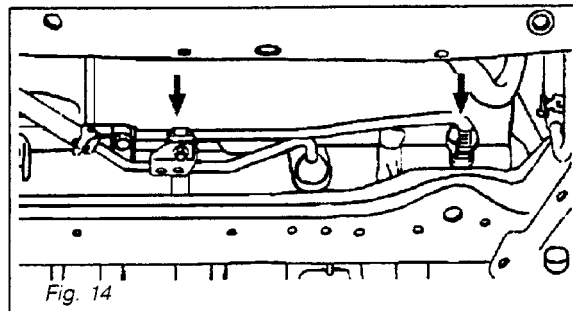
- A. Reconnect the coolant temperature switch connector and wire clamp as illustrated in figure 14.

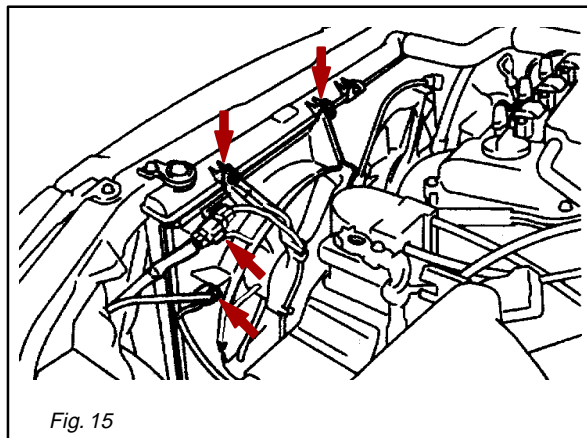
- B. Install the cooling fan with 2 bolts.
 C. Reconnect the cooling fan connector and the No.1 engine temperature switch wire connector as shown in figure 15.
 D. Reinstall battery and tray.
 E. Start the engine.

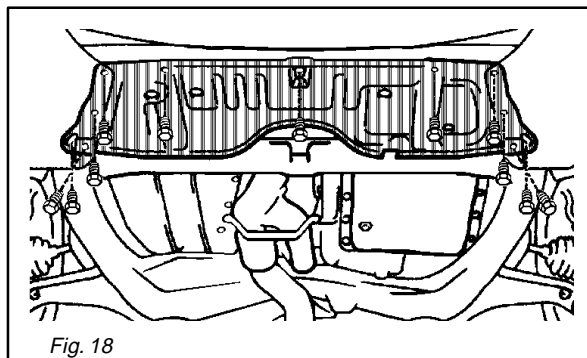
- K. Shut off the engine and reinstall the center engine under cover with 9 bolts and 2 screws as shown in figure 18.

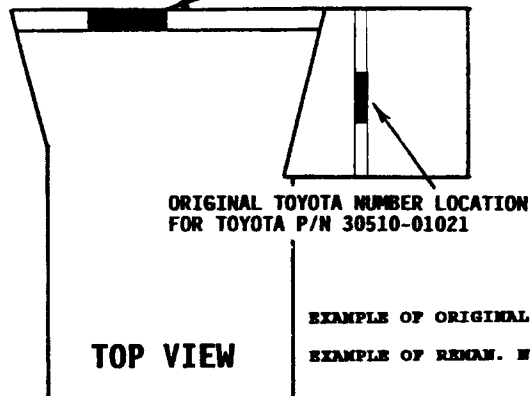
A131L

ORIGINAL TOYOTA NUMBER & REMAN. NUMBER LOCATION
(EXCEPT TOYOTA P/N 30510-01021)

EXAMPLE OF ORIGINAL TOYOTA NUMBER 9AY-0001

EXAMPLE OF REMAN. NUMBER 89AY-0001A X

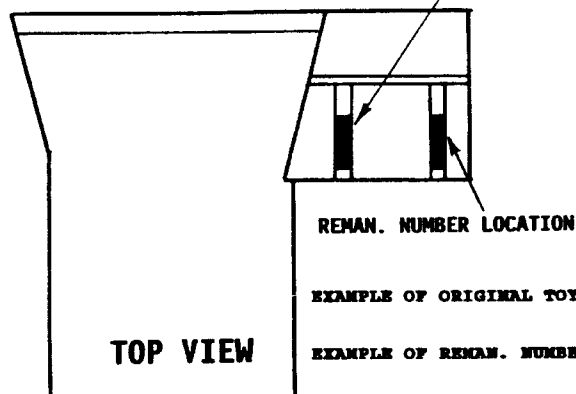
A140E/L

ORIGINAL TOYOTA NUMBER LOCATION

EXAMPLE OF ORIGINAL TOYOTA NUMBER 9A-0001
901-0001

EXAMPLE OF REMAN. NUMBER 9AX-0001A X

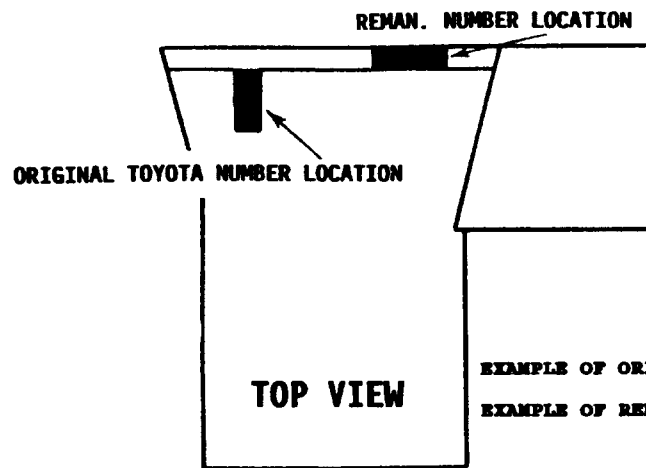
A540E

EXAMPLE OF ORIGINAL TOYOTA NUMBER 901-0001

EXAMPLE OF REMAN. NUMBER 9AX-0001A X

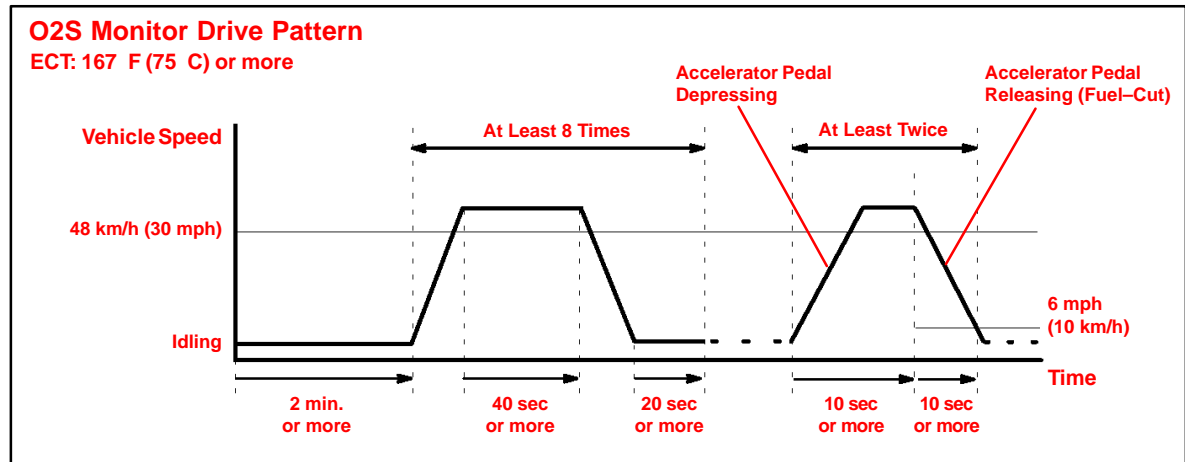
1. Clear any stored Diagnostic Trouble Codes (DTCs) using the Toyota Diagnostic Tester.
2. Start the engine.
3. Perform the drive pattern below to run and complete the Oxygen Sensor (O2S) Monitor.

The O2S Monitor is completed when the following conditions are met:

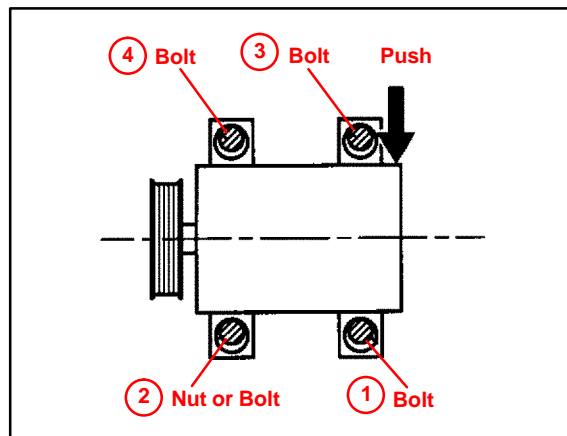
**Installation
Procedure
(Continued)****1. AZ Series Engine:
Install A/C Compressor**

- A. Loosely install the compressor
(with the 3 bolts and nut or
4 bolts.)

Push down on the rear side of the
compressor and tighten the
bolts/nut in the order shown.

Torque: 24.5 N•m (250 kgf•cm, 18 ft•lbf)

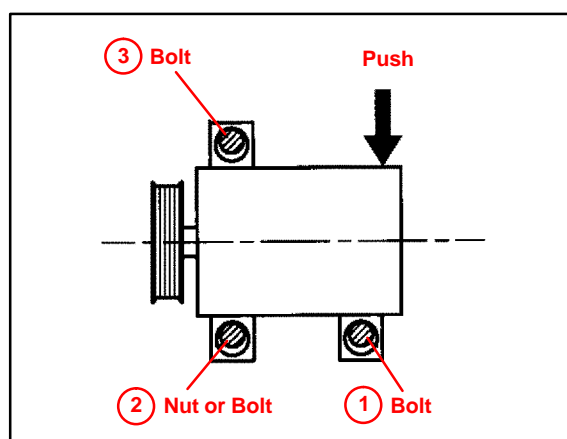
**2. ZZ Series Engine:
Install A/C Compressor**

- A. Loosely install the compressor
(with the 2 bolts and nut or
3 bolts).

Push down on the rear side of
the compressor and tighten the
bolts/nut in the order shown.

Torque: 29 N•m (295 kgf•cm, 21 ft•lbf)

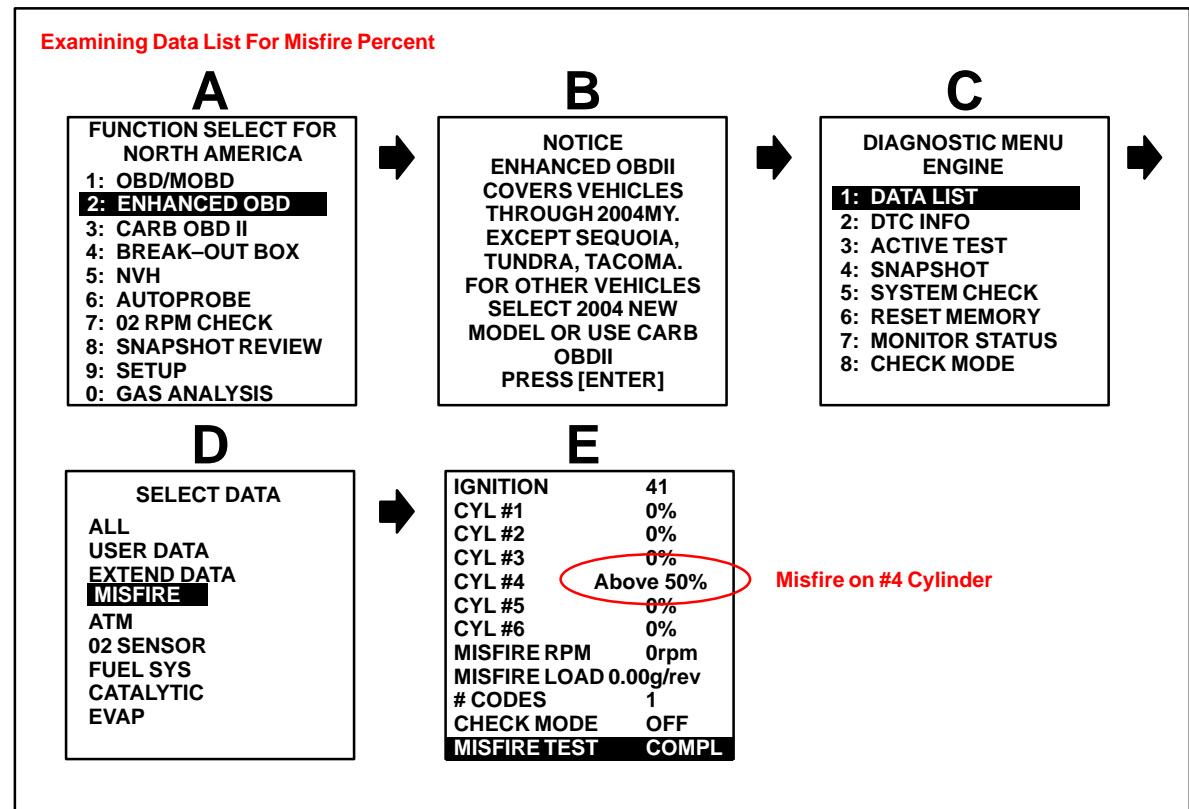
- Confirm if misfire is currently occurring on cylinder(s) identified by DTC(s) using the Diagnostic Tester while engine is idling (see below).
